PROFESSIONAL ENGINEERING INSPECTIONS, INC.

Re: 2094 Huntsville Lane, Houston, Texas

QUALITY INSPECTION REPORT

Mrs. Selma Alabama
2094 Huntsville Lane
Houston, Texas
June 11, 2004

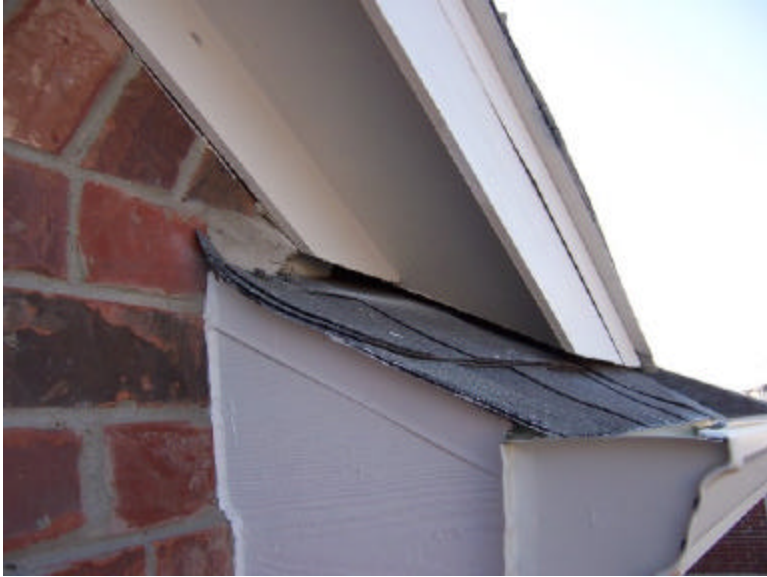
1. There was no head flashing at the eyebrow section of roof at the front gables, including at the front of the garage. Additionally there were large gaps in the cornice work, which can allow animals access to the building.

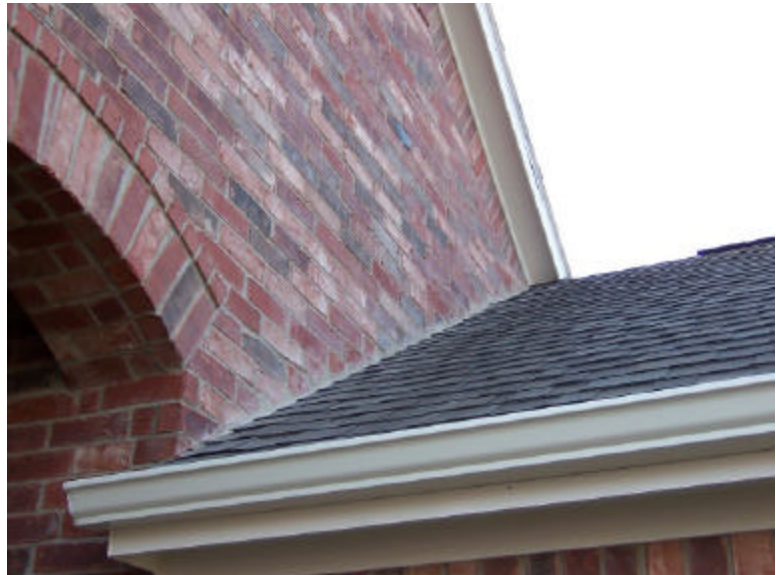
2. The brick veneer installed over the roof of the garage at the front of the building was not installed in accordance with current requirements. This results in the brick resting directly on the surface of the roof and will make reflashing of the roof when future replacement is required more difficult. It is pointed out that this is not an uncommon method of installation of brick by many builders.

7. Brick veneer was resting directly on the surface of the roof over the garage. This makes replacement of the roof more difficult and will make reflashing of the roof more difficult at this location in the future. If the brick were installed in accordance with current code requirements, replacement of the roof in the future, when necessary, would be more easily performed.

19. Brick veneer had been installed over the surface of the roof at the garage directly on the surface of the shingles. It did not appear that the brick was installed in accordance with current code requirements since there was no steel angle observed to support the brick off the surface of the roof, and it did not appear that the brick was flashed with a through flashing and weep holes to divert water to the outer surface of the brick. It was not determined if bolt fasteners required at the rafters supporting the brick had been installed since they are not visible after construction. Many builders install brick in this manner, even though it is not the specified method of installation in accordance with code requirements.

2. Brick siding was resting directly on the surface of the roof over the garage. This can make replacement and reflashing of the roof more difficult.

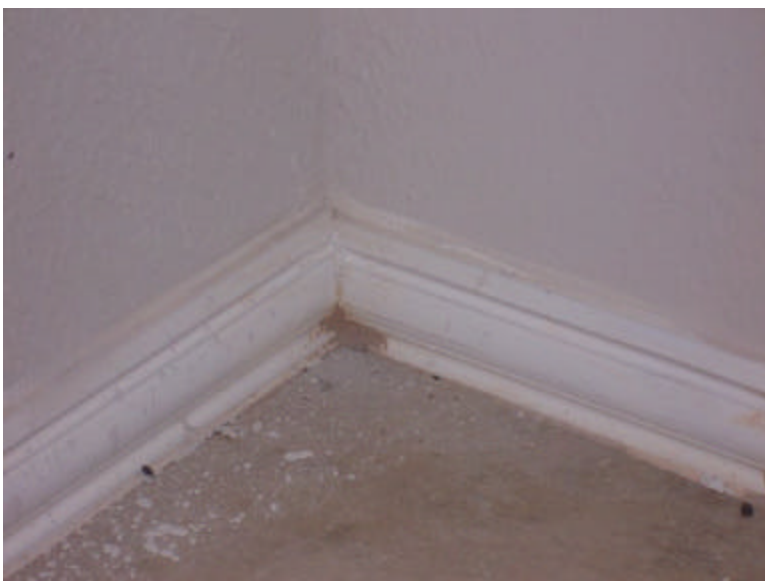
3. Floor tiles were installed above the surface of the base molding. This created a depression with the tile around the perimeter of the rooms, which held dirt.

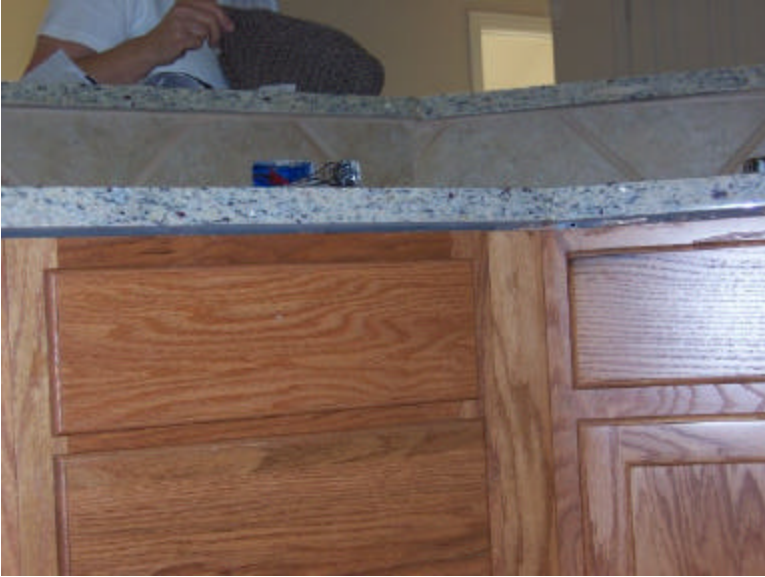
- 4. There was an unsightly gap between the granite counter and the cabinet at the kitchen.

- 5. There was an unsightly gap between the granite counter and the cabinet at the dinette.

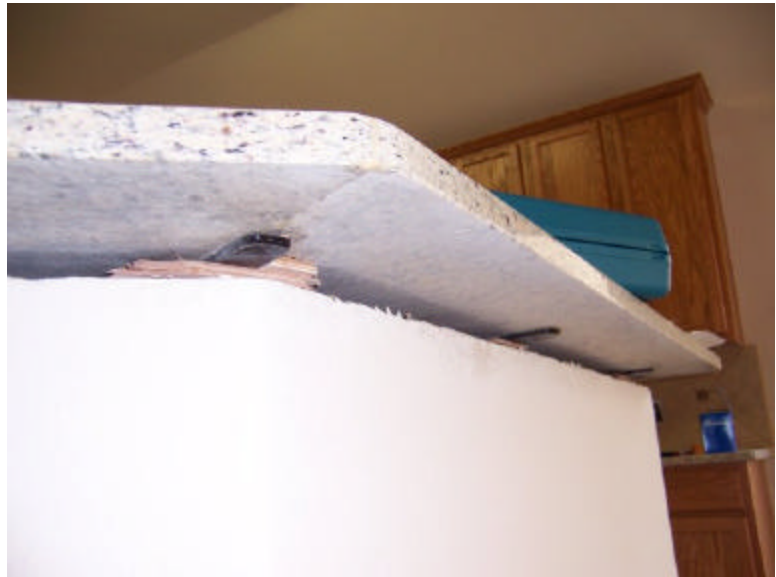
1. The column at the rear porch was installed at the wrong location, preventing proper installation of the cornice work around the top of the column. It is recommended that this column be torn down and relocated.

32. The column at the rear porch was constructed at the wrong location, leaving a gap between the brick veneer column and the cornice work at the northeast corner of the porch. It is recommended that the column be torn down and replaced.

- 6. The column at the northeast corner of the rear porch was improperly located and needs to be removed and replaced in the correct position.

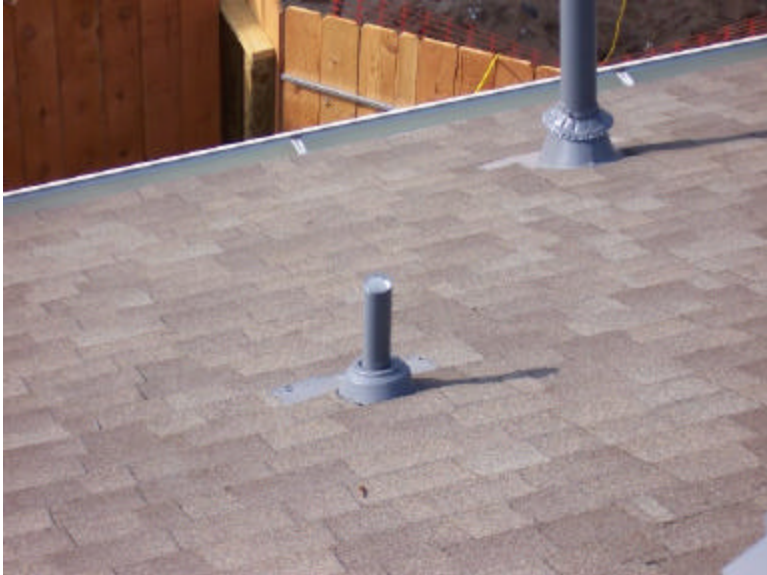
9. There was a neoprene seal at a plumbing vent roof jack at the south roof over the area of the utility room that was pushed down around the plumbing vent and will hold water. This is likely to allow water penetration into the building and is in need of repair.

7. There was a neoprene seal that was improperly positioned over the utility room. This seal will hold water and leak in the future.

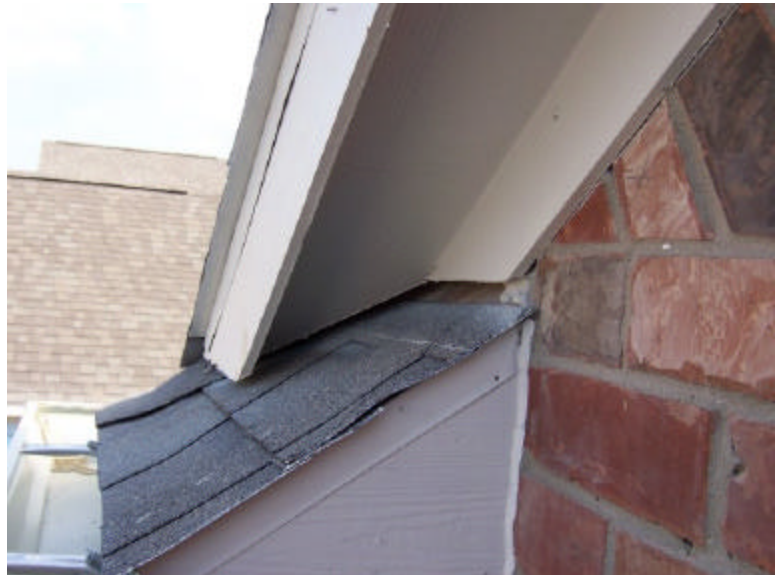
8. Roof decking was visible over the eyebrow roof at the front of the dining room due to the lack of a properly installed head flashing and roofing felt.

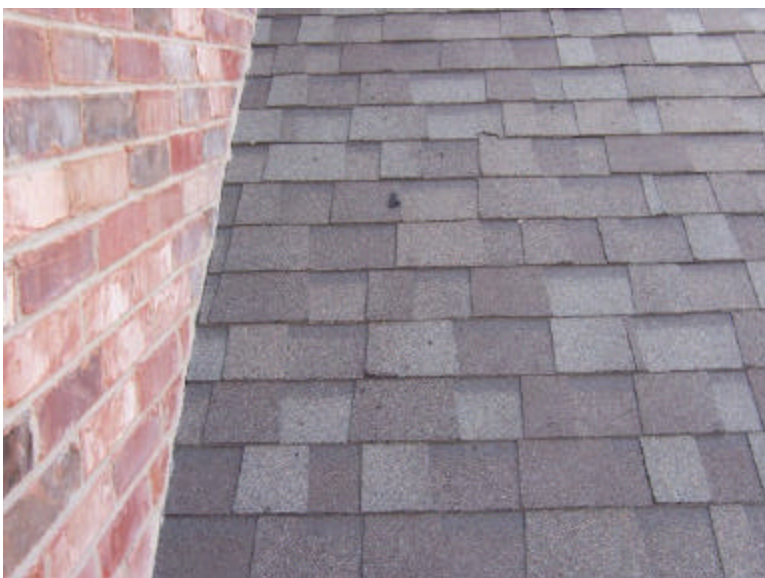
3. Nail holes could be observed through the surface of the roof over the front of the garage, and there is a need for replacement of these shingles to prevent leaks in the future.

4. There were large unrepaired or improperly repaired nail holes left in the roof surface including nail holes through the roof over the garage. All holes should be located and repaired in a permanent manner by a qualified roofer.

9. Nail holes existed in the roof over the north side of the garage, which will leak. These shingles should be replaced.
