PROFESSIONAL ENGINEERING INSPECTIONS, INC.

STRUCTURAL INSPECTION REPORT

Mr. Austin Conroe
9305 Cleveland
Houston, Texas
August 1, 2007

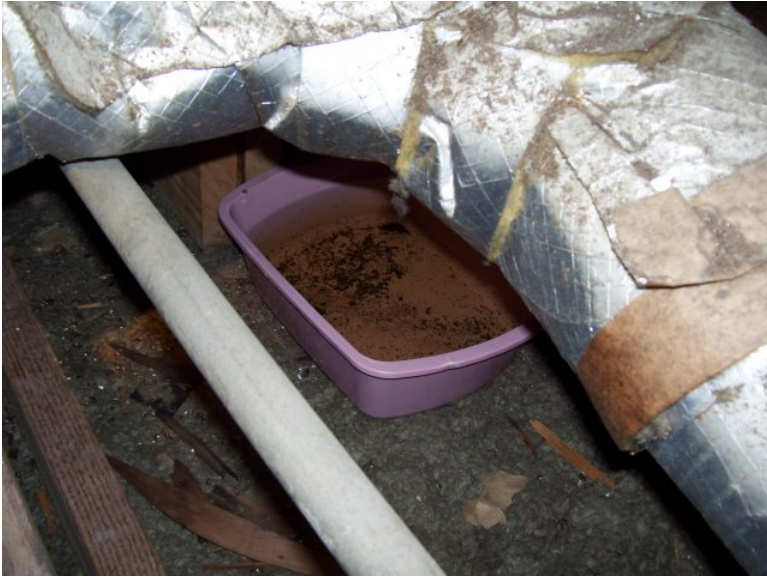
2. The composition shingle roof was showing premature signs of wear and deterioration in the form of: worn shingles.
3. Catch basins were noted in the attic at possible points of roof leakage. The catch basins may or may not be necessary at the current time. They may have been necessary before repairs were made, so further inquiry of the current owner is recommended. Reference Photograph 1

1. Catch basins were noted in the attic at possible points of roof leakage. The catch basins may or may not be necessary at the current time. They may have been necessary before repairs were made.

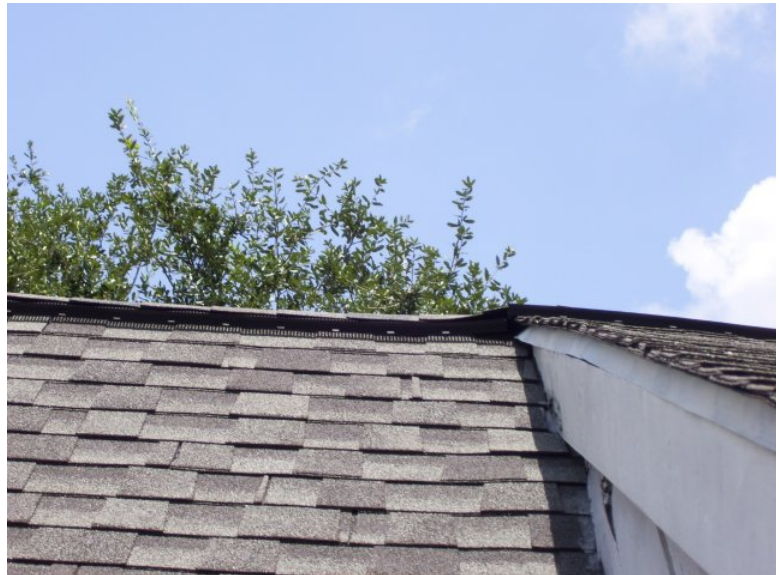
2. The ridge vent was continuous at the change in pitch of roof along the main ridge. This left openings where animals may be able to gain access to the attic space through the ridge vent or water penetration may be able to occur.

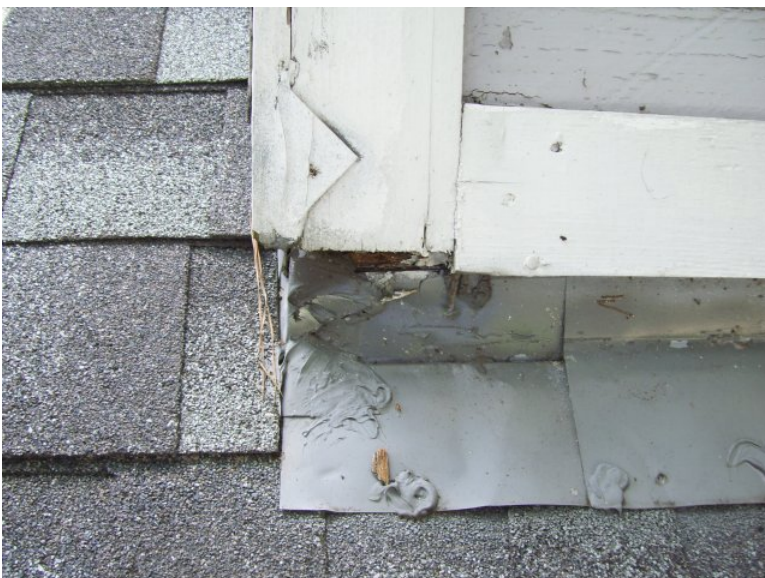
10. The flashing installation at the front dormer was improper where the top edge of the head flashing was visible. This will allow water to bypass the flashing at this location and run into the structure of the building. Many of the evidences of water entry at the interior of the building appeared to occur under areas where roof-to-wall flashings exist, and it appeared possible that some of these locations may still be active leaks. There is a need for evaluation and repair of the roof-to-wall flashings as necessary to prevent further water penetration into the building. Due to the deteriorated condition of the siding, it may be possible to evaluate or replace all flashings to ensure that water entry is not occurring or is corrected in these areas with replacement of the siding. Reference Photograph 3

3. The flashing installation at the front dormer was improper where the top edge of the head flashing was visible. This will allow water to bypass the flashing at this location and run into the structure of the building.

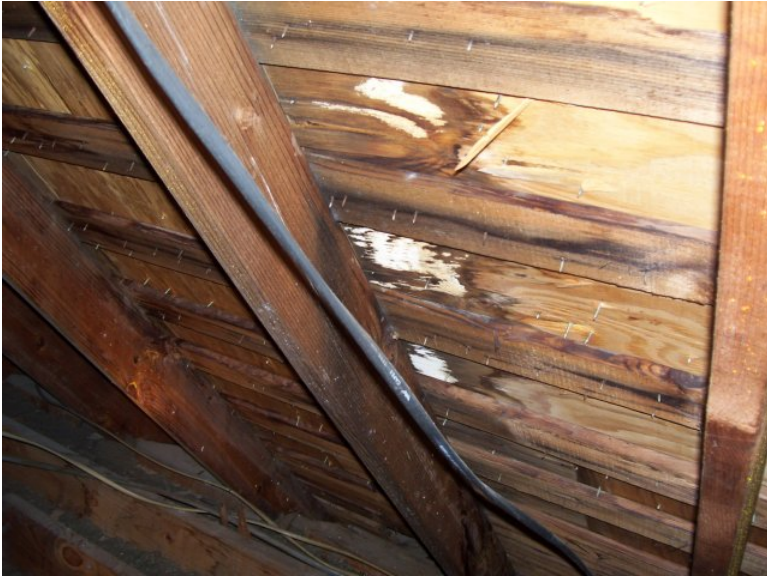
12. The roof decking was deteriorated below the southwest corner of the upstairs dormer adjacent to the center bedroom. There is evidence that the flashings at this location may not be well fitted and may be the cause for evidences of water penetration at this location. A catch basin full of water located below this area indicates that leaks through the roof may be active in some areas,

including this location, and should be further investigated by a roofer, which will require some disassembly of the siding to determine if there is a defect in the installation of the flashing. Reference Photograph 4

4. The roof decking was deteriorated below the southwest corner of the upstairs dormer adjacent to the center bedroom. There is evidence that the flashings at this location may not be well fitted and may be the cause for evidences of water penetration at this location. A catch basin full of water located below this area indicates that leaks through the roof may be active in some areas.

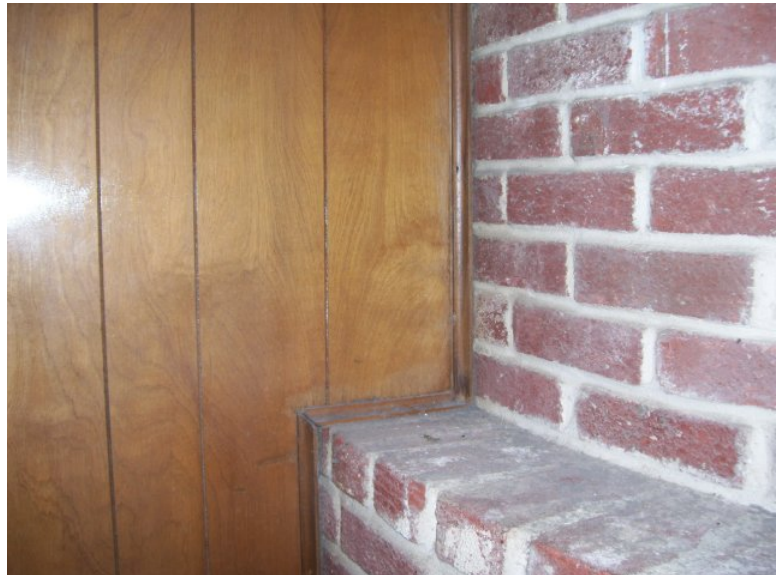
13. Stains could be observed around the fireplace, including damage to the paneling. This appeared to be related to water penetration around the south dormer roof-to-wall interfaces or fireplace flue. It could not be determined if these are indicative of current water entry and warrant further investigation. Reference Photograph 5

5. Stains could be observed around the fireplace, including damage to the paneling. This appeared to be related to water penetration around the south dormer roof-to-wall interfaces or fireplace flue.

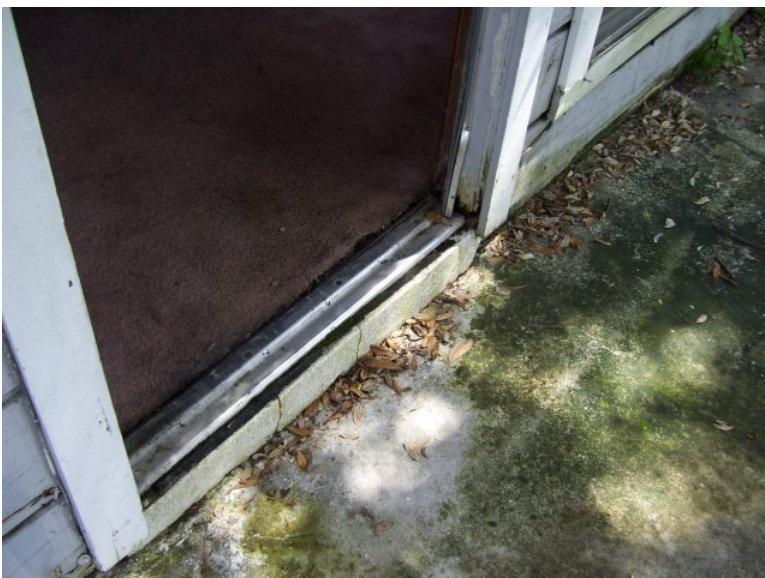
2. Vulnerability to termite infestation was observed where siding was in contact with a concrete surface that is not monolithic with the foundation. Subterranean termites can enter the structure below or through the siding without being observed. Reference Photograph 6

6. Vulnerability to termite infestation was observed where siding was in contact with a concrete surface that is not monolithic with the foundation. Subterranean termites can enter the structure below or through the siding without being observed.

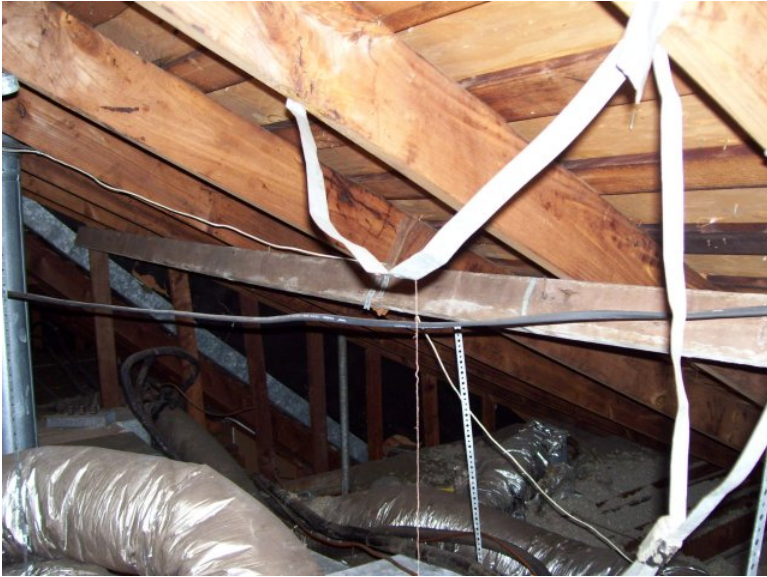
7. Vertical bracing normally used to support the mid span of the roof rafters did not exist where the warm air furnace had been installed.

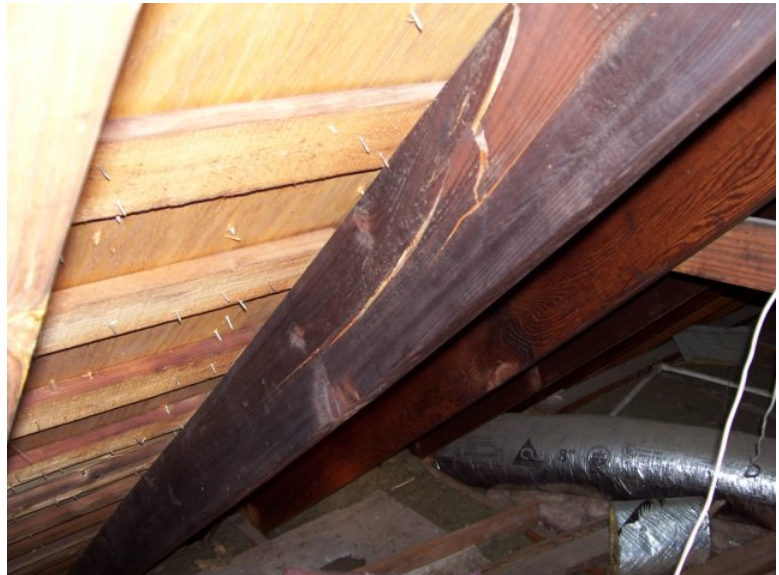
8. It was observed that one or more of the roof rafters were split and/or cracked and should be repaired to provide adequate strength for the roof surface. Reference Photograph 8

8. It was observed that one or more of the roof rafters were split and/or cracked and should be repaired to provide adequate strength for the roof surface.

Broken rafters could be observed at the attic space. Repair of the broken rafters where they exist is recommended.

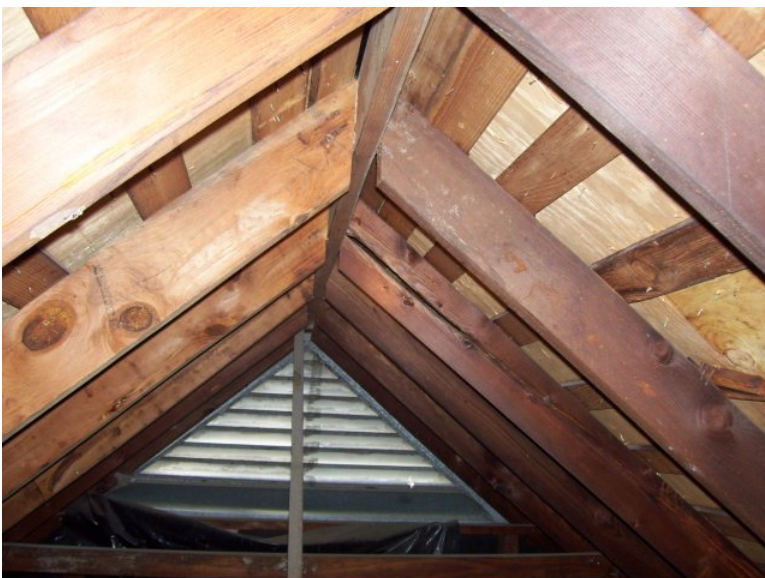
9. The ridge beams were not wide enough to support the entire width of the miter cut on the end of the roof rafters. Even though this is a common observation, the greatest strength requires that the ridge beam be wide enough to uniformly distribute the roof load across all the width of the rafter miter cuts.

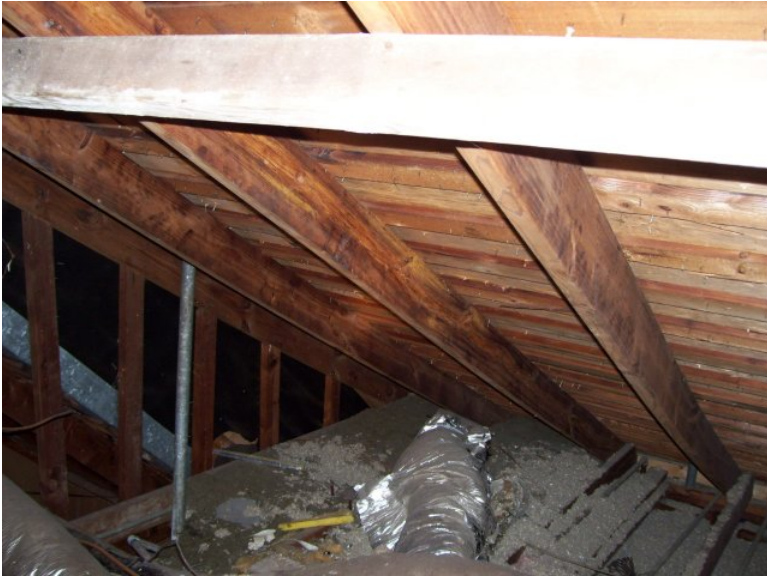
12. The quality of a rafter over the area of the furnace appeared to be poor. The rafter was performing satisfactorily; however, the deterioration at the rafter may reduce its strength. Reference Photograph 10

10. The quality of a rafter over the area of the furnace appeared to be poor. The rafter was performing satisfactorily; however, the deterioration at the rafter may reduce its strength.

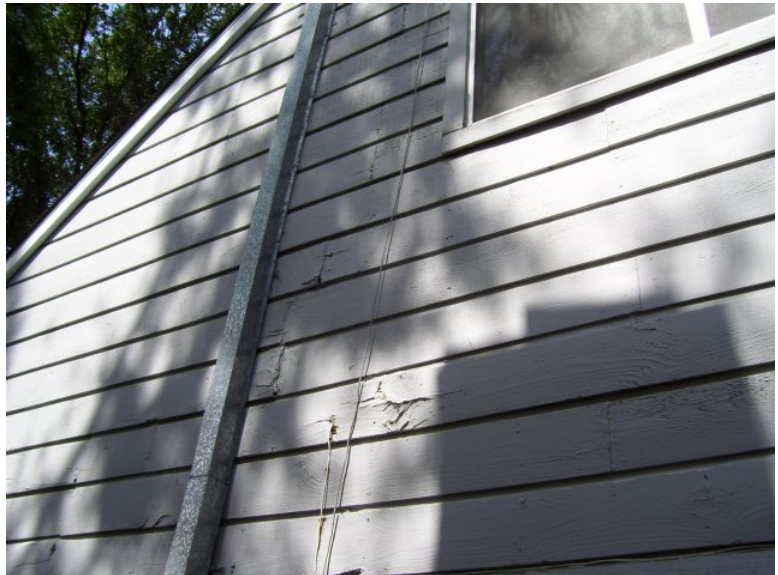
11. Some of the exterior siding was observed to be in need of repair or replacement due to loose and rotted siding at many locations around the perimeter of the house and garage.

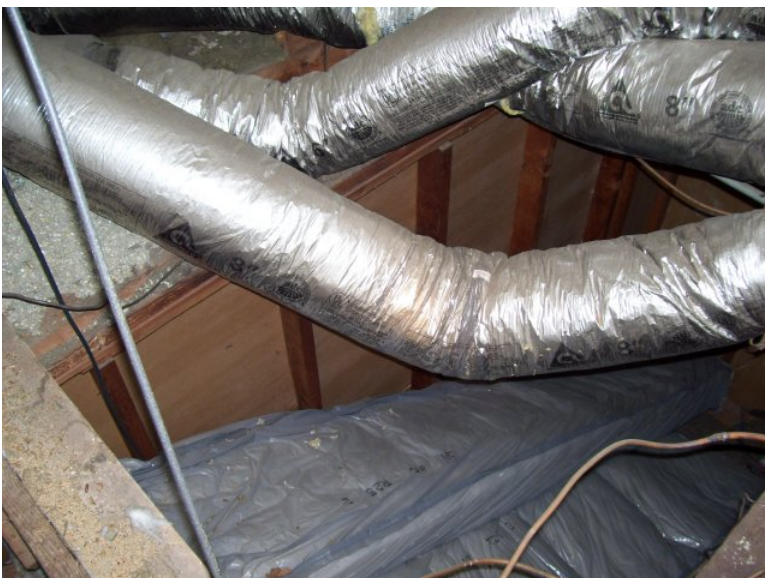
12. The attic insulation was observed to be missing or out of place at the den, at the vertical walls at the south attic and at the attic over the stairs, which can result in loss of energy.

result in loss of energy. The insulation should be replaced. Reference Photograph 12

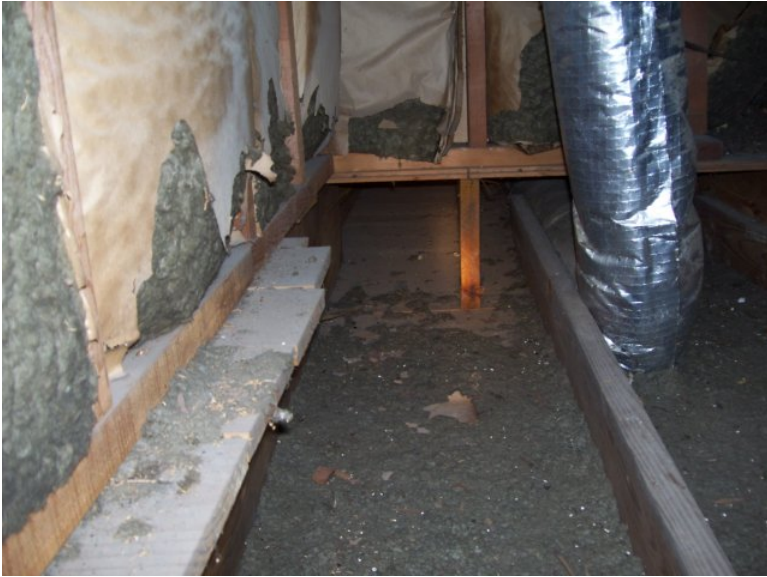
13. The space between the upstairs floors and the downstairs ceilings was open to the attic and uninsulated. This can be a significant source of energy loss that can be eliminated by insulating or sealing the opening.

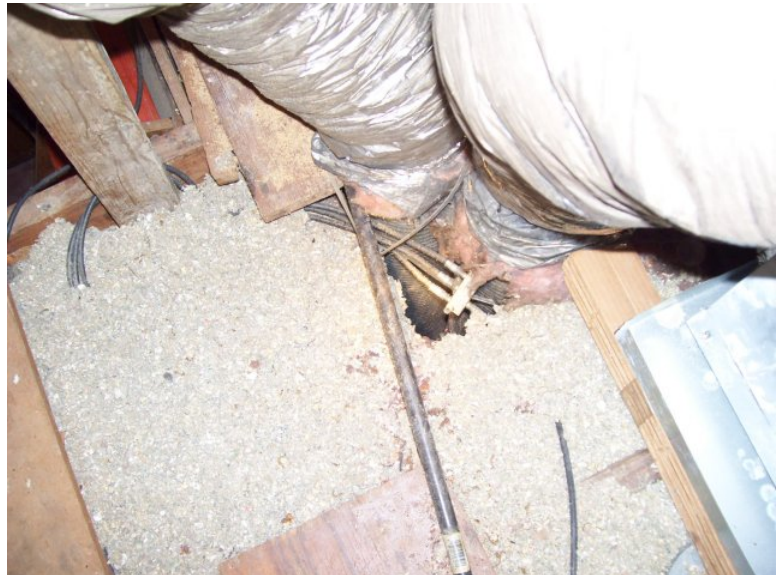
14. Some of the uninsulated interior walls of the house were open to the attic at duct chases to the lower floors, which will result in loss of energy during the seasonal extremes. The openings around the ducts should be sealed and covered with insulation.

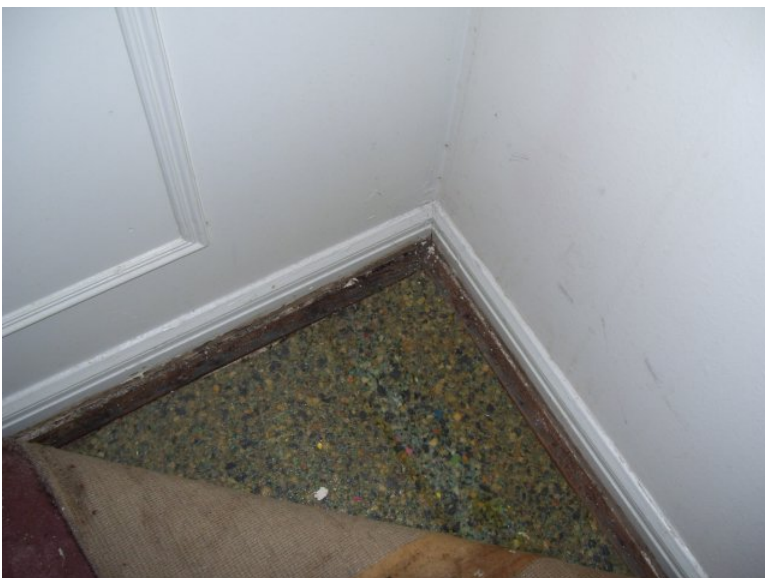
15. Evidence of water entry, past or current, was observed at several locations, including at the north side of the living room, as indicated by stains in the tack strip and carpeting along the north wall; at the dining room, as indicated by stains in the tack strip along the north wall; and at the north bedroom at the northwest corner of the room, as indicated by stains in the tack strip.

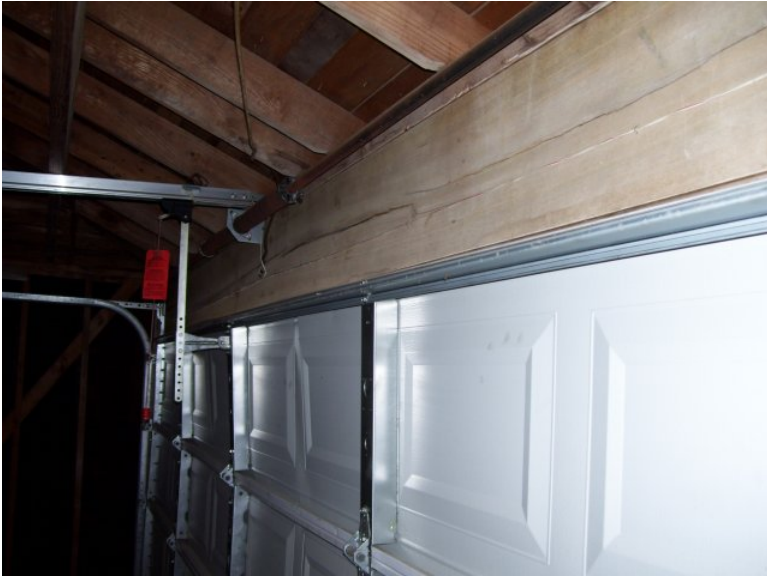
16. Panels at the overhead garage door were bent or damaged at some locations, which may require replacement of sections of the door in order to improve its appearance to a normal condition.

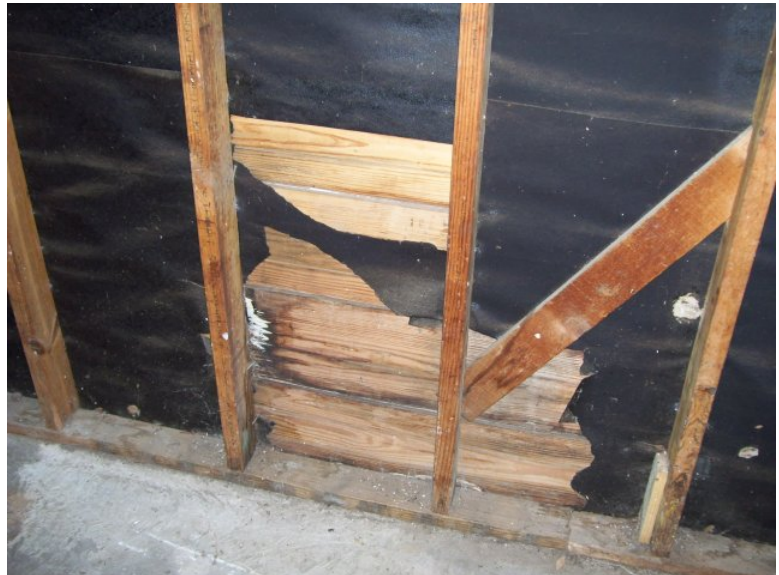
17. The vapor barrier was missing behind the siding at the garage area and may allow water penetration into the building since the siding was rotting away at the ends of the planks at some locations.

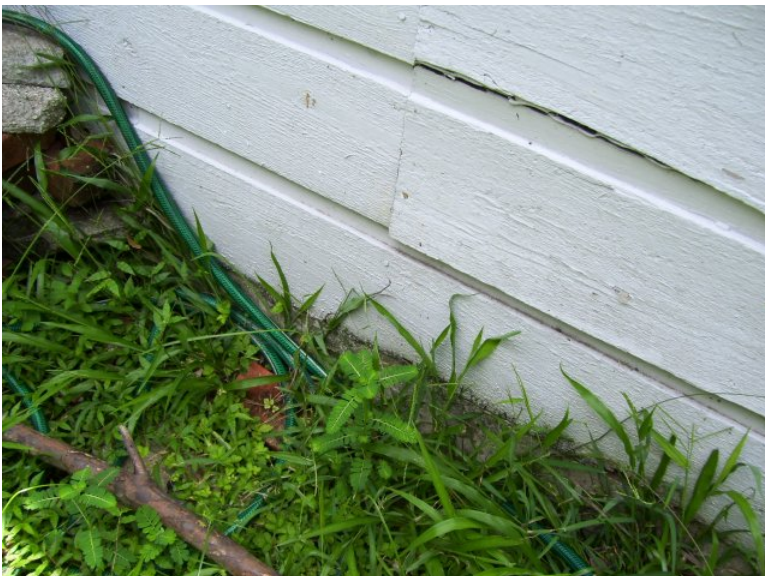
18. Siding along the west side of the garage did not appear to lap the edge of the foundation. This creates a potential for water running down the siding to run onto the foundation and into the garage if not corrected.

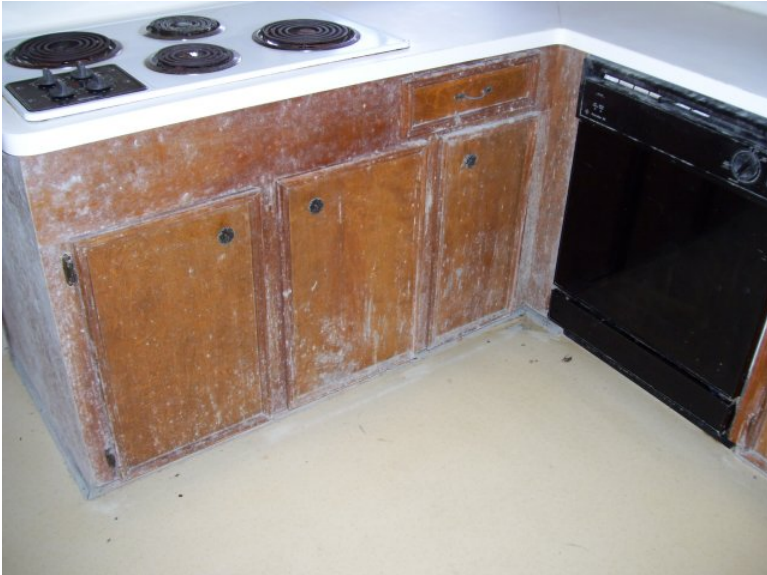
19. Mildew could be observed on many of the finished surfaces at the interior of the building, indicating a higher than normal humidity at the interior of the building.

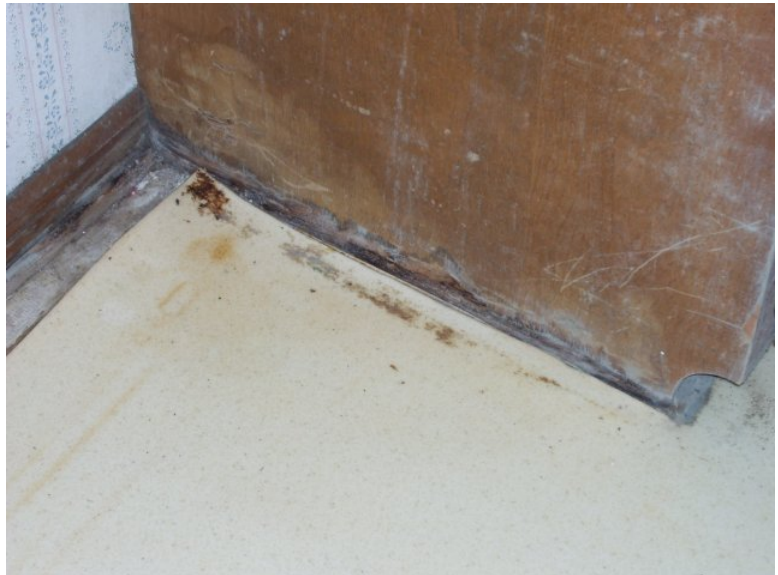
20. Cabinetry at the kitchen area was rotted along the base of the cabinetry. This may be related to water entry or failure of the mechanical equipment or plumbing inside the building.

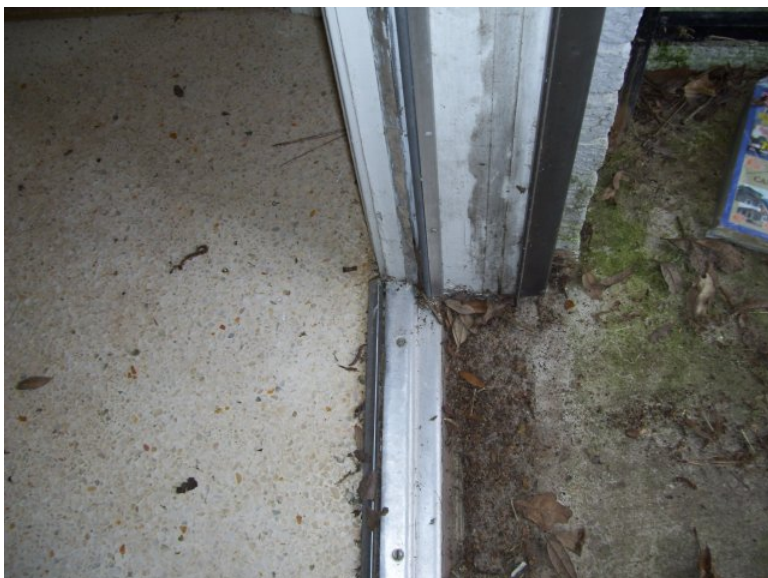
21. The threshold at the entry porch appeared to be at or above the floor height at the entry foyer. This may allow water blowing onto the front porch to run in around the entry door threshold and may be difficult to repair due to its configuration.
