PROFESSIONAL ENGINEERING INSPECTIONS, INC.

FOUNDATION QUALITY INSPECTION REPORT

Mr. John Smith
1234 Myword Dr.
Houston, Texas
May 24, 2017

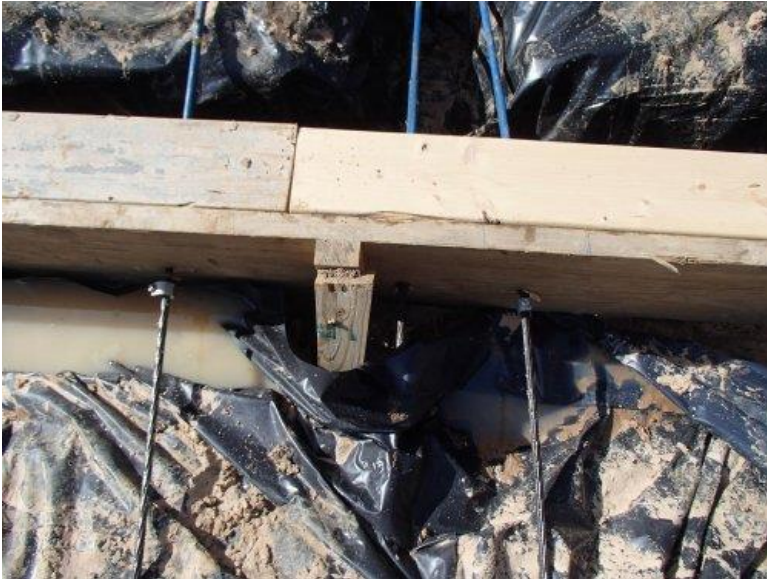
2. Grading of the soil to obtain acceptable drainage at the perimeter of the foundation has not been implemented. It is recommended that the yard grading be accomplished in accordance with the recommendations contained in the attached Foundation Care Information sheet. The soil should be graded to slope away from the edge of the foundation with a slope of at least 1 inch per foot for approximately 4 feet, and there should be at least 4 inches between the surface of the soil and the top of the floor or concrete deck in the building. Reference Photograph 1

1. Grading of the soil to obtain acceptable drainage at the perimeter of the foundation has not been implemented. The soil should be graded to slope away from the edge of the foundation with a slope of at least 1 inch per foot for approximately 4 feet, and there should be at least 4 inches between the surface of the soil and the top of the floor or concrete deck in the building.

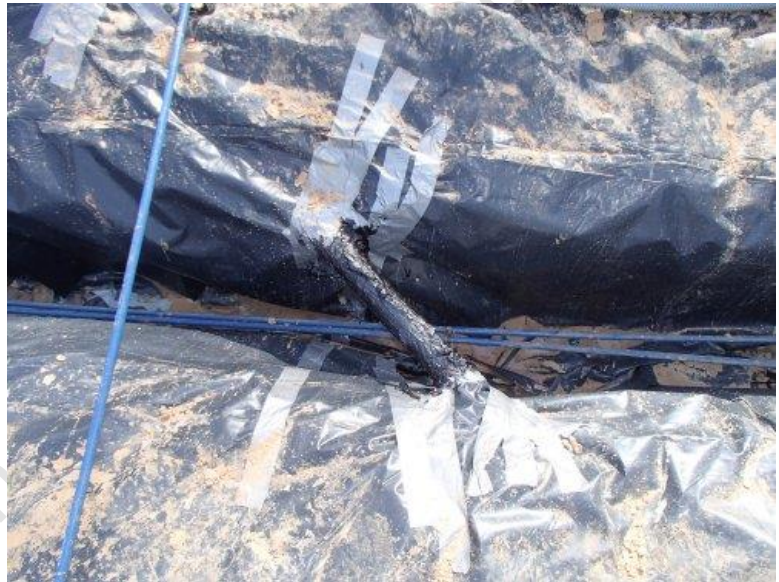
5. No sleeves had been installed at the plumbing penetrations of the concrete slab or beams. Sleeves are necessary to prevent the concrete from chemically damaging the pipe and from being so tight around the pipes that damage can occur. Reference Photograph 2

2. No sleeves had been installed at the plumbing penetrations of the concrete slab or beams. Sleeves are necessary to prevent the concrete from chemically damaging the pipe and from being so tight around the pipes that damage can occur.

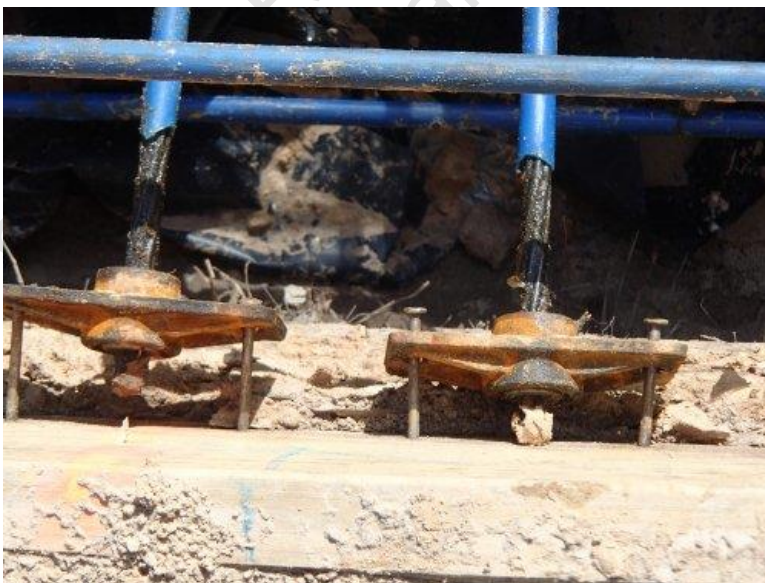
8. The fixed ends of the reinforcing tendons were in contact with the forms. The cables should be installed hung against forming nails to ensure a minimum of ¾ inches between the ends of the tendons and the surface of the finished concrete. Failure to properly install the cable ends can result in corrosion failure of the anchor point, leaving a portion of the foundation without sufficient reinforcement. Reference Photograph 3

3. The fixed ends of the reinforcing tendons were in contact with the forms. The cables should be installed hung against forming nails to ensure a minimum of 3/4 inches between the ends of the tendons and the surface of the finished concrete. Failure to properly install the cable ends can result in corrosion failure of the anchor point, leaving a portion of the foundation without sufficient reinforcement.

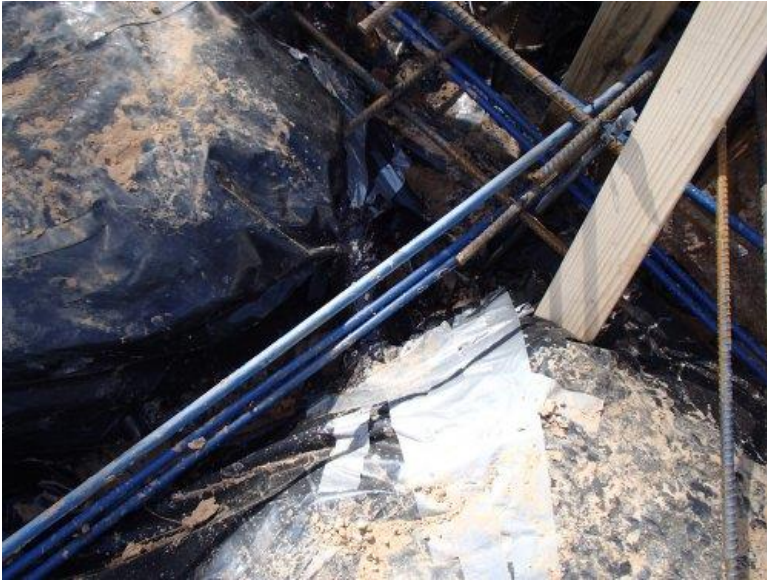
9. Plumbing lines occupied the bottom of grade beam trenches and affecting the proper placement of the reinforcing cables. This may affect the performance of the cables and their ability to provide sufficient reinforcing to the beams. Reference Photograph 4

4. Plumbing lines occupied the bottom of grade beam trenches and affecting the proper placement of the reinforcing cables. This may affect the performance of the cables and their ability to provide sufficient reinforcing to the beams.

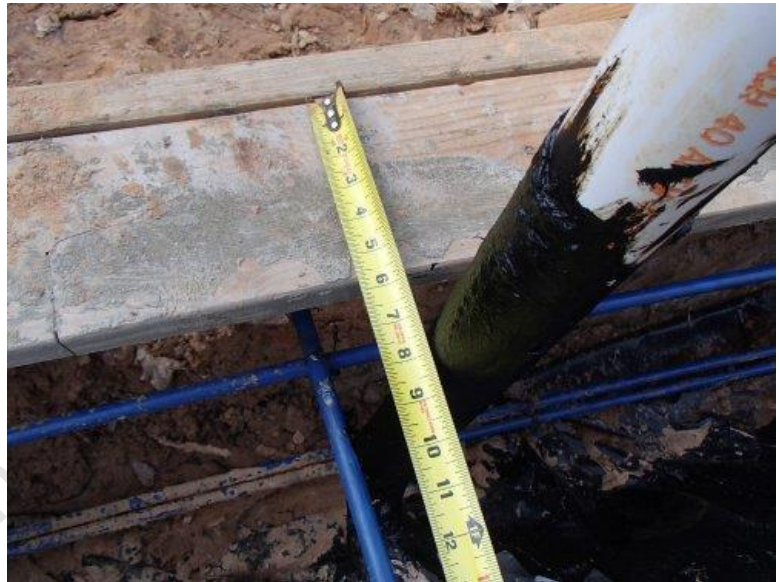
4. There were openings observed to be located within the high stress zone behind the anchor of a tendon. The area 18 inches behind the anchor and at an angle of 45 degrees from the back of the anchor should be free of items that could cause failure of the concrete. The presence of the opening may result in a blowout during tensioning activities. The engineer of record should be consulted for special provisions where penetrations are necessary in this area.

12. There were openings observed to be located within the high stress zone behind the anchor of a tendon. The area 18 inches behind the anchor and at an angle of 45 degrees from the back of the anchor should be free of items that could cause failure of the concrete. The presence of the opening may result in a blowout during tensioning activities. The engineer of record should be consulted for special provisions where penetrations are necessary in this area. Reference Photograph 5

5. There were openings observed to be located within the high stress zone behind the anchor of a tendon. The area 18 inches behind the anchor and at an angle of 45 degrees from the back of the anchor should be free of items that could cause failure of the concrete. The engineer of record should be consulted for special provisions where penetrations are necessary in this area.

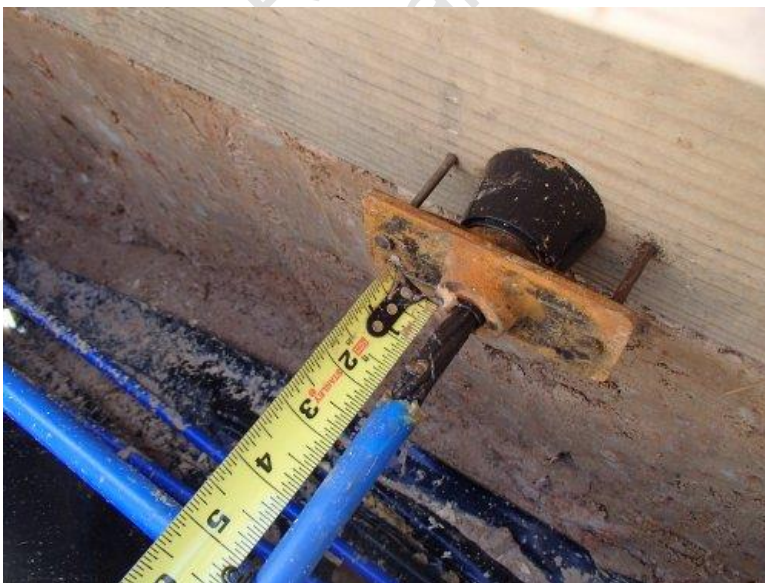
13. The protective sheathing had been excessively cut away from the tendons at the anchors to allow installation of the cables through the anchor points, leaving a portion of the tendons exposed. No more than one inch of the cable should be left exposed. The sheathing should be repaired to prevent bonding between the concrete and cable as the concrete cures, which can prevent proper tensioning of the cables. Reference Photograph 6

6. The protective sheathing had been excessively cut away from the tendons at the anchors to allow installation of the cables through the anchor points, leaving a portion of the tendons exposed. No more than one inch of the cable should be left exposed. The sheathing should be repaired to prevent bonding between the concrete and cable as the concrete cures, which can prevent proper tensioning of the cables.

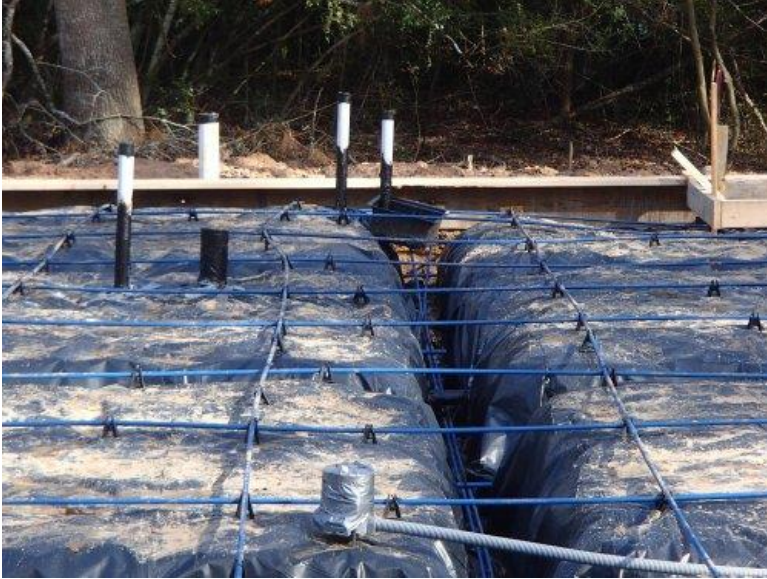
15. Cables were observed to deviate excessively from their intended path. The cables should be straightened to ensure that the cables can be properly tensioned and to reduce the introduction of undesirable stresses in the concrete. Reference Photograph 7

7. Cables were observed to deviate excessively from their intended path. The cables should be straightened to ensure that the cables can be properly tensioned and to reduce the introduction of undesirable stresses in the concrete.

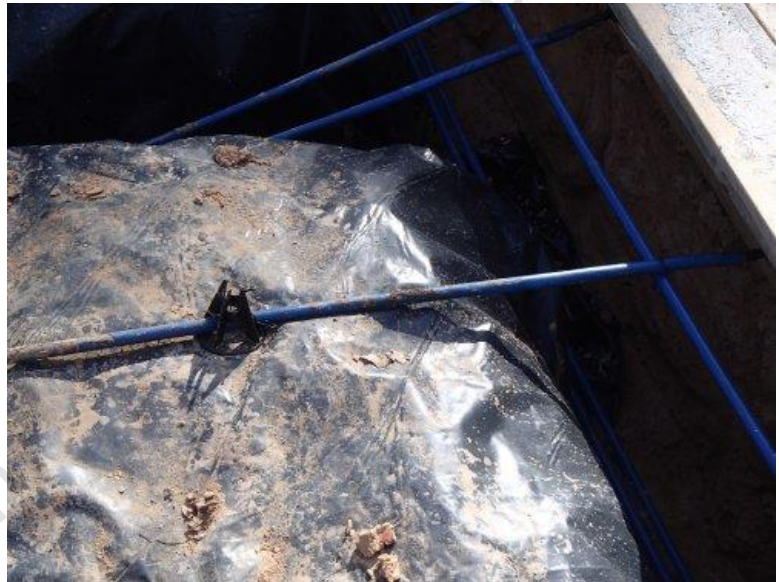
16. Tendons were observed to be draped down across the top of the pad edge. This condition will prevent the tendon from being properly encapsulated in the concrete which may cause the tendon to be damaged during tensioning and may result in a blowout. The pads should be trimmed or chairs added as necessary to achieve proper clearance between the ground and the tendon. Reference Photograph 8

8. Tendons were observed to be draped down across the top of the pad edge. This condition will prevent the tendon from being properly encapsulated in the concrete which may cause the tendon to be damaged during tensioning and may result in a blowout. The pads should be trimmed or chairs added as necessary to achieve proper clearance between the ground and the tendon.

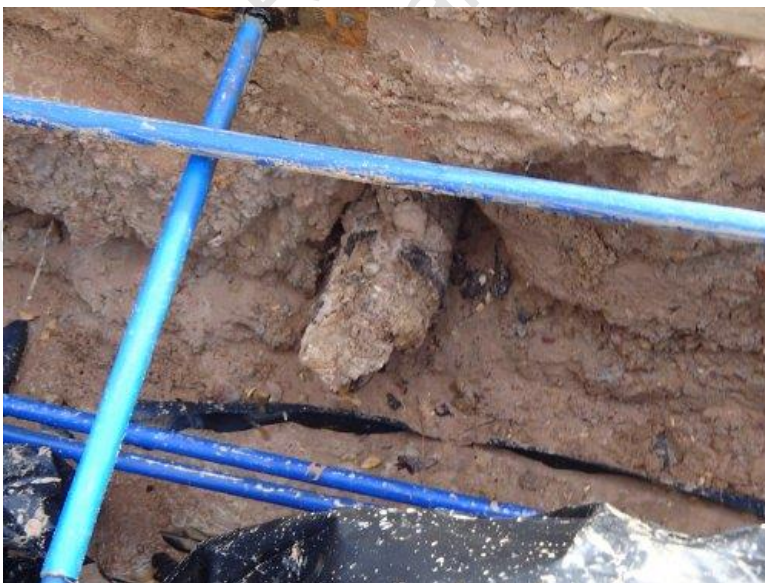
17. A tree root had not been sufficient cut off at the south grade beam allowing it to extend into the grade beam reducing its effective width. The root should be cut at the face of the beam. Reference Photograph 9

9. A tree root had not been sufficient cut off at the south grade beam allowing it to extend into the grade beam reducing its effective width. The root should be cut at the face of the beam.

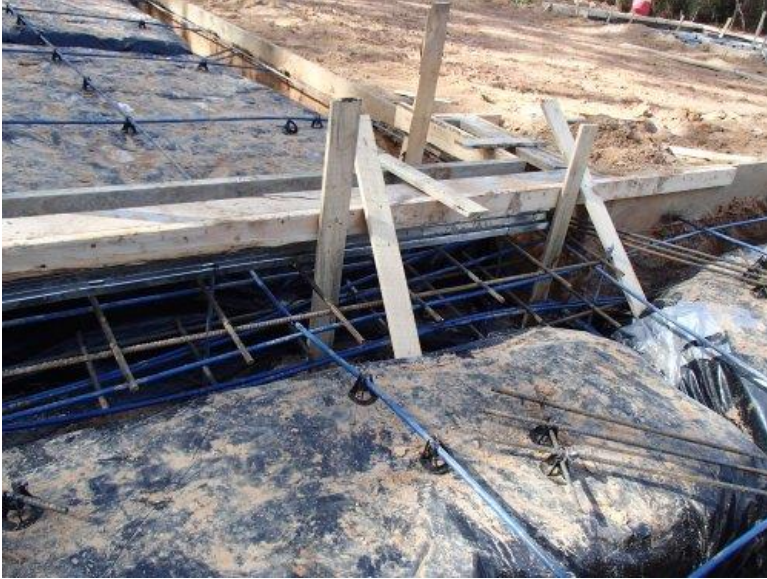
11. The installation of the metal keyway detail at the narrow section of foundation between the house and the south garage was incomplete and should be completed in accordance with the specification detail. It appeared this may require re-setting of the steel pin bars.

18. The installation of the metal keyway detail at the narrow section of foundation between the house and the south garage was incomplete and should be completed in accordance with the specification detail. It appears this may require re-setting of the steel pin bars. Reference Photograph 10

10. The installation of the metal keyway detail at the narrow section of foundation between the house and the south garage was incomplete and should be completed in accordance with the specification detail. It appears this may require re-setting of the steel pin bars.

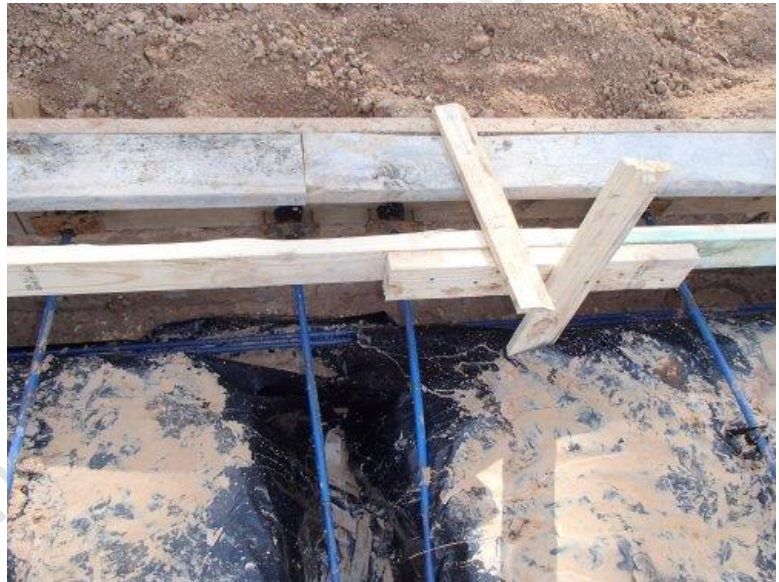
19. Reinforcing tendons were in contact with the sides of the beams where the double tendons spread at the bottoms of the beams to attach at the forms. It is required that there be a 2 inch coverage at this location and there is a need to modify the beams to accommodate this spread. Reference Photograph 11

11. Reinforcing tendons were in contact with the sides of the beams where the double tendons spread at the bottoms of the beams to attach at the forms. It is required that there be a 2 inch coverage at this location and there is a need to modify the beams to accommodate this spread.

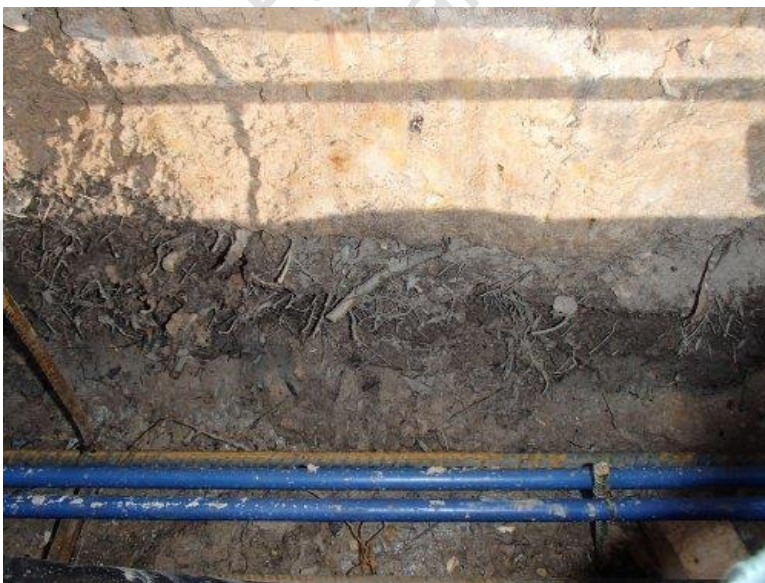
1. There was a layer of organic material observed between the virgin soil at the site and the fill soil which appeared to be the original forest floor. The observed debris included braches and leaves. This material should have been removed before placement of the fill because it may result in differential movement of the building's foundation in the future. This is an indication of poor site preparation, which may require reworking of the fill and should be brought to the attention of the engineer of record and/or the soils engineer who can make specific recommendations for further testing to determine the quality of site preparations if testing has not already been performed and corrective actions that may be necessary.

20. There was a layer of organic material observed between the virgin soil at the site and the fill soil which appears to be the original forest floor. The observed debris included braches and leaves. This material should have been removed before placement of the fill because it may result in differential movement of the building's foundation in the future. This is an indication of poor site preparation that may require reworking of the fill and should be brought to the attention of the engineer of record and/or the soils engineer who can make specific recommendations for further testing to determine the quality of site preparations if testing has not already been performed and corrective actions which may be necessary. Reference Photograph 12

12. There was a layer of organic material observed between the virgin soil at the site and the fill soil which appears to be the original forest floor. The observed debris included braches and leaves. This material should have been removed before placement of the fill because it may result in differential movement of the building's foundation in the future.

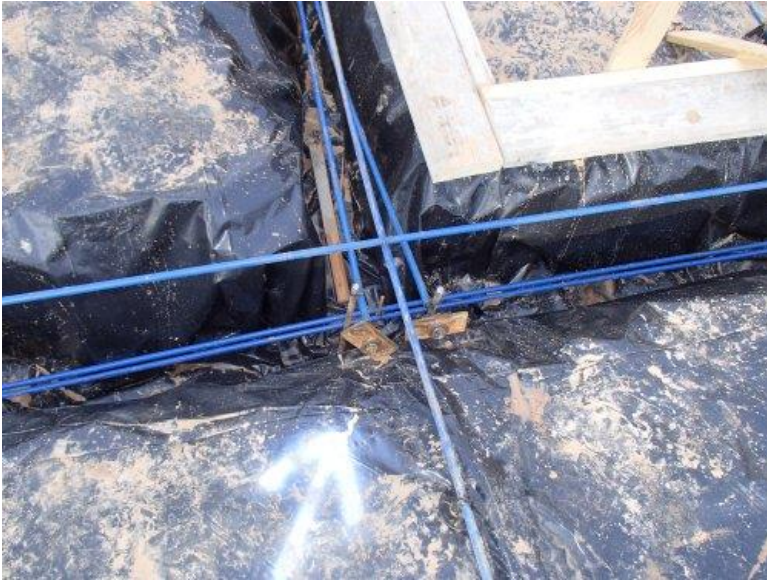
21. The dead ends of tendons terminating inside the forms were set too high and should terminate in accordance with the plans that appear to specify that they terminate at the interior of the beams. Reference Photograph 13

13. The dead ends of tendons terminating inside the forms were set too high and should terminate in accordance with the plans which appears to specify the at the interior of the beams.

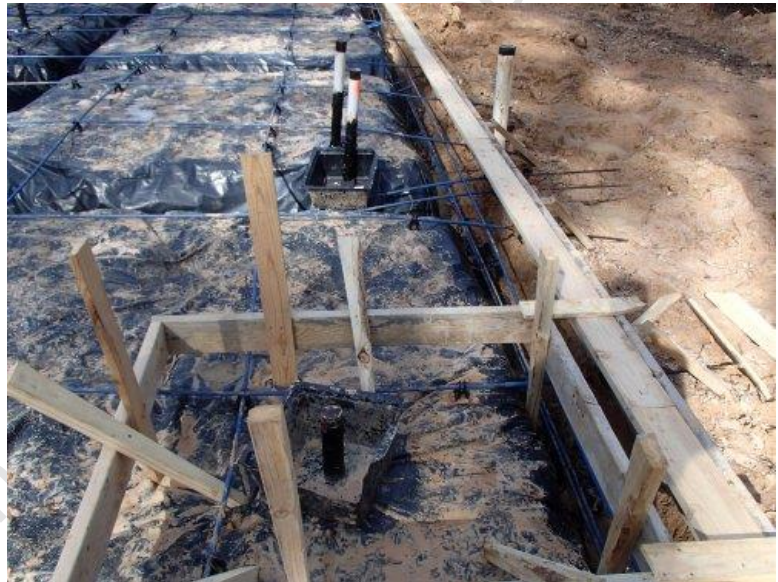
2. The vent pipe for the shower area at the east side of the forms was not identified. Independent plumbing vents for each drain appeared to exist except at this location. The existence and location of each vent should be verified prior to placement of concrete. If a vent does not exist or if "wet venting" is improperly implemented, it can result in siphoning of the drain trap allowing sewer gasses in the building after construction.

22. The vent pipe for the shower area at the east side of the forms was not identified. Independent plumbing vents for each drain appears to exist except at this location. The existence and location of each vent should be verified prior to placement of concrete. If a vent does not exist or if "wet venting" is improperly implemented it can result in siphoning of the drain trap allowing sewer gasses in the building after construction. Reference Photograph 14

14. The vent pipe for the shower area at the east side of the forms was not identified. Independent plumbing vents for each drain appears to exist except at this location. The existence and location of each vent should be verified prior to placement of concrete. If a vent does not exist or if “wet venting” is improperly implemented it can result in siphoning of the drain trap allowing sewer gasses in the building after construction.

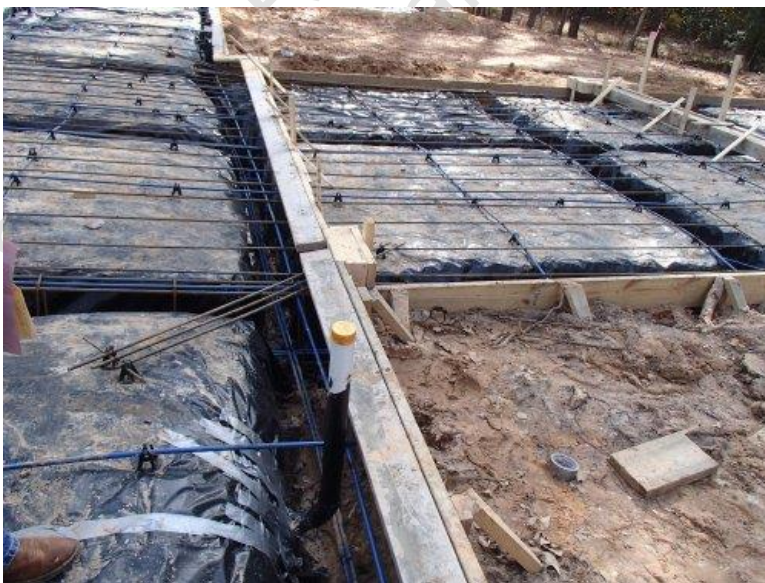
23. Brick ledges were not level at some locations and may hold water. This can increase the potential for water entry through the slab affecting the performance of interior floors and finishes. This should be corrected at locations including along the west side of the main house near the porte-cochere. Reference Photograph 15

15. Brick ledges were not level at some locations and may hold water. This can increase the potential for water entry through the slab effecting the performance of interior floors and finishes. This should be corrected at locations including along the west side of the main house near the porte-cochere.

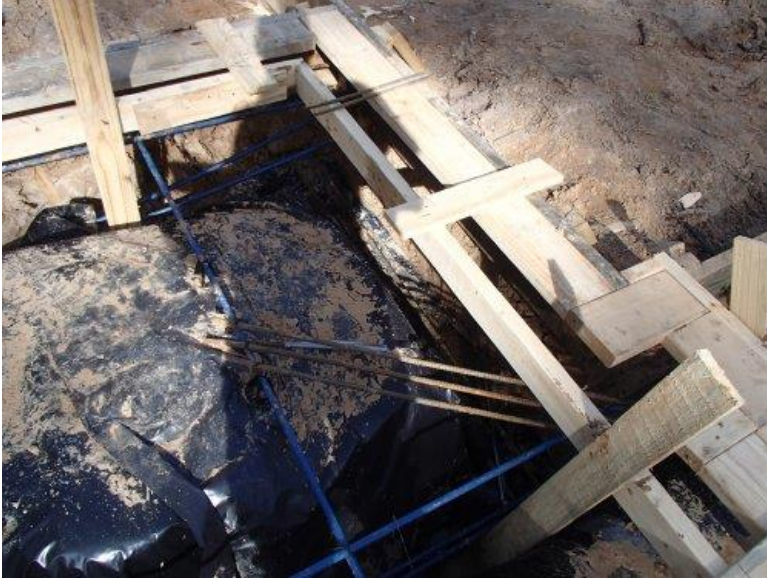
24. Reinforcing steel was missing in the forms at some locations where it was specified at the beams, including at the north side of the building. The steel should be placed in accordance with the plans. Reference Photograph 16

16. Reinforcing steel was missing in the forms at some locations where it was specified at the beams, including at the north side of the building. The steel should be placed in accordance with the plans.

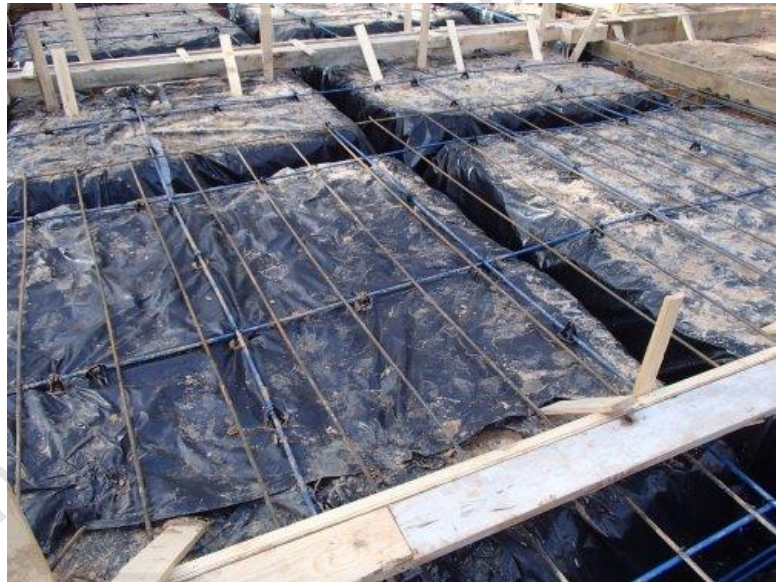
25. The reinforcing bar at the mat created at the porte-cochere was not adequately supported by chairs and should be supported in accordance with the specifications. Reference Photograph 17

17. The reinforcing bar at the mat created at the porte-cochere was not adequately supported by chairs and should be supported in accordance with the specifications.
