PROFESSIONAL ENGINEERING INSPECTIONS, INC.

TOPOUT QUALITY INSPECTION REPORT

Mr. John Smith
1235 Myword Dr.
Houston, Texas
May 24, 2017

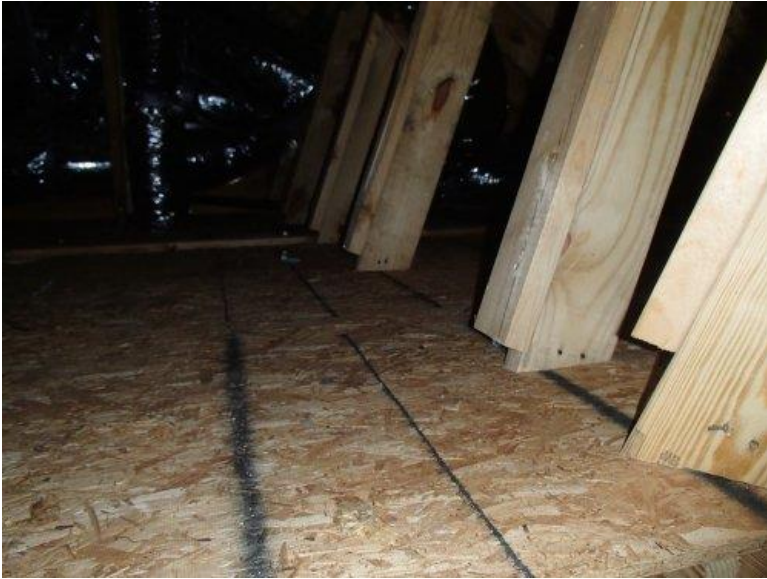
1. It appears as though vertical bracing at the attic has been installed between the roof and the open area of a ceiling at the master bathroom. Vertical bracing should only be applied between the roof and the load-bearing walls or between the roof and specially designed beams.

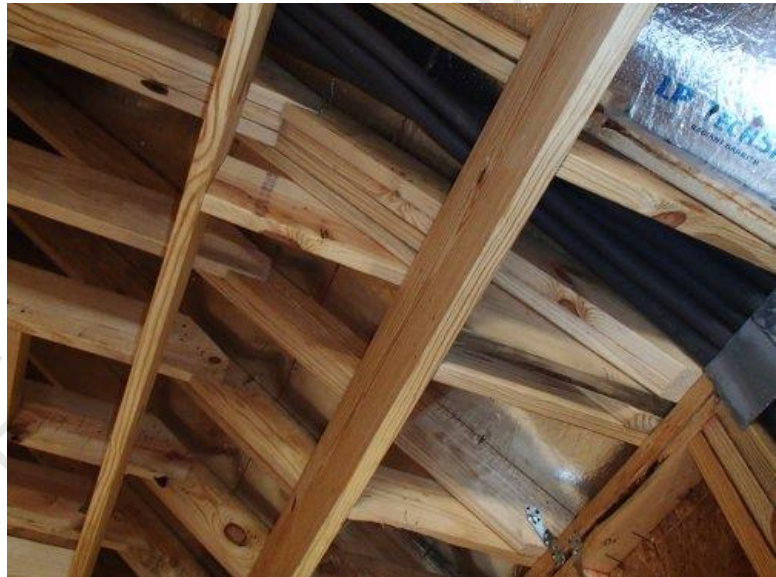
2. A beam installed across the ceiling of the master bedroom was blocked to the top plate of the wall along the side of a rafter rather than allowing the beam to straddle the rafter, creating a stronger tie-in.

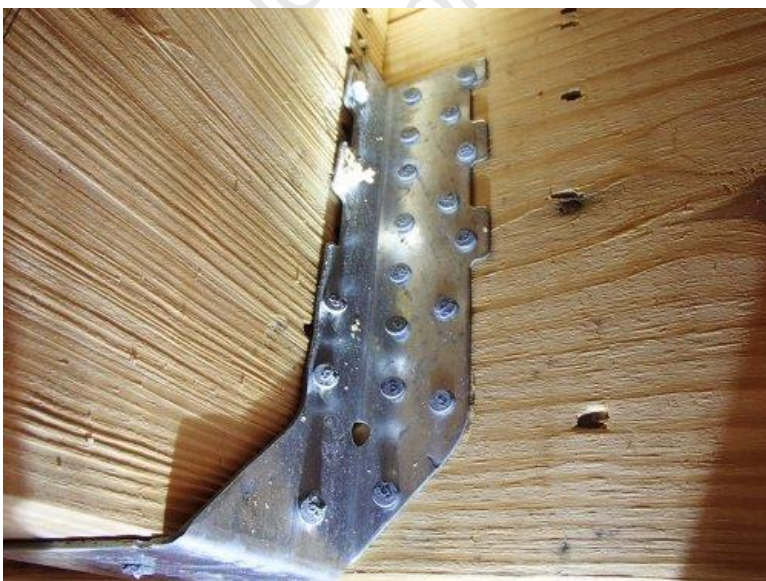
4. A hanger strap carrying the beam across the stairwell opening at the first floor foyer was installed with short nails at the shear nail locations, reducing the strength of the hanger straps. This is indicated by the embossed heads of the nails and should be investigated and repaired. Reference Photograph 3

3. A hanger strap carrying the beam across the stairwell opening at the first floor foyer was installed with short nails at the shear nail locations, reducing the strength of the hanger straps. This is indicated by the embossed heads of the nails and should be investigated and repaired.

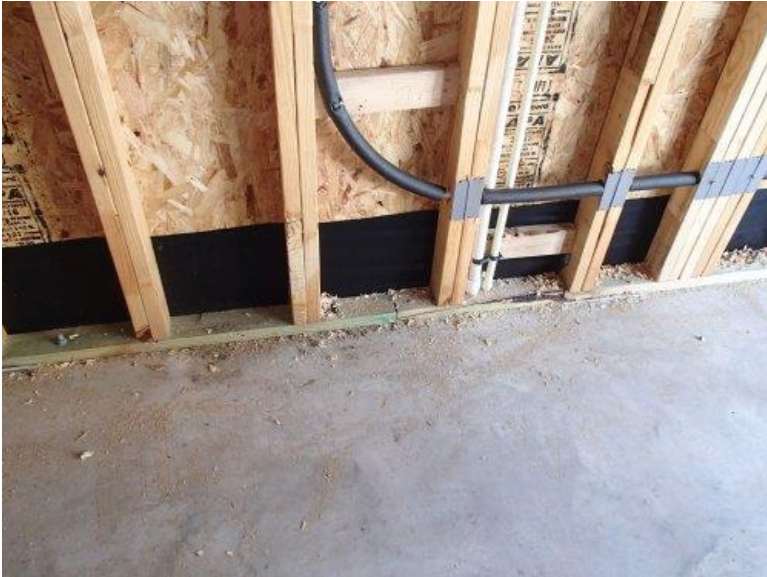
5. Anchor bolts used to secure the lower wall plate to the foundation were missing, where they were not installed within 12 inches of joints around the perimeter of the building at its exterior wall. Reference Photograph 4

- 4. Anchor bolts used to secure the lower wall plate to the foundation were missing, where they were not installed within 12 inches of joints around the perimeter of the building at its exterior wall.

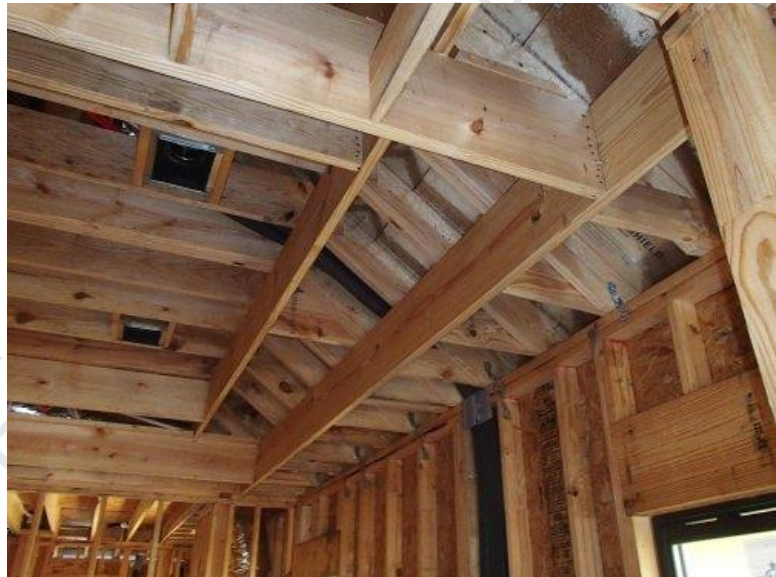
6. Ceiling joists carrying the coffered ceiling at the master bedroom were single joists. Double joists or larger are often used for this configuration to ensure deflections in the ceiling do not result in cracks or irregularities in the corners of the coffer finishes. It appeared some roof load will be transferred to the ceiling at this location since roof rafters cross the ceiling joists. Plans were unavailable for comparison as to the intended method of construction at the time of this inspection. Reference Photograph 5

- 5. Ceiling joists carrying the coffered ceiling at the master bedroom were single joists. Double joists or larger are often used for this configuration to ensure deflections in the ceiling do not result in cracks or irregularities in the corners of the coffer finishes. It appeared some roof load will be transferred to the ceiling at this location since roof rafters cross the ceiling joists.

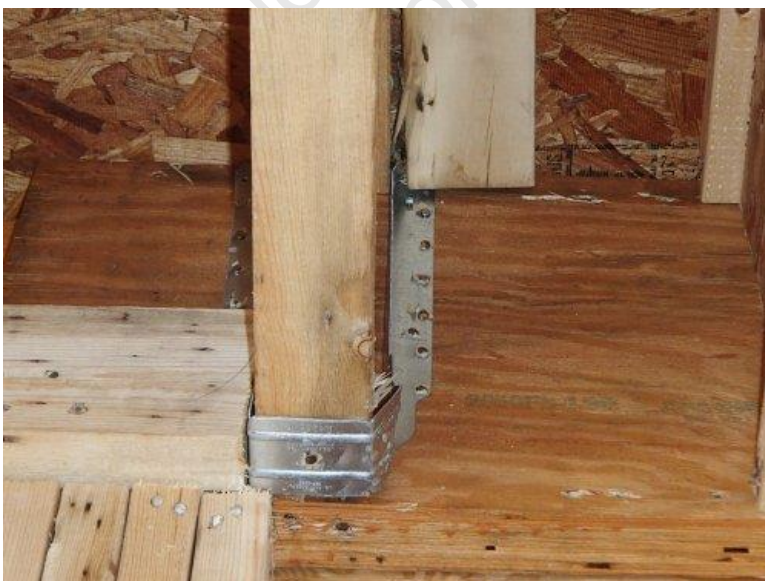
- 6. Hanger straps were bent or distorted at some locations in the building, including in the ceiling at the living room where they attach to the beam over the stairs. This can allow movement of the truss as the floors are loaded, possibly damaging sheetrock finishes in the future.

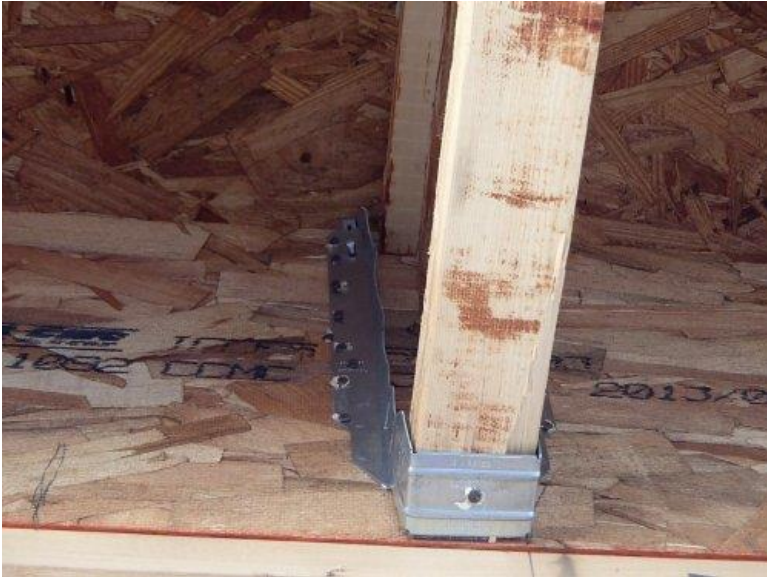
9. Hanger straps were loosely fit at some of the trusses, including: trusses over the living room stairs, trusses at the living room ceiling, trusses at the front porch, and trusses below the balcony at the east side of the first floor bedroom. Loose fitting hanger straps that do not extend up the

sides of the joists or trusses to touch the top cord have a greater potential to allow flexing of the trusses, which can result in noisy conditions. Reference Photograph 7

7. Hanger straps were loosely fit at some of the trusses, including: trusses over the living room stairs, trusses at the living room ceiling, trusses at the front porch, and trusses below the balcony at the east side of the first floor bedroom. Loose fitting hanger straps that do not extend up the sides of the joists or trusses to touch the top cord have a greater potential to allow flexing of the trusses, which can result in noisy conditions.

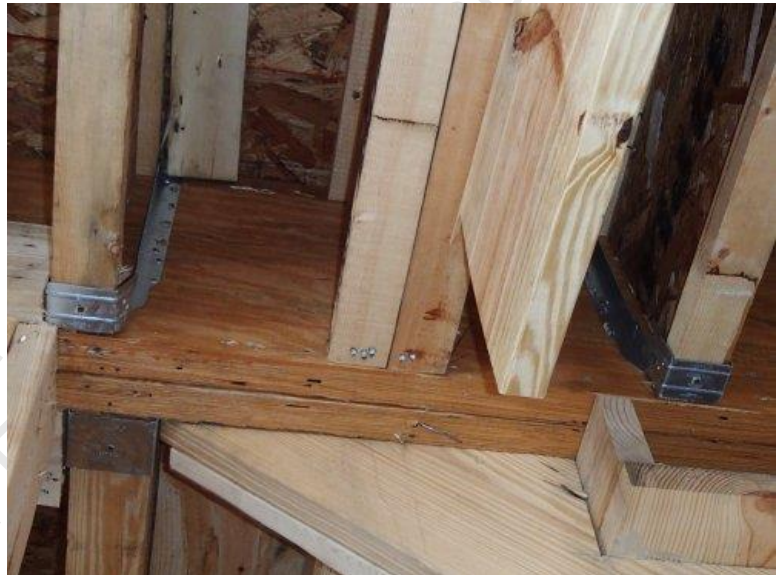
10. Hanger straps were missing at locations, including at the ceiling at the living room, the stairs at the living room, and the master bedroom ceiling. Hanger straps are installed to reinforce beam and joist connections. Reference Photograph 8

8. Hanger straps were missing at locations, including at the ceiling at the living room, the stairs at the living room, and the master bedroom ceiling. Hanger straps are installed to reinforce beam and joist connections.

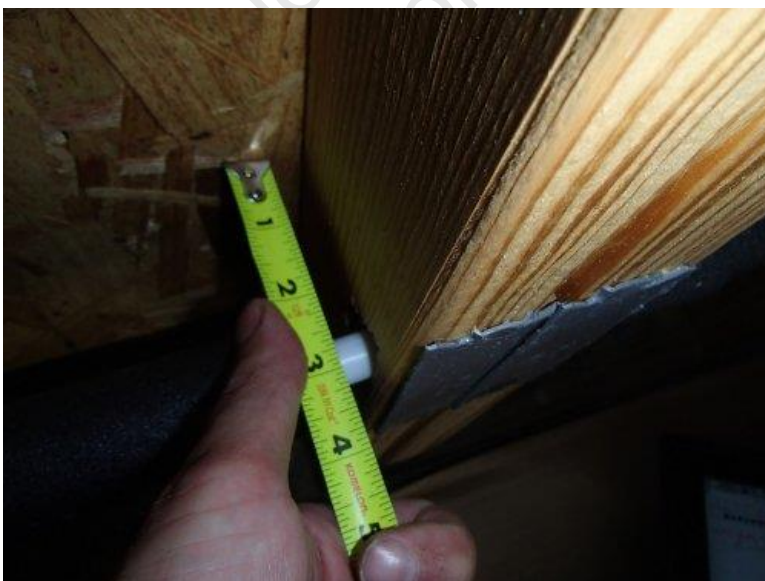
9. Holes were cut too close to the surface of the studs at some locations in the building, including at the downstairs east bedroom. This can reduce the strength of the studs. Holes should never be less than 5/8-inch from the edge of the stud face.

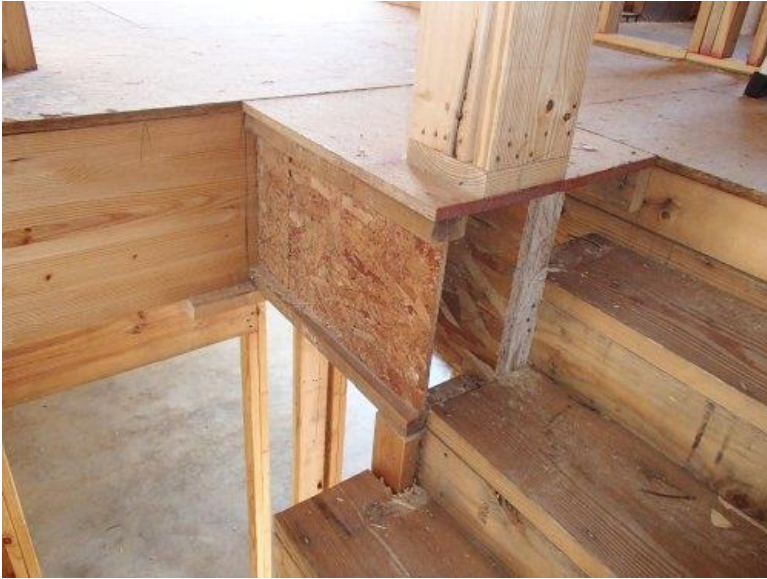
13. It appears there is a need for a compression block at the end of a truss at the edge of the floor decking and supporting a column at the top of the stairs between the first and second floor. Failure to install a compression block at this location may allow compression of the joist, causing it to distort. There was also a hanger strap missing at this joist to the supporting beam. Reference Photograph 10

10. It appears there is a need for a compression block at the end of a truss at the edge of the floor decking and supporting a column at the top of the stairs between the first and second floor. Failure to install a compression block at this location may allow compression of the joist, causing it to distort. There was also a hanger strap missing at this joist to the supporting beam.

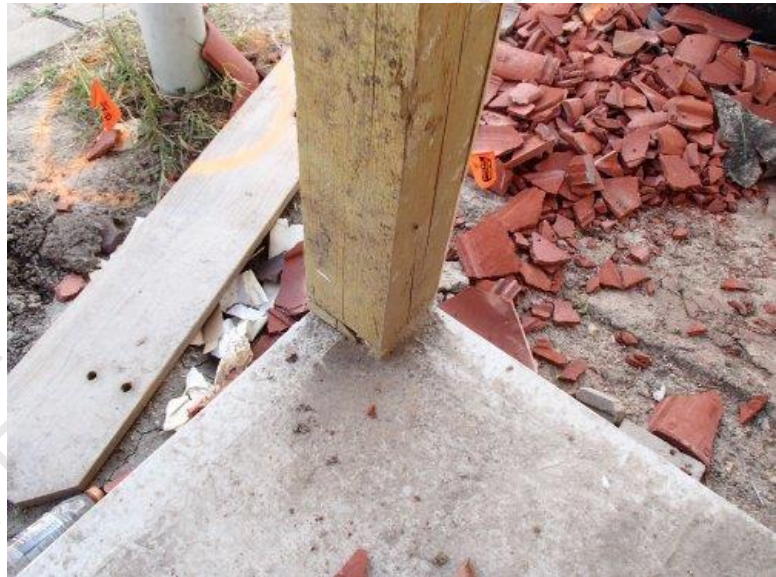
14. It was not determined how the column at the front porch was anchored at the foundation. Reference Photograph 11
15. Nails were missing from stud shoes installed at the south wall of the garage. For them to have their greatest effectiveness, all nails should be installed.

11. It was not determined how the column at the front porch was anchored at the foundation.

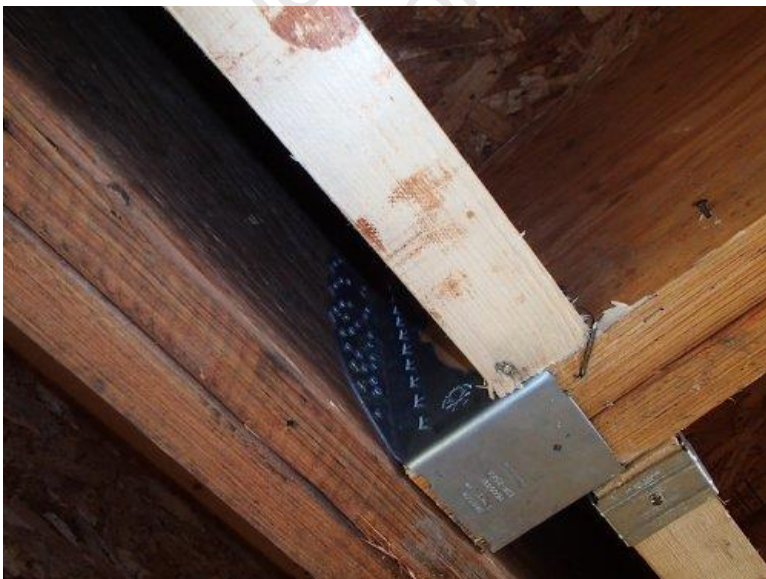
16. Nails were missing from the shear nail locations at hanger straps that reinforce joints between beams at locations, including: at the downstairs bedroom at the southeast corner, at the beam supporting the ceiling at the living room adjacent to the stairs, and at the third floor stairs at the top of the stairs. Shear nails significantly increase the load capacity of the hangers. There is a need for installation of the nails or evaluation to determine if they are unnecessary based on known load values. Reference Photograph 12

12. Nails were missing from the shear nail locations at hanger straps that reinforce joints between beams at locations, including: at the downstairs bedroom at the southeast corner, at the beam supporting the ceiling at the living room adjacent to the stairs, and at the third floor stairs at the top of the stairs. Shear nails significantly increase the load capacity of the hangers.

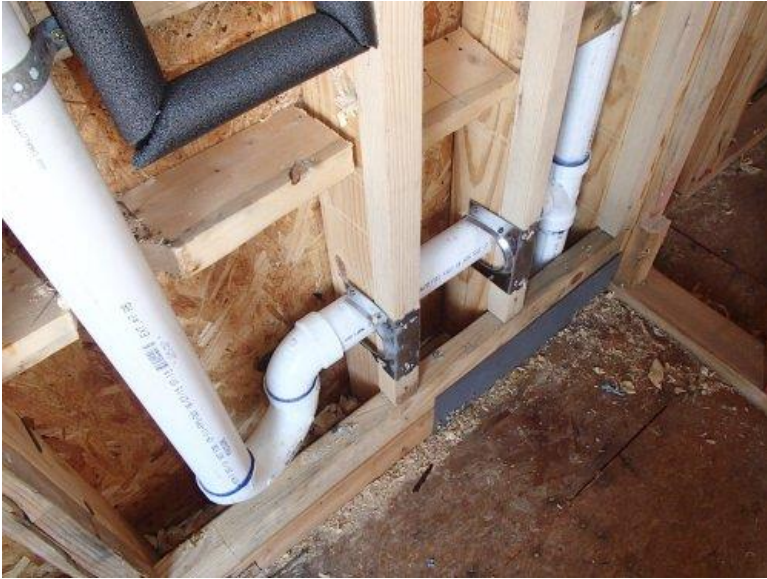
17. Stud shoes had been improperly installed over pipe penetrations through the structural stud wall at the third floor utility room. This effectively results in notching of the stud. The stud shoes were installed over the furring strips and are not likely to provide effective reinforcement in this configuration. Reference Photograph 13

- 13. Stud shoes had been improperly installed over pipe penetrations through the structural stud wall at the third floor utility room. This effectively results in notching of the stud. The stud shoes were installed over the furring strips and are not likely to provide effective reinforcement in this configuration.

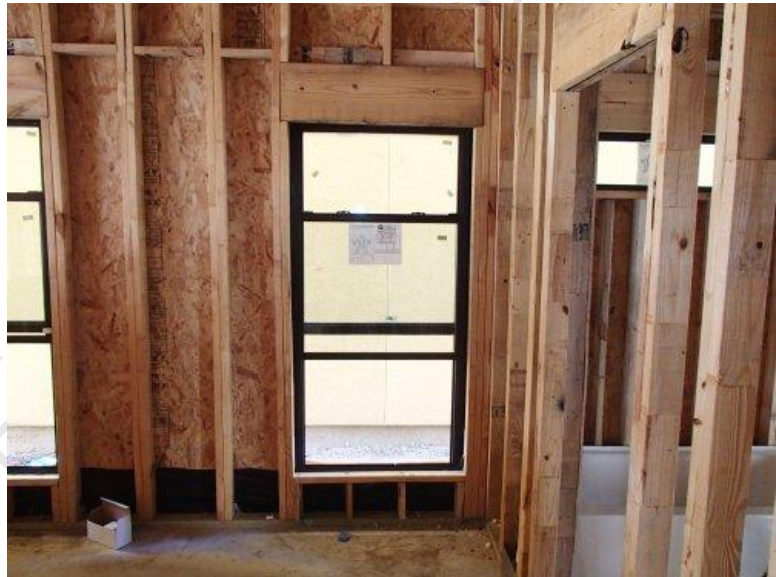
- 14. Studs were warped in the walls at some locations, including at the downstairs west bedroom windows. The warping was more than normally observed and may affect the implementation of finish work. Warped studs can often be adjusted prior to installation of the sheathing, and excessively warped studs may affect their load-carrying capacity.

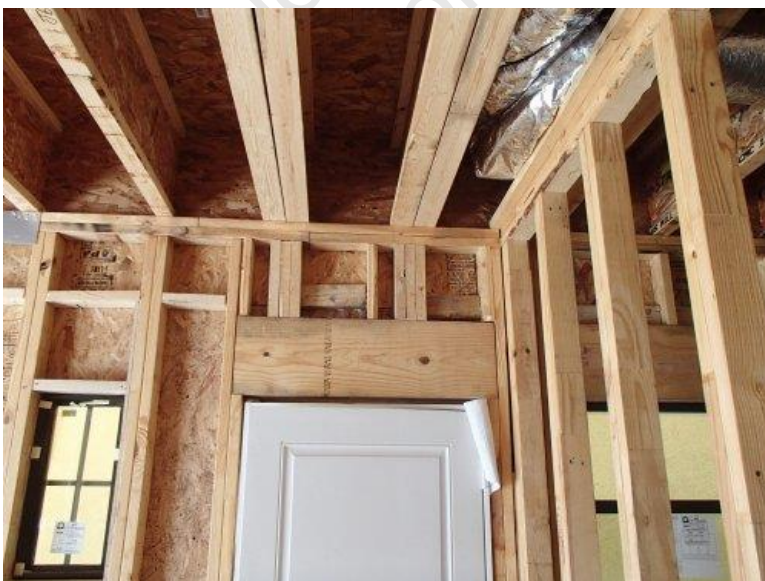
- 15. The header supporting doubled floor joists at the north side of the garage at the exit door from the garage to the yard was carried by single crippled studs. Plans for construction should be consulted to ensure that additional studs are not required.

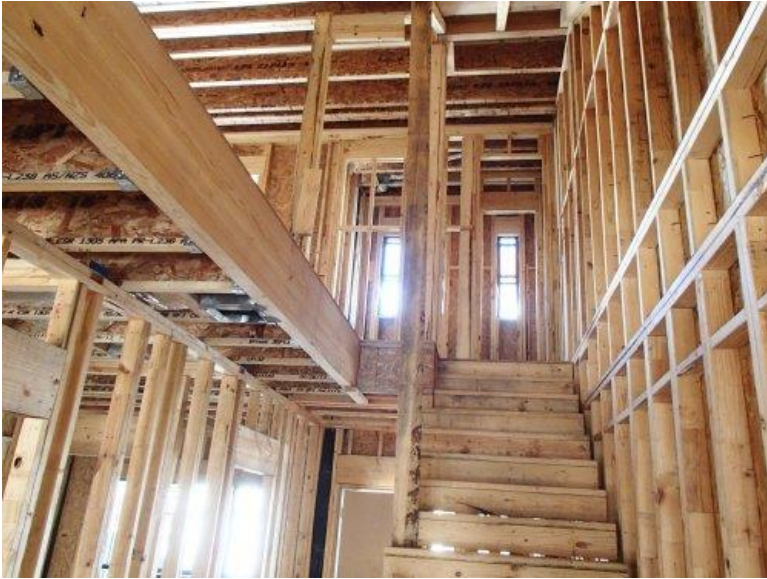
21. The nuts used to secure the lower wall structure to the foundation were loose or missing at some locations at the first floor of the building.
22. The stairs between the second and third floor had been supported along their outer edge relying on a temporary support, apparently because of excessive flexing of the stairs. There was a detectable slope at the stair treads, and there is a need for permanent stiffening of the structure. Reference Photograph 16

16. The stairs between the second and third floor had been supported along their outer edge relying on a temporary support, apparently because of excessive flexing of the stairs. There was a detectable slope at the stair treads, and there is a need for permanent stiffening of the structure.

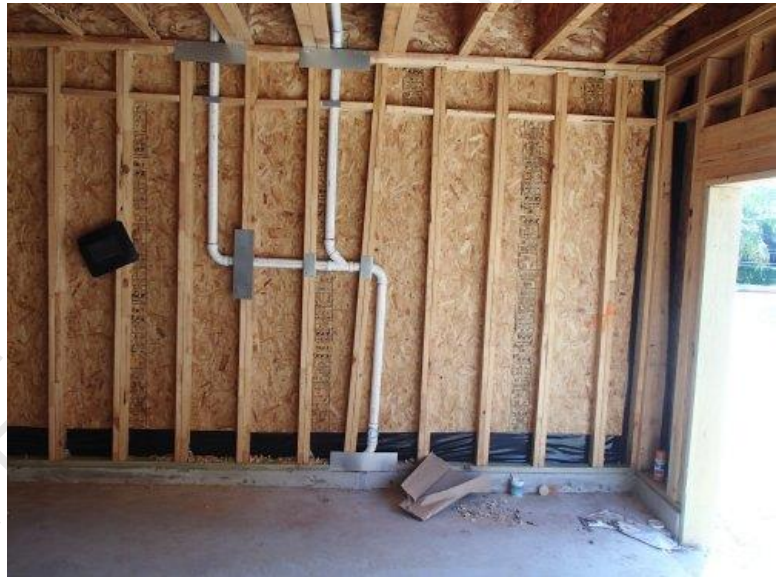
17. There was a stud pack installed at the south wall of the garage that was installed at an angle rather than reducing the spacing between studs. Studs are intended to be installed vertically for their best load-carrying capacity.

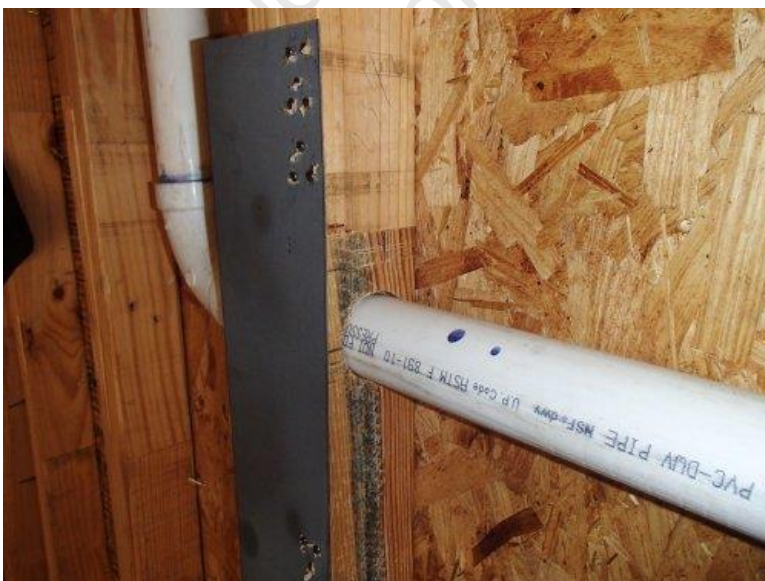
25. There was a stud shoe missing at a stud at the south wall of the garage. Installation of a stud shoe is recommended at this location as the stud was excessively bored. Reference Photograph 18

18. There was a stud shoe missing at a stud at the south wall of the garage. Installation of a stud shoe is recommended at this location as the stud was excessively bored.

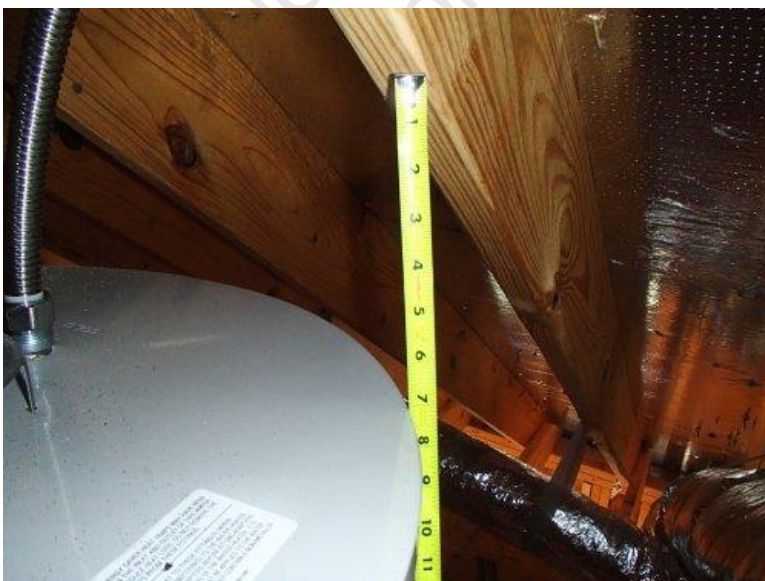
10. The trap for the master bath tub was over 6 feet to the vent. Six feet is the maximum allowable run for the drain between the drain trap and the vent, which may increase the potential for it to siphon empty with normal use.
11. The water supply line was located at the west exterior of the garage at the northwest corner of the building. Reference Photograph 20
12. There was insufficient clearance between the water heater and the underside of the roof. The water heater requires a minimum 12 inches of clearance to prevent a fire hazard. Reference Photograph 21

- 21. There was insufficient clearance between the water heater and the underside of the roof. The water heater requires a minimum 12 inches of clearance to prevent a fire hazard.

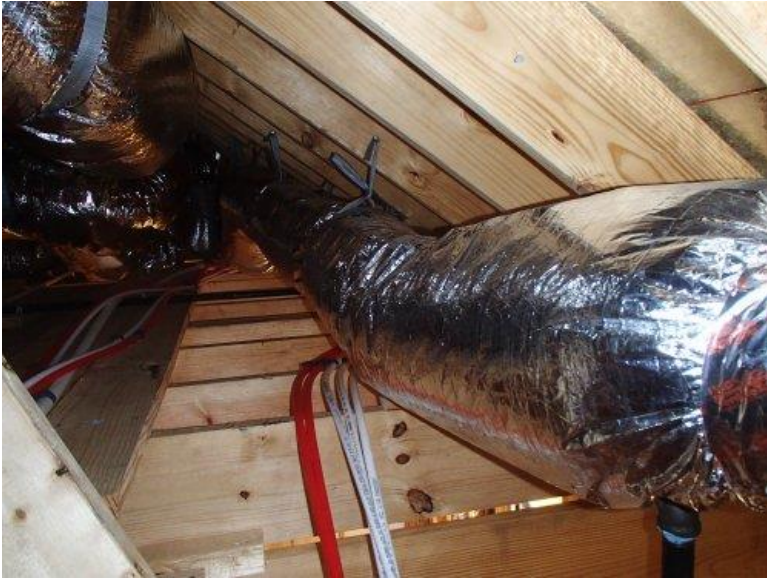
22. Ductwork sagged in the attic space in some areas. Unnecessary turns or sags reduce energy efficiency.

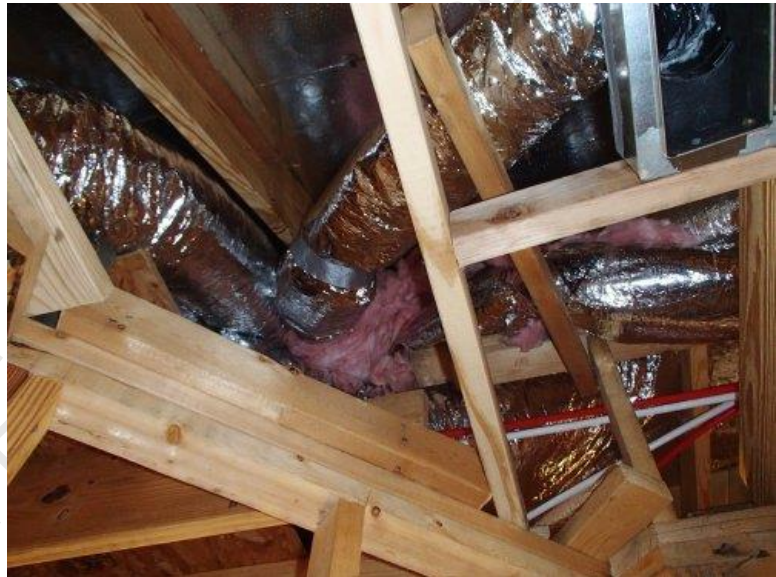
23. Ductwork was compressed together in the attic space over the master bedroom and master bathroom. Compressed ductwork has a greater potential to sweat and reduces energy efficiency.

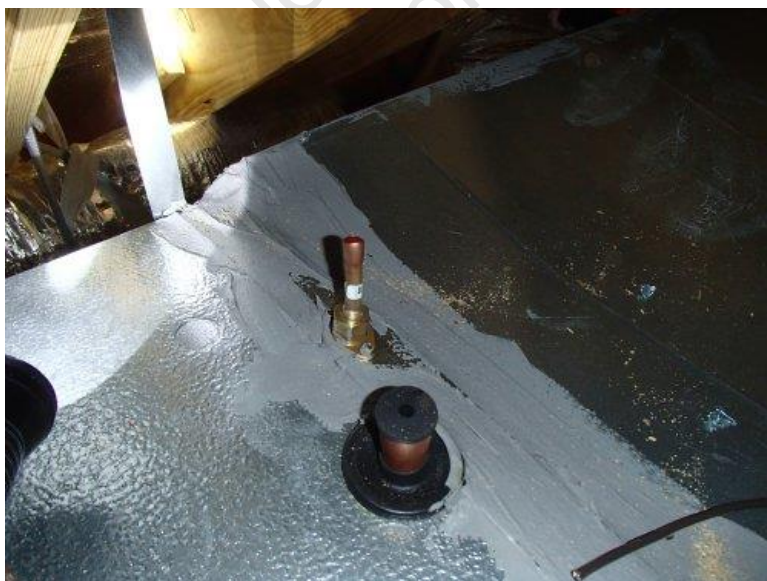
7. The liquid line connection at the evaporator coil was left open and facing upward. This creates a greater potential for contamination to enter the liquid line and could cause damage to the thermal expansion device inside the coil. Reference Photograph 24

24. The liquid line connection at the evaporator coil was left open and facing upward. This creates a greater potential for contamination to enter the liquid line and could cause damage to the thermal expansion device inside the coil.

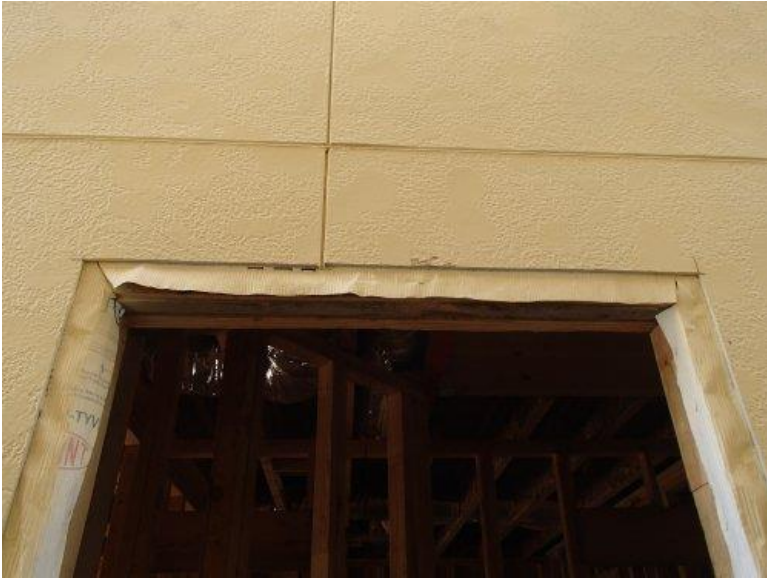
1. A window was missing at the south exterior of the building at the downstairs hall adjacent to the stairwell, where siding was already installed. It will be necessary to remove the siding to allow a window to be installed in the opening properly interfacing the moisture barrier in order to prevent water penetration into the building. Reference Photograph 25

- 25. A window was missing at the south exterior of the building at the downstairs hall adjacent to the stairwell, where siding was already installed. It will be necessary to remove the siding to allow a window to be installed in the opening properly interfacing the moisture barrier in order to prevent water penetration into the building.

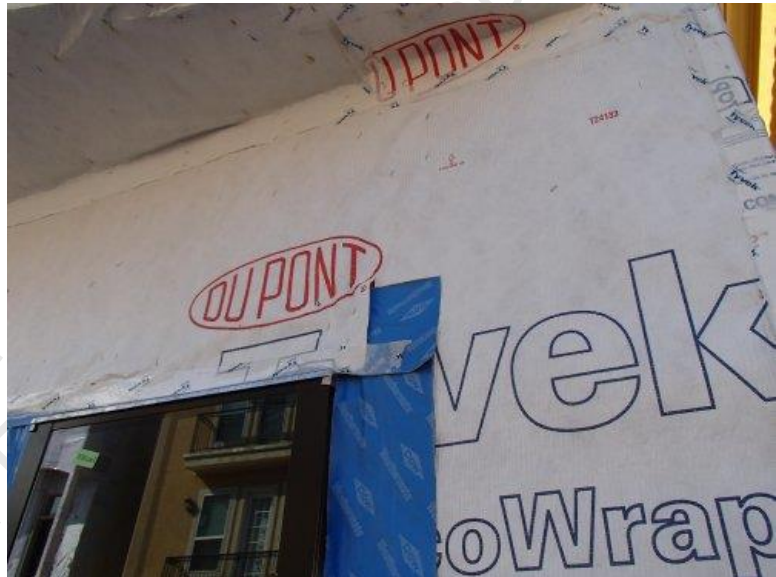
2. Flashing details above some windows were improper, where water running down the moisture barrier can run behind the tape flashing details and reach the interior of the building. Reference Photograph 26

- 26. Flashing details above some windows were improper, where water running down the moisture barrier can run behind the tape flashing details and reach the interior of the building.

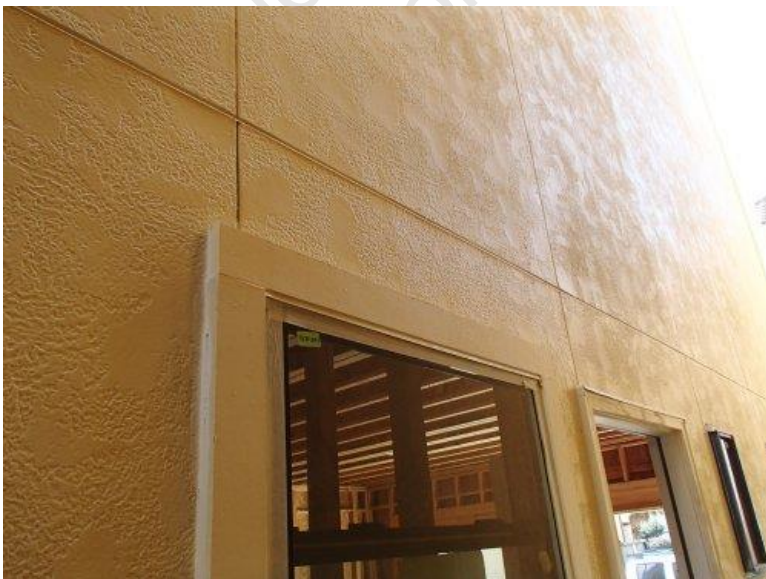
3. Flashings were missing over the exterior fiber cement siding trim. Flashings are required continuously above projecting trim. Reference Photograph 27

- 27. Flashings were missing over the exterior fiber cement siding trim.

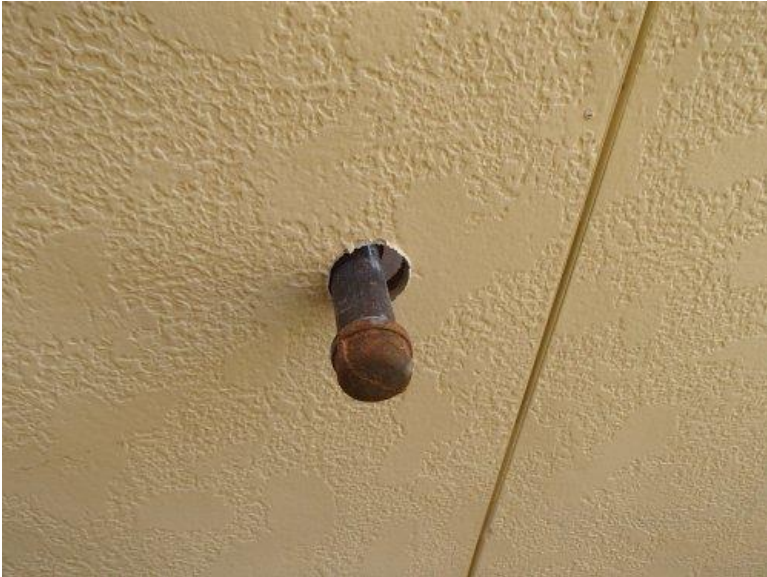
28. Flashings were not evident around pipe penetrations through the fiber cement siding. This creates a potential for water penetration to the sheathing.

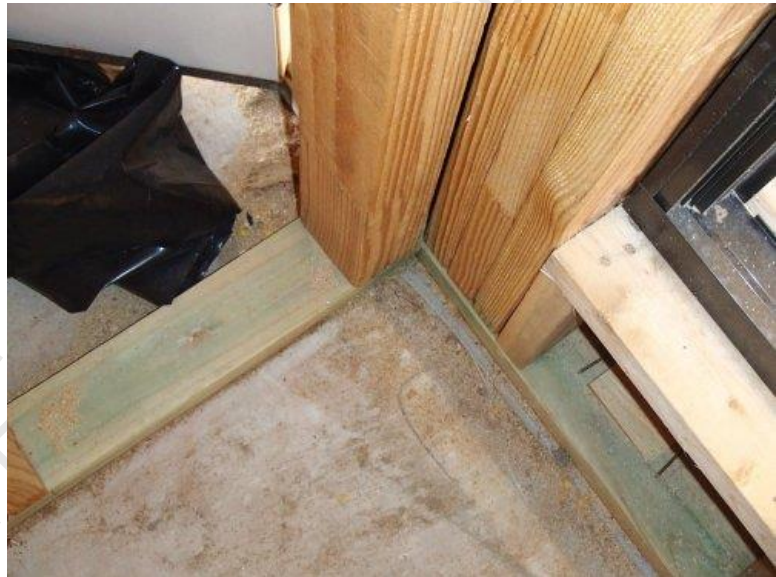
5. It appeared that the foam gasket may be missing at the wall between the garage and interior of the building. This is intended to improve energy efficiency by preventing air infiltration at the bottom of the wall. Reference Photograph 29

29. It appeared that the foam gasket may be missing at the wall between the garage and interior of the building. This is intended to improve energy efficiency by preventing air infiltration at the bottom of the wall.

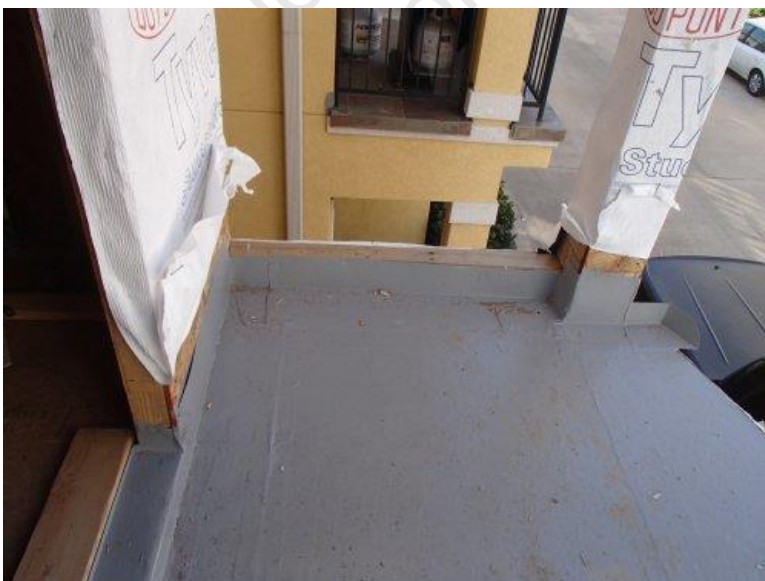
30. It was indicated that the curb along the north end of the living room balcony was to be removed, requiring modification of the balcony dry pan.

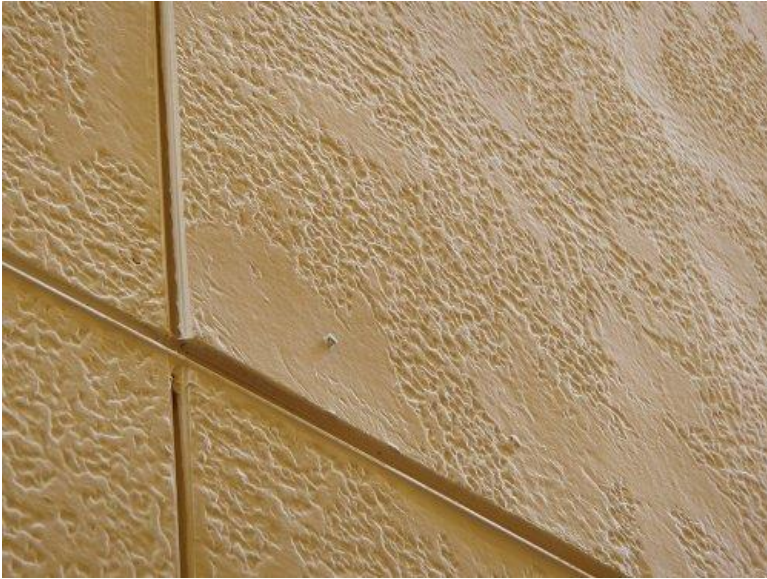
7. Nails used to secure fiber cement siding to the structure of the building had been improperly driven at angles and were underdriven at numerous locations. The fasteners should be repaired in accordance with the manufacturer's specifications. Reference Photograph 31

31. Nails used to secure fiber cement siding to the structure of the building had been improperly driven at angles and were underdriven at numerous locations. The fasteners should be repaired in accordance with the manufacturer's specifications.

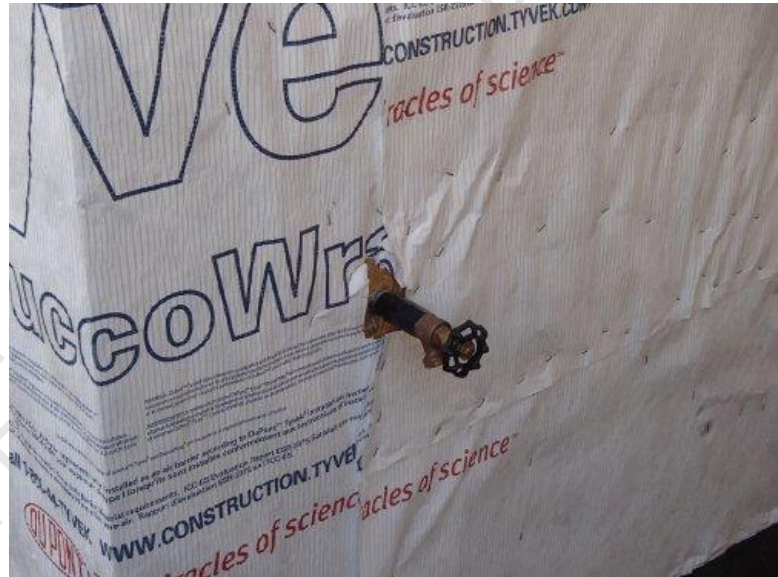
32. Penetrations through the moisture barrier were not flashed at vent and pipe penetrations. This increases the potential for water penetration, especially where stucco siding is to be installed, and a method of flashing should be implemented.

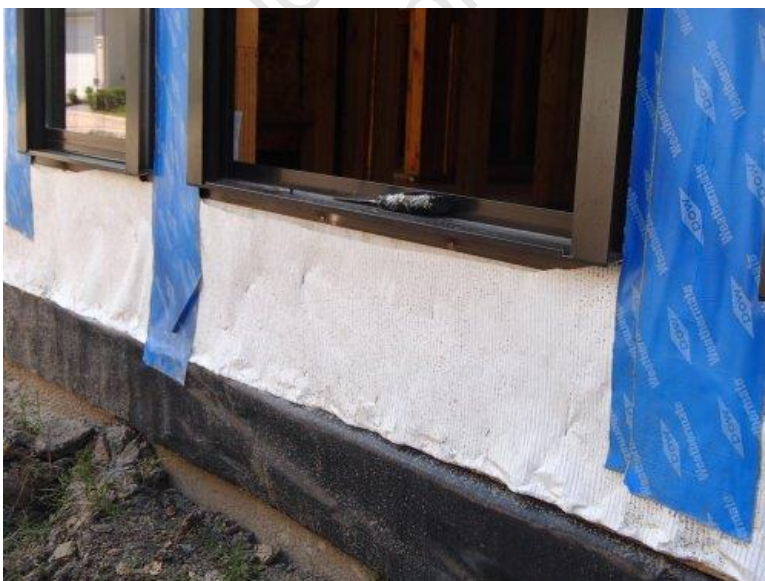
10. Sill flashings below the windows had been improperly installed so that they adhered to the OSB sheathing rather than lapping the moisture barrier. This does not appear to be repairable without removal and reinstallation of the windows to allow the sill flashing to be properly installed and, in its current configuration, is likely to allow water penetration to the structure. Sill flashings should lap the moisture barrier at the bottoms of the windows. Reference Photograph 33

33. Sill flashings below the windows had been improperly installed so that they adhered to the OSB sheathing rather than lapping the moisture barrier. This does not appear to be repairable without removal and reinstallation of the windows to allow the sill flashing to be properly installed and, in its current configuration, is likely to allow water penetration to the structure.

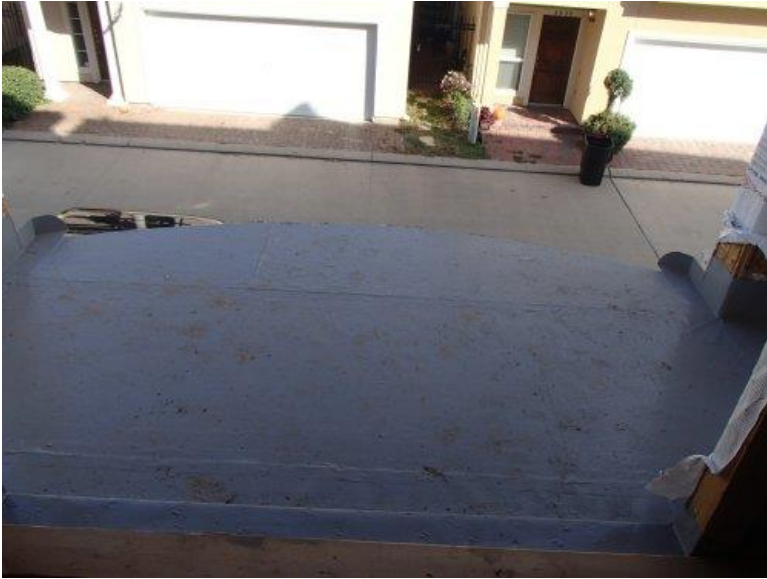
34. The method of securing the guardrail to the outer edge of the balcony was not determined, but it appears it may require installing fasteners through the surface of the balcony, which create a potential for water penetration in the future.

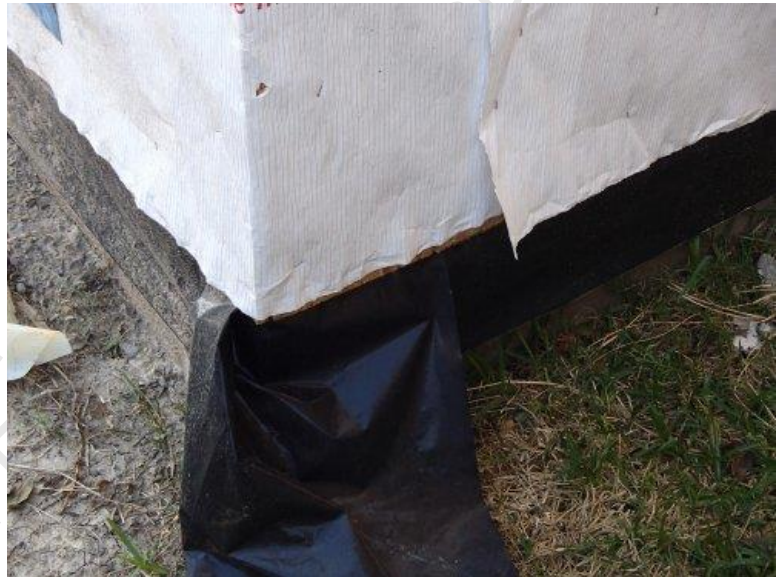
15. Tyvek installed as a moisture barrier at the outside surface of the building was indicated to be the primary moisture management membrane. Its quality of workmanship in installation was below normal. It was observed that the moisture barrier did not extend past the structural sheathing, which could allow wetting of the sheathing. Reference Photograph 35

35. Tyvek installed as a moisture barrier at the outside surface of the building was indicated to be the primary moisture management membrane. Its quality of workmanship in installation was below normal. It was observed that the moisture barrier did not extend past the structural sheathing, which could allow wetting of the sheathing.

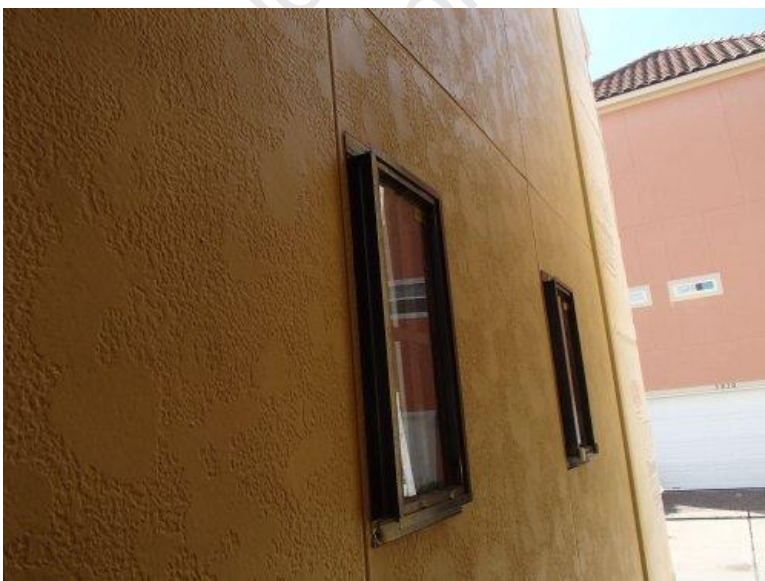
36. Windows were improperly installed over the surface of the fiber cement siding at the garage. Proper installation of the windows requires removal of the siding so that they can be flashed into the moisture barrier to prevent water penetration into the building.

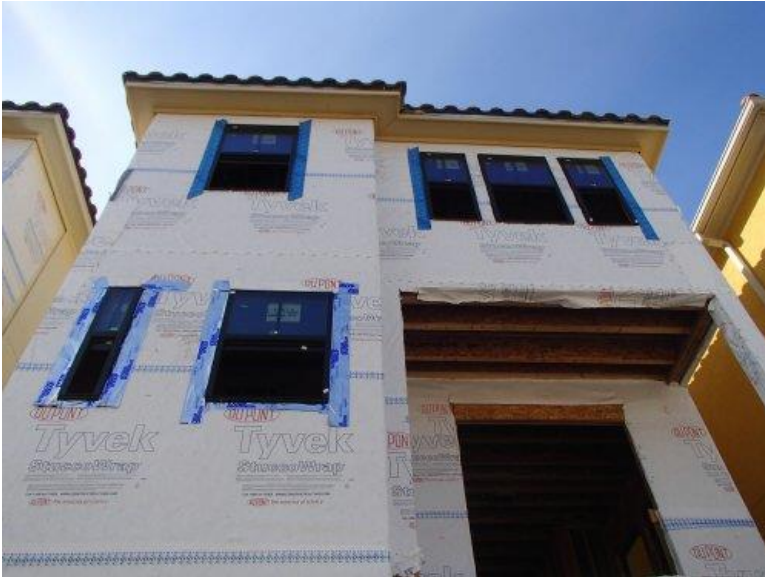
37. Windows were not uniformly flashed at the front of the building. The reason for variation was not determined; however, some windows appeared to have a significant potential to allow water penetration after siding is installed if the quality of workmanship in installing the flashing details around the windows is not corrected.

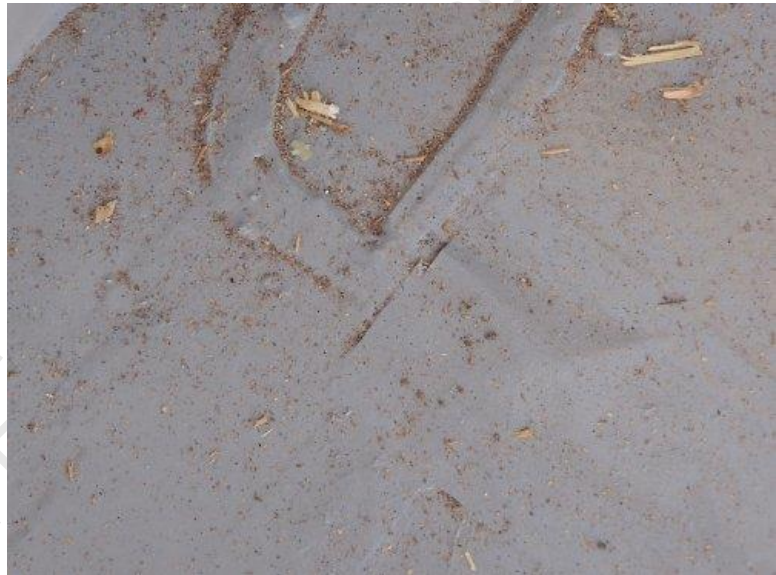
3. Wrinkles could be observed in the ceiling tape used at the decking joints of the living room balcony. These open wrinkles create a concern that water penetration may occur through these joints. Repair of the joints is recommended prior to placement of final finishes.

38. Wrinkles could be observed in the ceiling tape used at the decking joints of the living room balcony. These open wrinkles create a concern that water penetration may occur through these joints. Repair of the joints is recommended prior to placement of final finishes.
