Re: 221-B Baker Street, Holmes, Texas

STRUCTURAL INSPECTION REPORT

Mr. Sam Sample
221-B Baker Street
Holmes, Texas
January 1, 2023

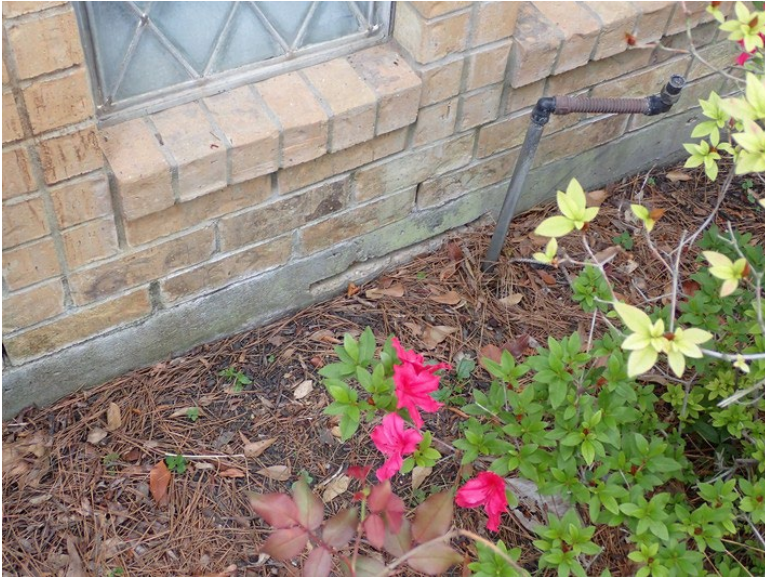
16. There was a slot cast into the foundation at the east exterior of the dining room whose purpose was not determined. Reference Photograph 1
17. The concrete drive was cracked and uneven, which is an indication of differential movement in the drive, possibly caused by expansive soils and/or poor drainage.
18. The drive was broken at its west edge adjacent to the garage. It was indicated that soil loss has been occurring at this location, creating a hole that has been backfilled several times, which was indicated by the client based upon an interview by the contractor maintaining the irrigation system. This should be investigated since it may indicate a leak in the plumbing of the irrigation system or a yard drain system, which may continue to have a detrimental effect on the performance of the drive. Reference Photograph 2

1. There was a slot cast into the foundation at the east exterior of the dining room whose purpose was not determined.

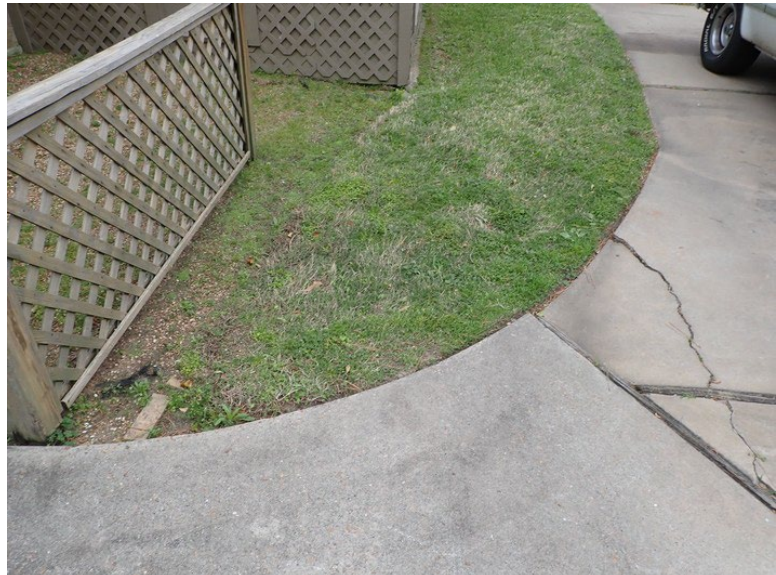
2. The drive was broken at its west edge adjacent to the garage. It was indicated that soil loss has been occurring at this location, creating a hole that has been backfilled several times, which was indicated by the client based upon an interview by the contractor maintaining the irrigation system. This should be investigated since it may indicate a leak in the plumbing of the irrigation system or a yard drain{...full text in report}

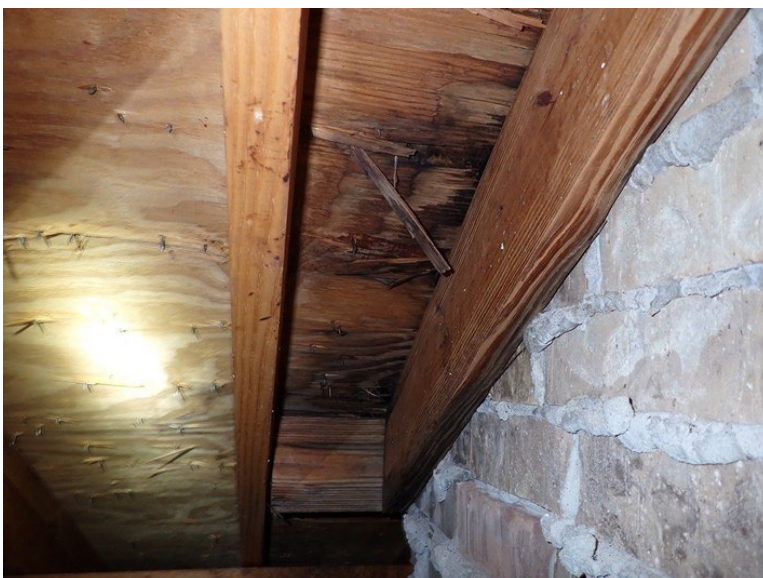
2. The composition shingle roof was starting to show signs of wear and deterioration in the form of: discolored shingles and rusted flashings.
3. You should make further inquiry as to the status of the following observed evidences of roof leaks, current or previous: decking stains at the hall bathroom; seam bulges in the living room; sheetrock patches in the master bathroom closet; rotted decking at the fireplace in the attic; and stained fascia at the east side of the northeast bedroom as viewed from the attic. You are cautioned that other evidences of roof leaks may exist which were not detected at the time of this inspection. Reference Photograph 3

3. You should make further inquiry as to the status of the following observed evidences of roof leaks, current or previous: decking stains at the hall bathroom; seam bulges in the living room; sheetrock patches in the master bathroom closet; rotted decking at the fireplace in the attic; and stained fascia at the east side of the northeast bedroom as viewed from the attic. You are cautioned that other{...full text in report}

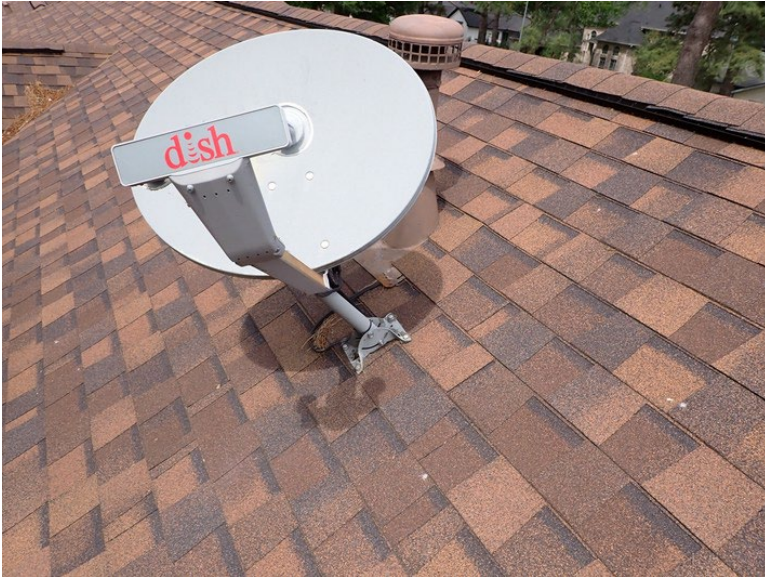
4. An antenna or dish had been improperly mounted through the surface of the shingles at the roof. This can result in leaks at the fasteners as the roof ages, causing water entry and rot of the deck. Reference Photograph 4

4. An antenna or dish had been improperly mounted through the surface of the shingles at the roof. This can result in leaks at the fasteners as the roof ages, causing water entry and rot of the deck.

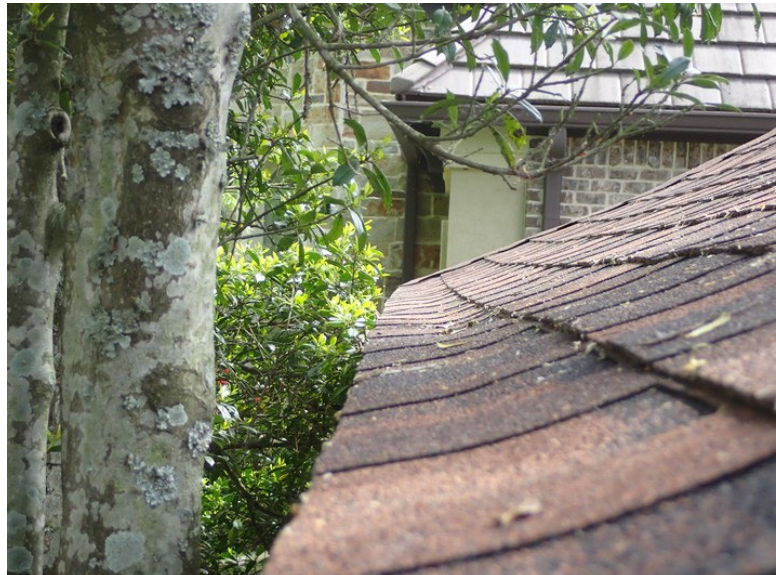
6. There was evidence the shingles flared along the lower edge of the roof at the east side of the southeast bedroom. This can allow water penetration at the lower edges of the roof into the eaves below. This can occur as a result of improper installation of the drip edge flashing, decking, or fascia and should be investigated for repair. Reference Photograph 5

5. There was evidence the shingles flared along the lower edge of the roof at the east side of the southeast bedroom. This can allow water penetration at the lower edges of the roof into the eaves below. This can occur as a result of improper installation of the drip edge flashing, decking, or fascia and should be investigated for repair.

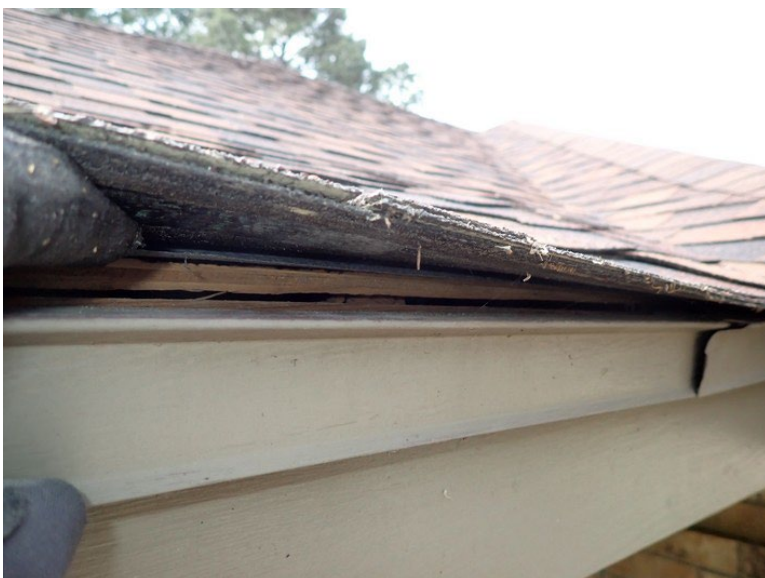
6. The roof deck did not extend to the fascia boards along the lower edge of the roof, leaving a gap. The drip edge flashings were installed resting on the fascia boards rather than properly extending up the deck of the roof as required by current construction code. This allows the drip edge to lay horizontally, which could allow water running off the edge of the roof to be directed into the eaves and may be related to evidences {...full

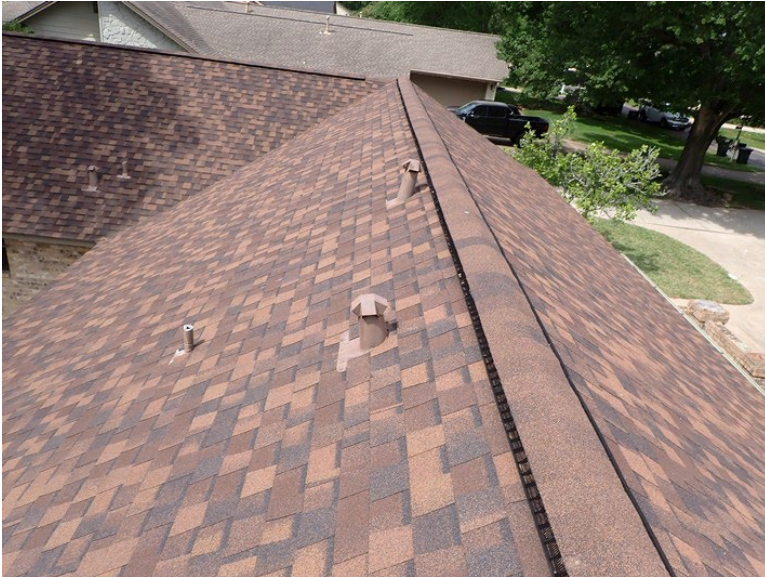
7. The wrong roof jacks had been used at some of the gas-fired appliances, including at the north furnace and at the water heater at the attic. Gas-fired appliance flues are required to terminate at the exterior of the building and must penetrate the roof jack with a storm collar for safety.

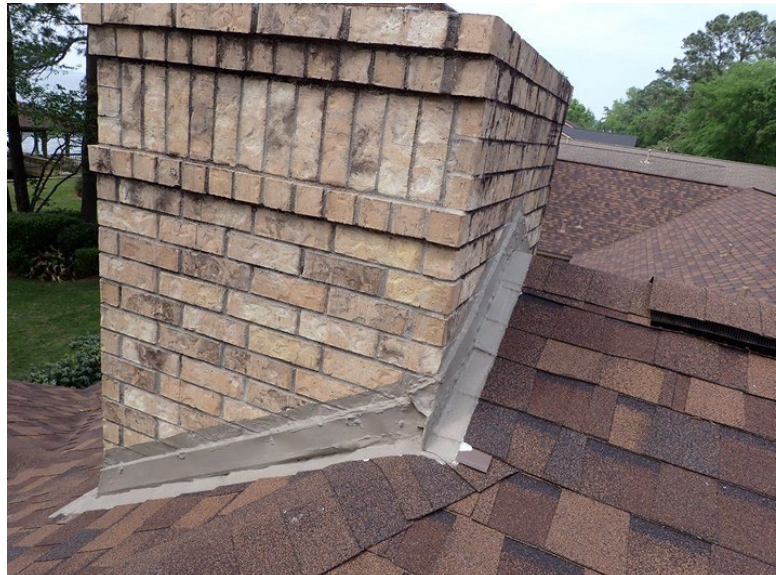
8. A roof sealant material had been used to seal the flashing details at the fireplace chase extending from the surface of the composition shingles to the brick veneer above the counterflashing. This is improper as it eliminates the flashing/counterflashing detail, which allows relative movement between the dissimilar materials of the masonry fireplace and wood structure supporting the roof. {...full text in report}

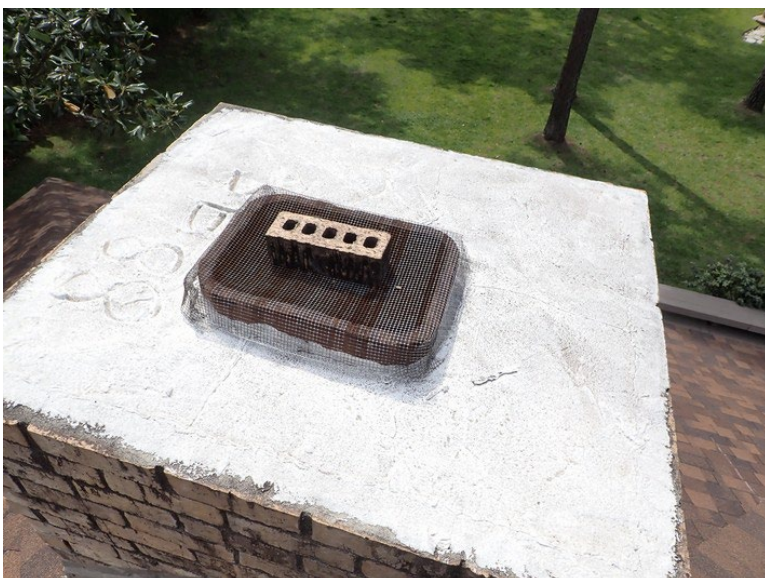
9. Sealant had been applied at the cap at the fireplace flue chase where it had developed cracks. There were evidences of water penetration at the interior of the building, indicating past water penetration through the cap. The sealant may be a temporary repair, and this should be investigated by a chimney sweep.

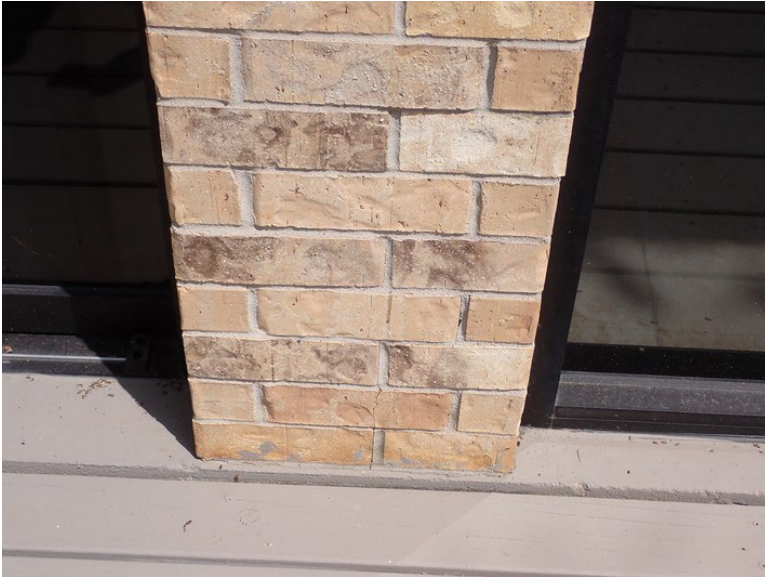
10. Cracks could be observed in the brick veneer at the base of the columns at the back porch. The configuration of the cracking observed may indicate wood-framed structure inside the columns that was in contact with the masonry and has become wet, causing it to expand and split the brick veneer. Further investigation is recommended and would require removal of brick veneer for inspection as water {...full text in report}

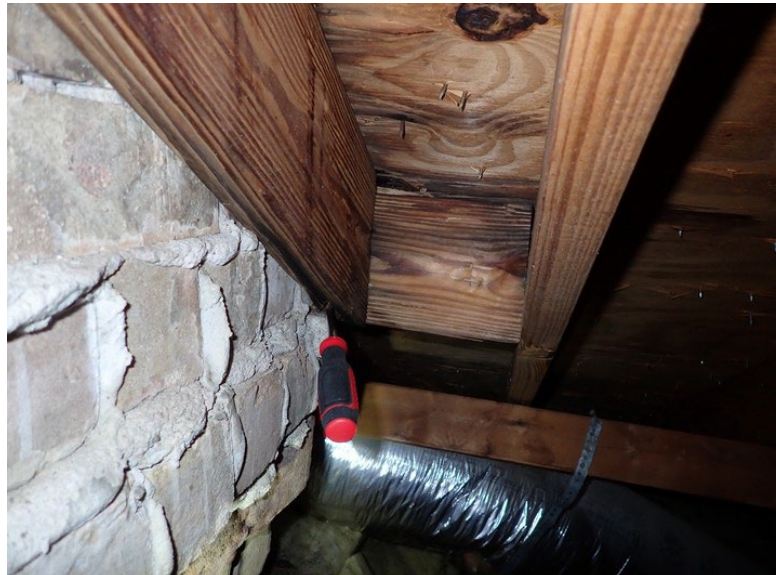
No irregularities were observed that would indicate that the basic structure of the building, including load-bearing walls and other framing members, was in need of repair or not performing adequately with the exception: wood rot could be observed at the structure around the fireplace chase in the attic space. The extent of rot could not be determined at the west side and should be investigated.

11. Roof framing was rotted around the fireplace chase over the living room due to long-term water penetration. The framing on the west side of the chase was not readily accessible, and further investigation is recommended to determine the extent of repair required.

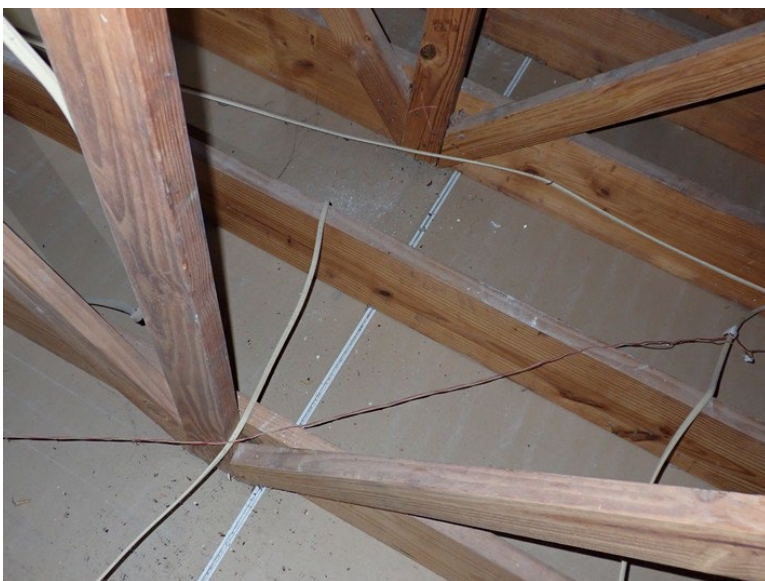
12. Trusses had been constructed to support the midspan of the roof over the area of the garage nailed to the sides of the ceiling joists. Site-built trusses often do not perform as well as engineered trusses, and some of the connections were starting to separate, although the roof structure appeared to be performing satisfactorily. The trusses should be monitored and reinforced if the connections further {...full text in report}

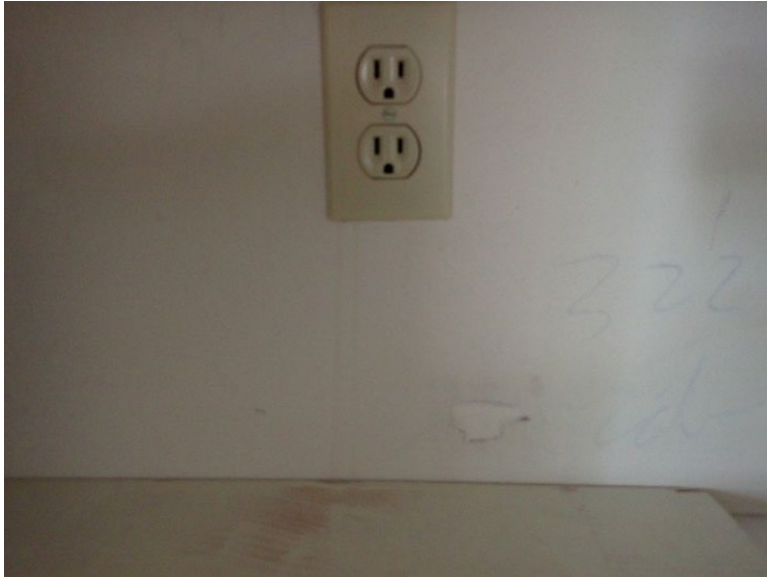
13. Evidence of water entry, past or current, was observed at the quarters' microwave oven cabinetry, as indicated by water streaks below the outlet; at the quarters' living room, as indicated by stained carpeting; at the enclosed porch glass walls and south partition wall addition; at the west wall of the living room at the fireplace, as indicated by a seam bulge; at the fireplace firebox, as indicated by mineral {...full text in report}

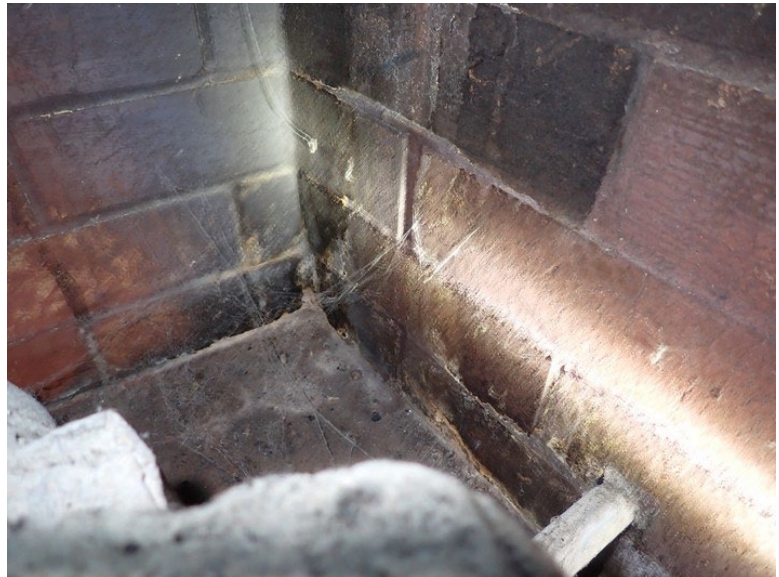
14. Mineral deposits were visible in the fireplace firebox behind the gas log, which are consistent with water soaking through the fireplace cap at the roof and discharging from the base of the fireplace.

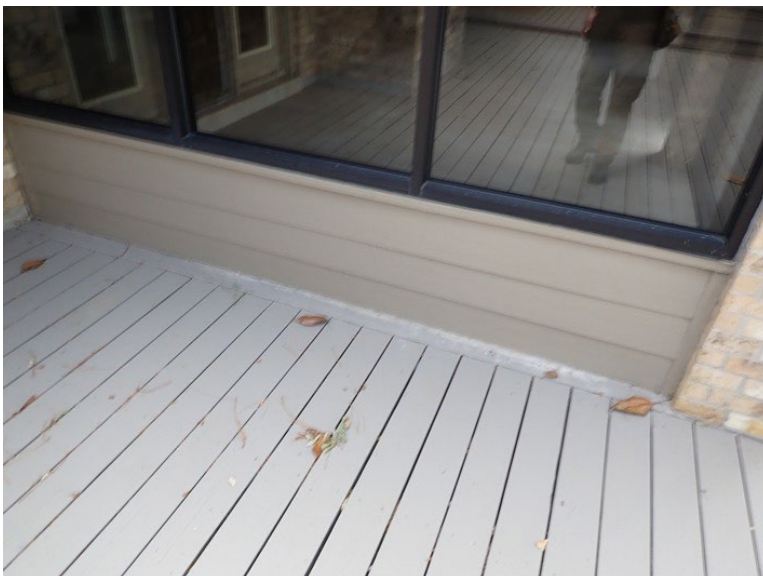
15. The concrete surface of the enclosed porch at the west side of the building extended past the constructed wall panels and glass walls with no apparent flashing. Sealants had been applied at the constructed walls at the north side of the porch area, indicating previous problems with water entry. This is prone to allow water penetration under the wall assembly and glass wall as sealants {...full text in report}

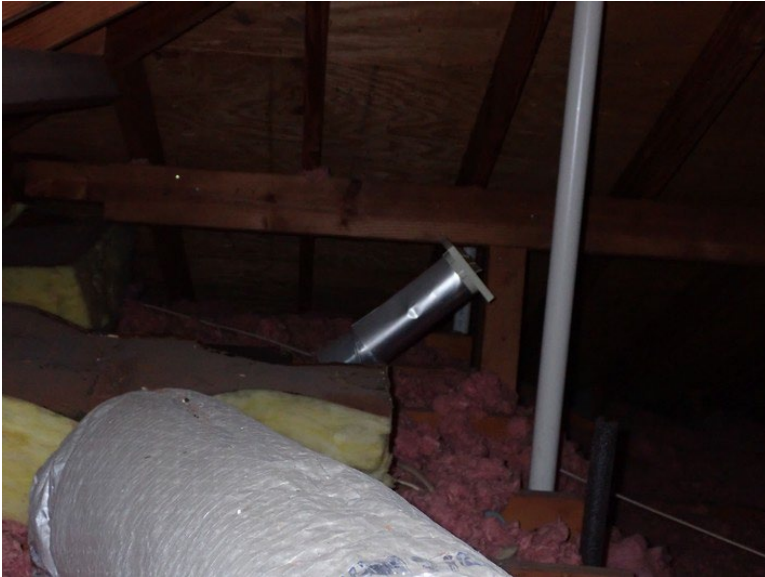
1. The exhaust fan at the master bath was improperly vented to the attic. It should be vented to the outside to prevent accumulation of moisture and odor in the attic.

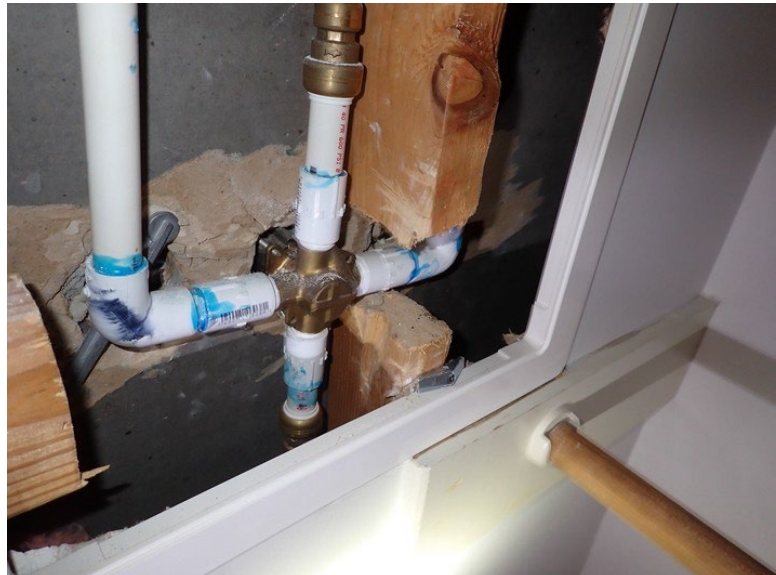
2. PVC had been used in the water distribution system at the control valve of the master bath shower enclosure. PVC is not typically considered acceptable for use inside the building where it is required that CPVC be used.

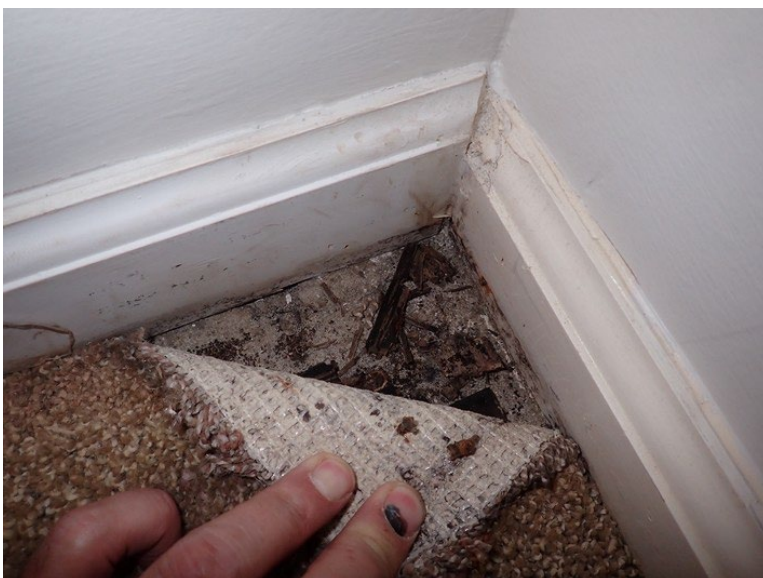
3. High moisture readings and evidences of deterioration in the finishes could be observed at the base of the wall at the master bathroom closet adjacent to the shower. The source for moisture causing high moisture readings and deterioration was not determined. Further inquiry of the owner to provide history of repairs at the shower is recommended. Investigation may require removal of wall coverings {...full text in report}

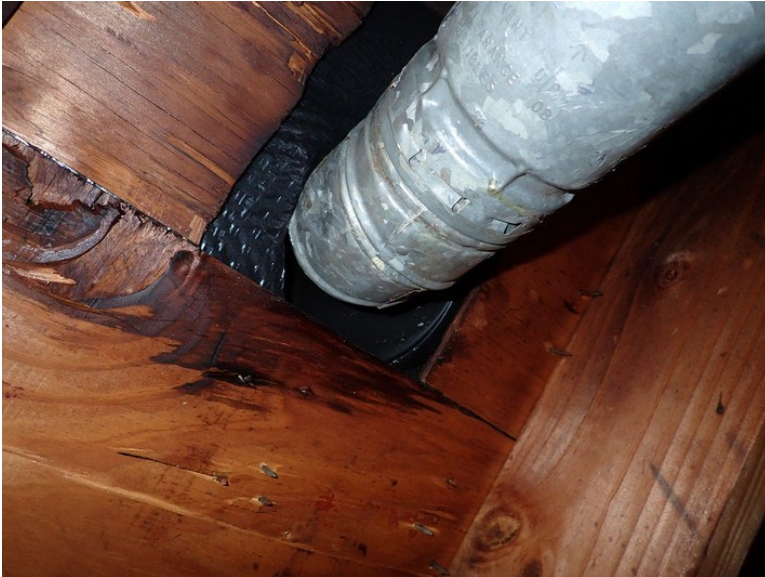
4. The double-wall pipe of the attic hot water heater vent was touching combustible material. Double-wall pipes should have a clearance of 1-inch minimum between any combustible surface and the wall of the pipe.

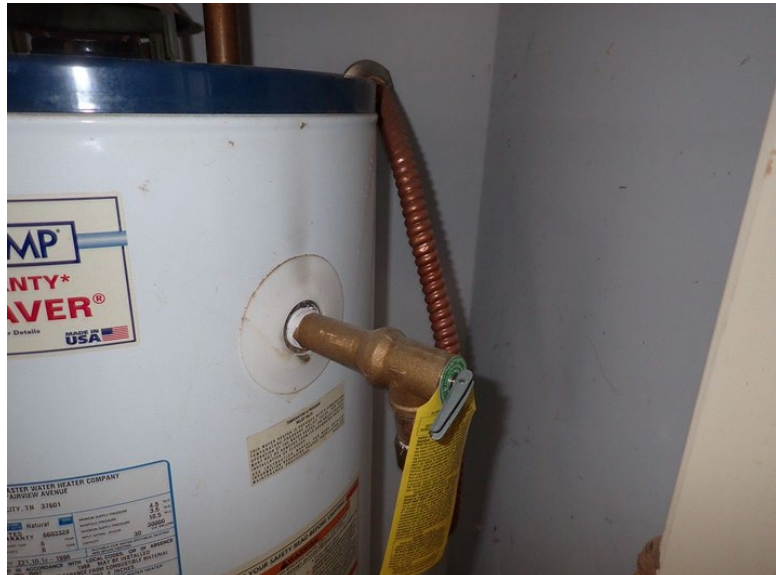
5. The drain line of the temperature/pressure relief valve for the garage water heater was routed upward from the valve, which will result in water standing on the operating mechanism of the valve, causing corrosion and malfunction of the valve.

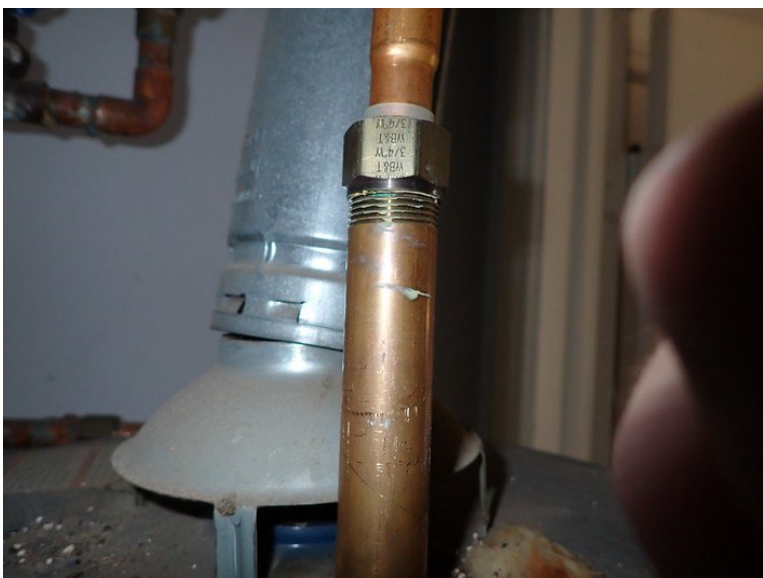
6. The hot gas vent pipe was not properly connected to the garage water heater draft diverter. Combustion products may be emptied into the building.

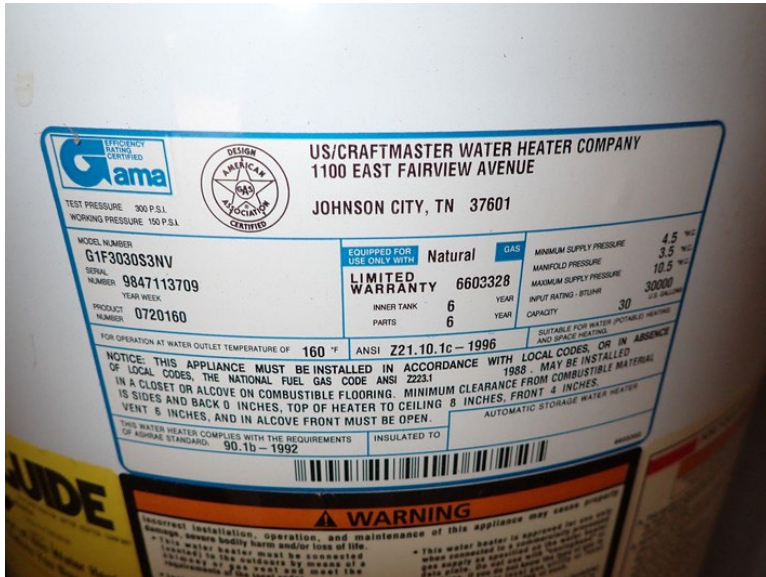
7. Due to the age and condition of the garage water heater, it is the opinion of this inspector that its remaining serviceability is limited.

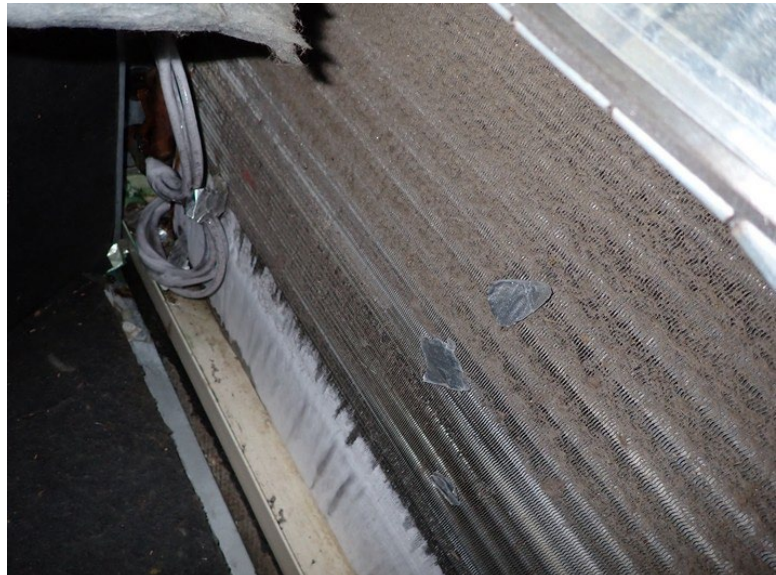
8. The north zone evaporator coil face was observed to be partially clogged with debris and dust, as observed through the access port at the evaporator coil. It is recommended that the coil be checked and cleaned. Other adjustments may be necessary after returning the coil to its normal operating condition.

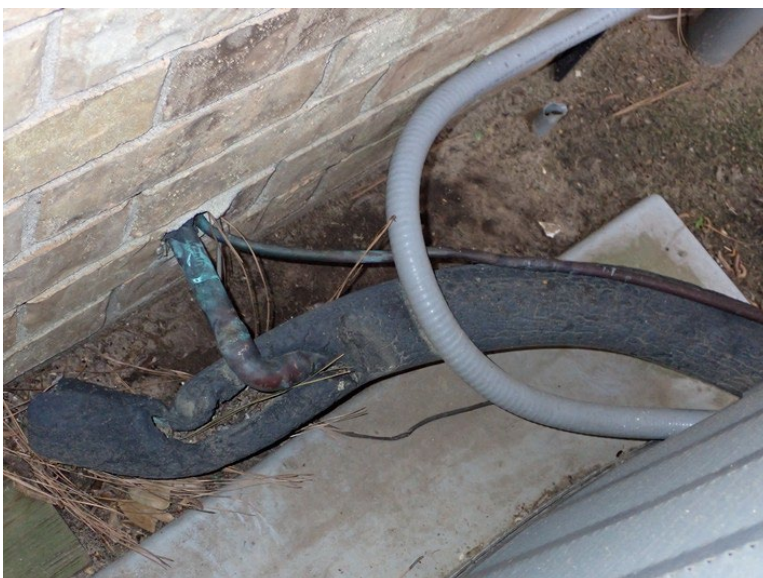
9. Some foam insulation was torn off the refrigerant return line near the north zone condensing unit. Some energy will be lost as a result of the missing insulation. In newer construction, a protective covering is required on the insulation.

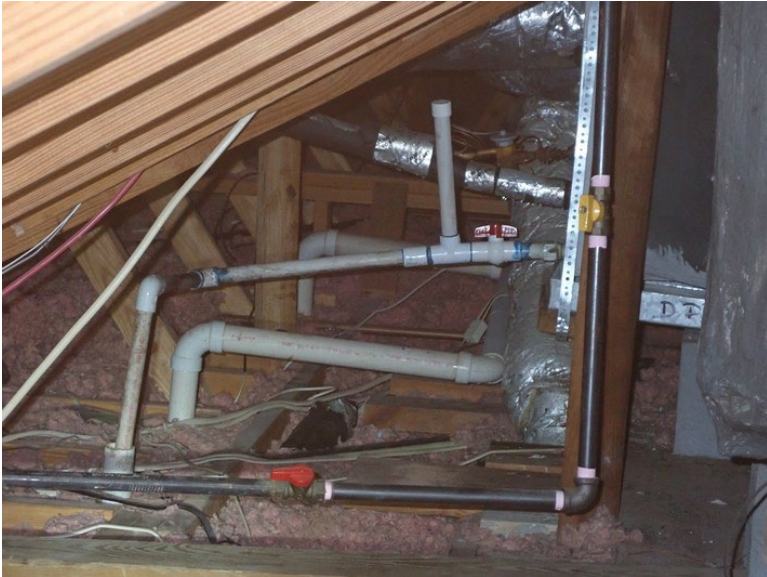
10. The primary condensate drain line for the north zone evaporator coil was not sufficiently insulated. A minimum 10-ft. of insulation is recommended.

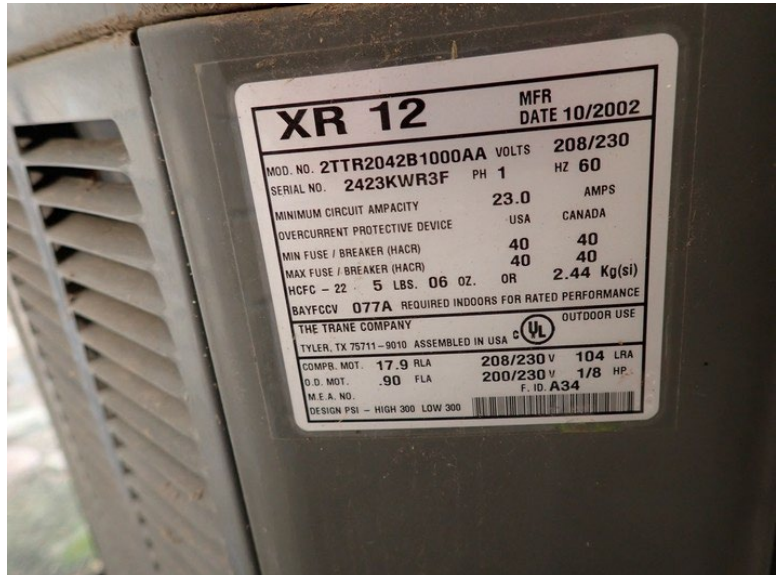
11. The north zone electric air conditioner has a capacity of 3.5 tons. A determination of adequacy of capacity is beyond the scope of a visual inspection. In older residential buildings that are not well air sealed and insulated, this size of system is considered to ordinarily cool a building of approximately 1,750 sq. ft. when a rule of thumb of 500 square foot per ton is considered. In newer {...full text in report}

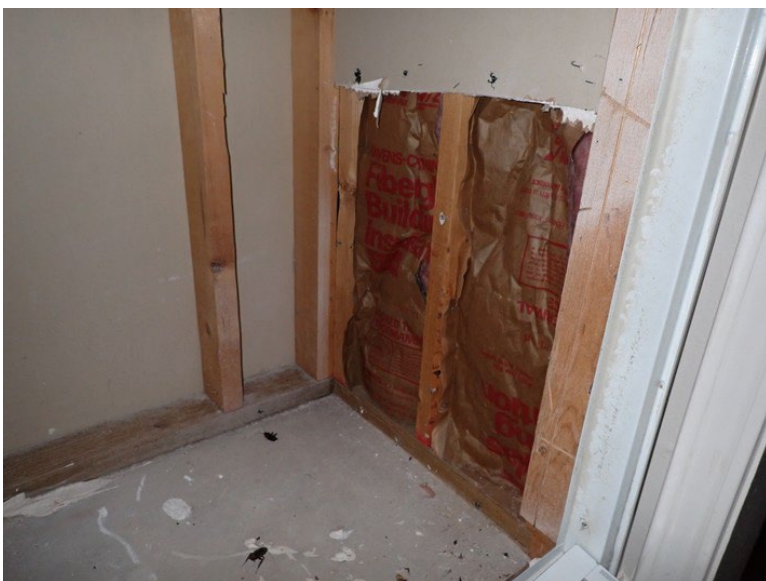
12. Batt fiberglass insulation could be observed in the north zone air conditioning return chase. This is considered unacceptable since this could result in insulation contaminating the air stream, allowing it to be distributed in the zone through the registers. The inside of the chase should be covered with drywall wall coverings or the insulation should be removed.

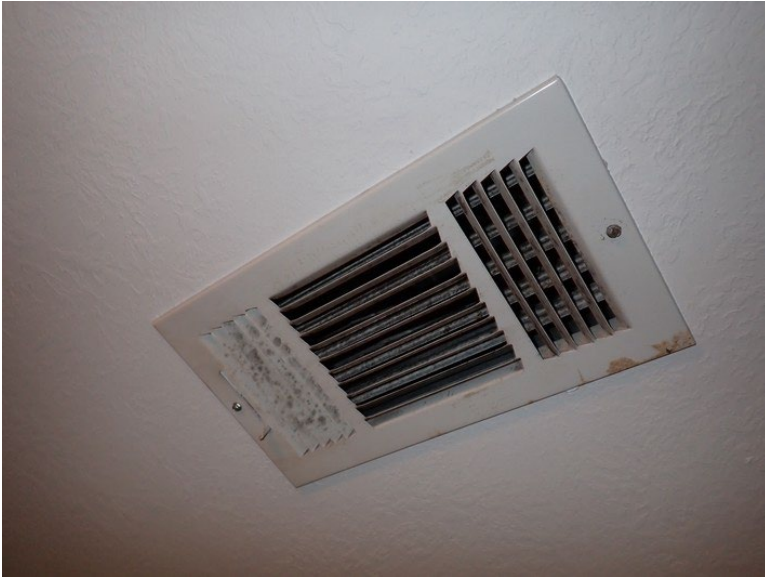
13. Mildew could be observed at diffuser outlets in the rooms, including at the quarters' bedroom and at the quarters' kitchen. This can indicate sweating of the diffuser grille due to air infiltration at the register box and, in some cases, may indicate a negative pressure created by poor balancing or a lack of adequate ventilation air. This should be investigated by an HVAC contractor.

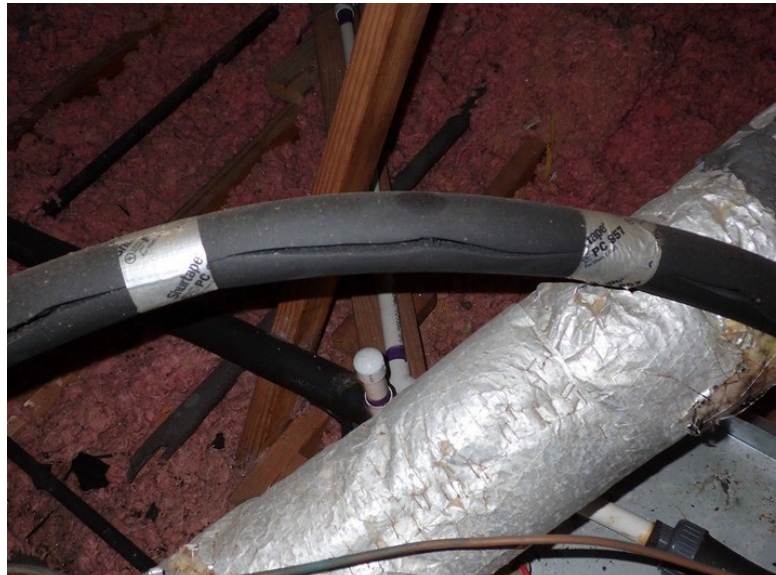
14. The quarters' zone refrigerant line insulation at the attic space was split along its length and had not been adequately taped. This was allowing condensate to form on the refrigerant line which could allow it to drip to the ceilings below and should be corrected.

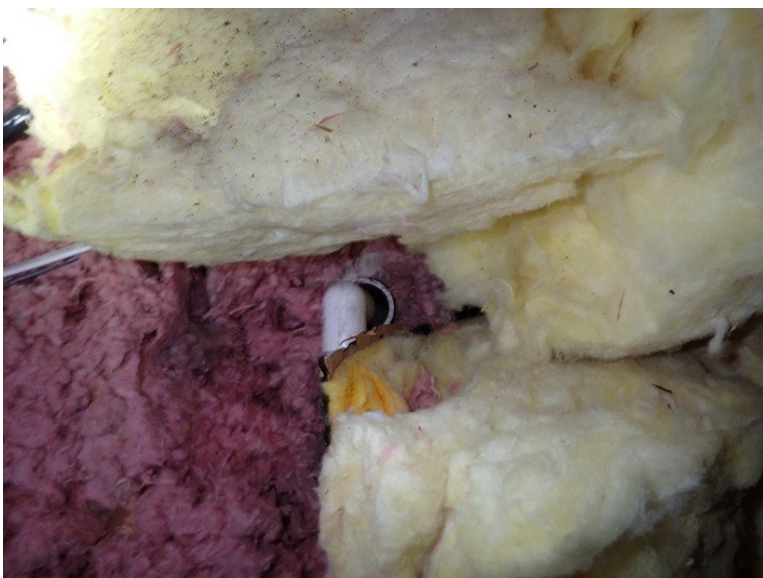
15. It was observed that the south zone air conditioner primary condensate drained into a dedicated trap. Careful observation of this dedicated trap is recommended to ensure that it does not dry out in the wintertime when the air conditioner is not used and allow sewer gases to be drawn back into the conditioned air stream. Further, algae may form in the drain trap, causing the drain to overflow. {...full text in report}

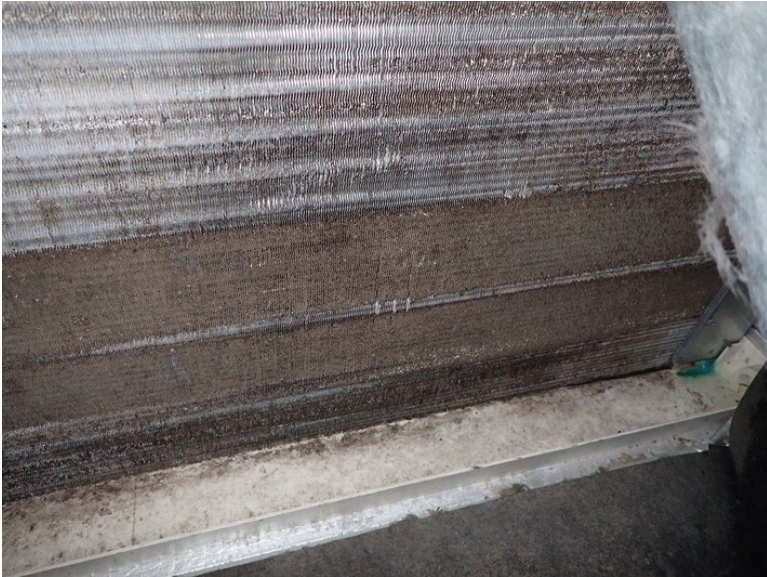
16. The south zone evaporator coil face was observed to be partially clogged with debris and dust, as observed through the access port at the evaporator coil. It is recommended that the coil be checked and cleaned. Other adjustments may be necessary after returning the coil to its normal operating condition.

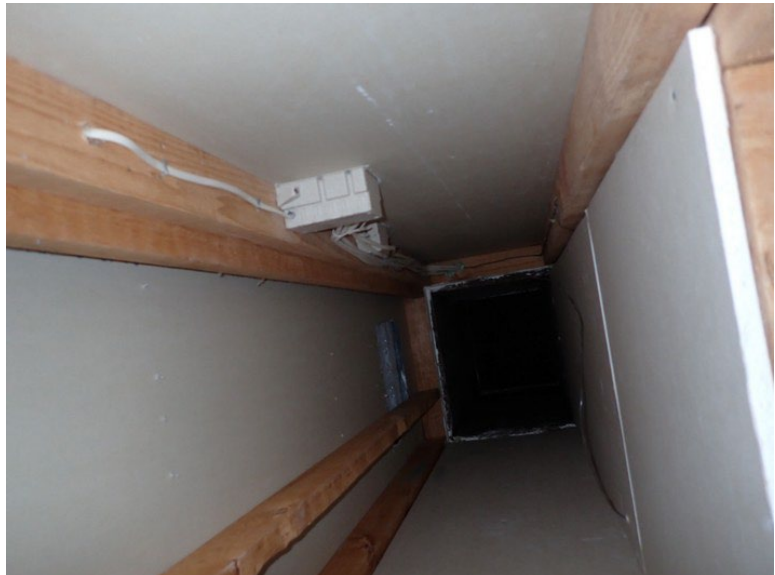
17. The return plenum for the south zone air handler contained one or more inappropriate installations, such as gas lines, electrical wiring, sewer vents, or refrigerant piping. The presence of these materials should be eliminated from the return air path. A qualified contractor should be asked to provide cost estimates for repairing this condition.

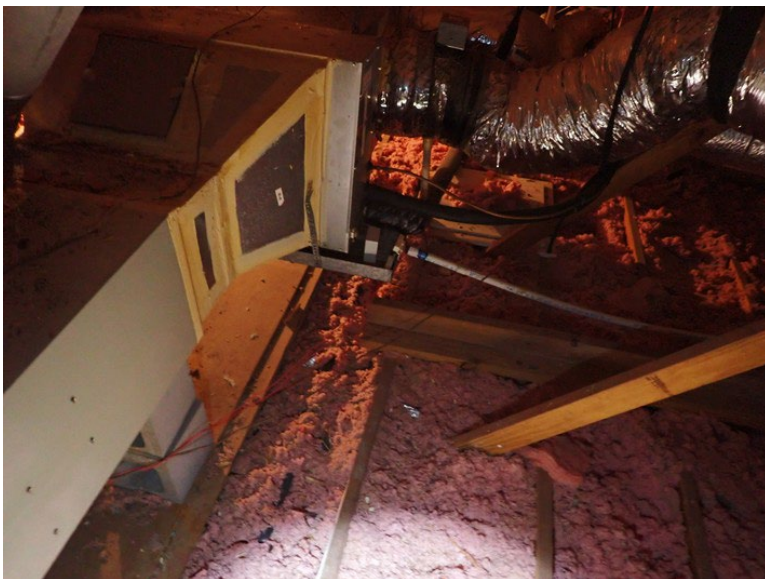
18. There was no service decking provided to service the south zone evaporator coil, which creates a hazard.

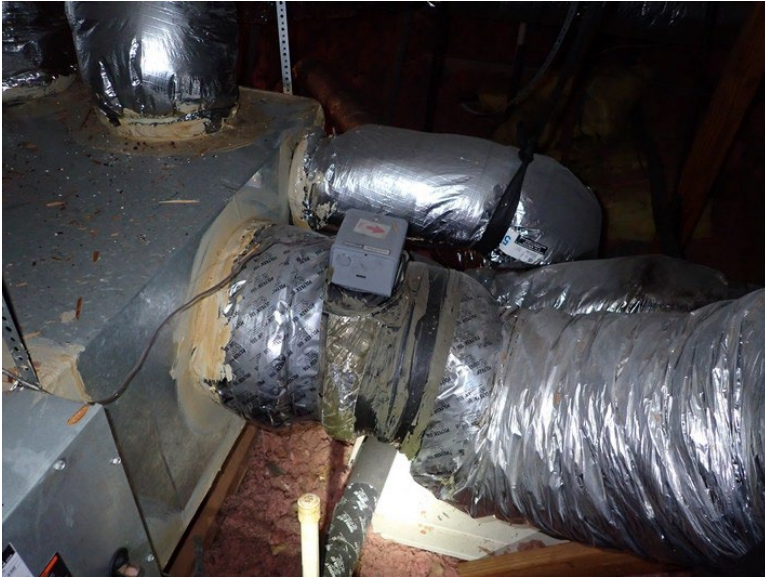
19. There were duct runs to the enclosed porch that appear to be damper controlled. The control mechanism for the damper was not identified, and the damper control was not tested. The controls should be demonstrated by the homeowner, or further evaluation should be made by a licensed repair contractor.

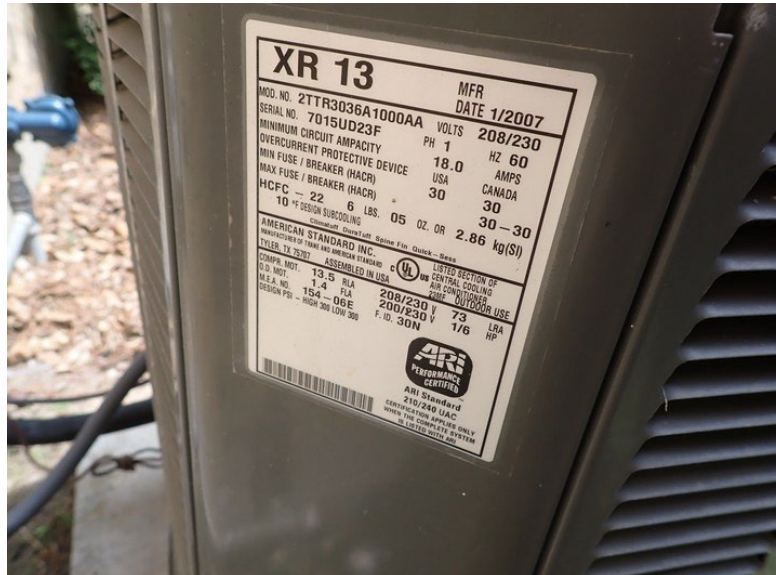
20. Due to the age and condition at the south zone condensing unit and the evaporator coil, it is the opinion of this inspector that the remaining serviceability is limited.

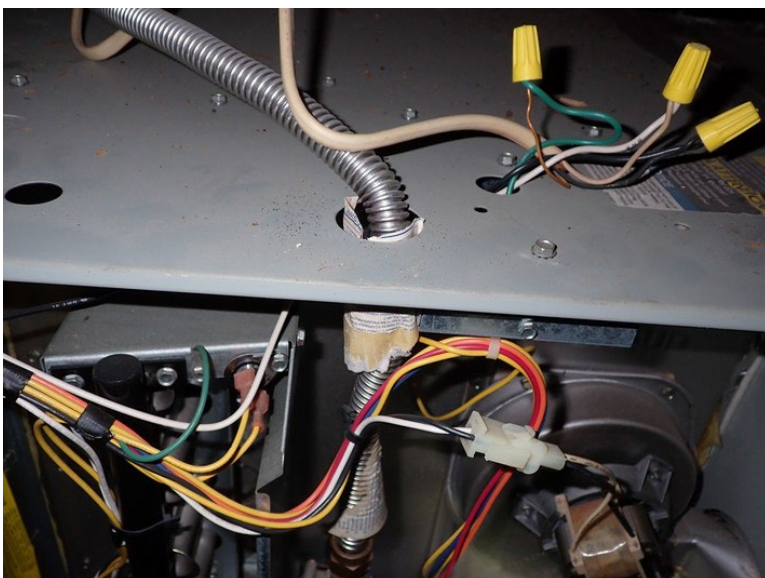
21. Flexible gas coupling was routed into the north zone furnace case. Most codes do not allow flexible coupling to extend inside the case as it is a fire hazard. The gas control valve should be hard-piped to the outside of the case, where flexible coupling should then be attached.

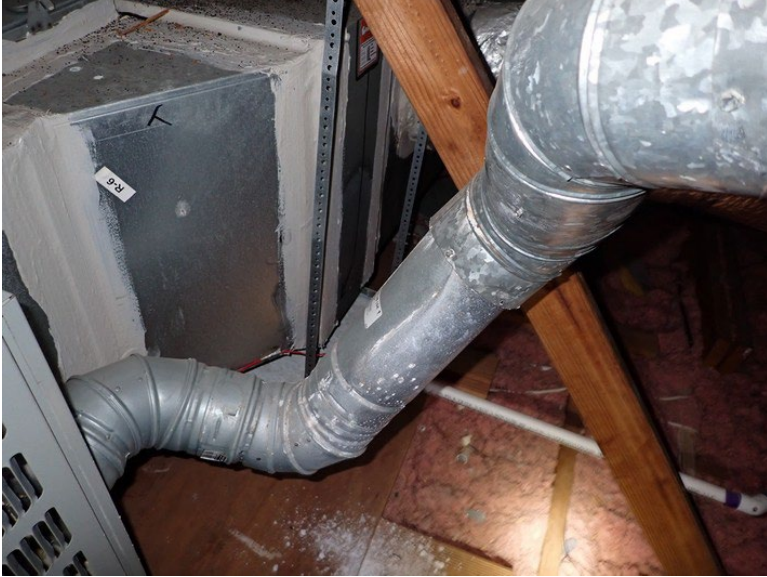
22. The north zone vent flue pipe appeared to be pieced together from segments with poorly made joints and evidence of leaks in at least one joint. This should be investigated by an air conditioning contractor who can repair or replace the flue as necessary.

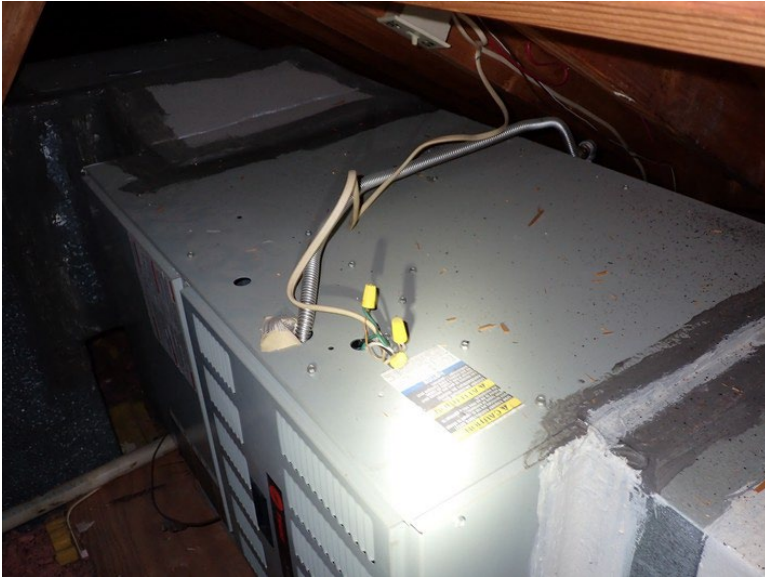
1. Electrical wire splices that were not in junction boxes were observed in the following locations: at the attic, at the north air handling unit, and at the attic over the dinette.

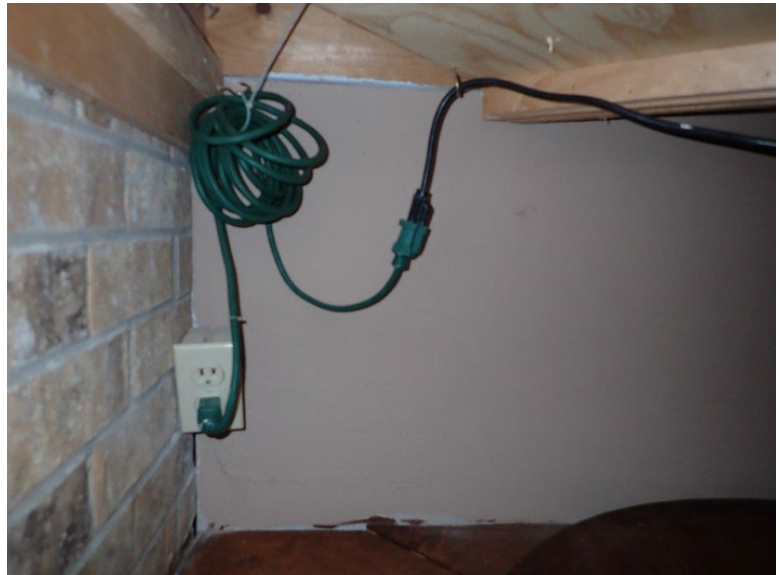
2. Extension cord had been used for powering the kitchen range appliance at the cabinet below the range. This should be corrected by an electrician who can relocate the outlet, eliminating the need for the electric cord.

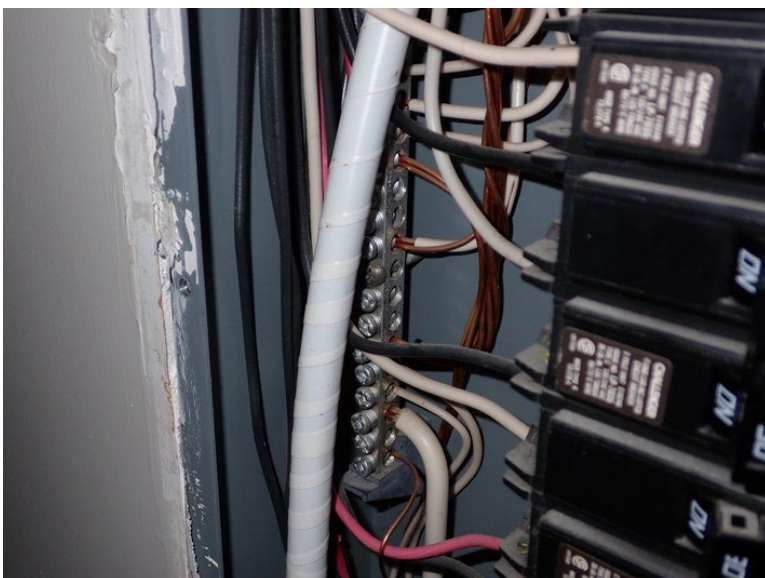
3. Neutral buss connections were made with more than one wire attached at each set screw at the study closet panel box. Normally, only one wire (circuit) is connected to each buss terminal opening. In some cases, this can require expansion of the buss.

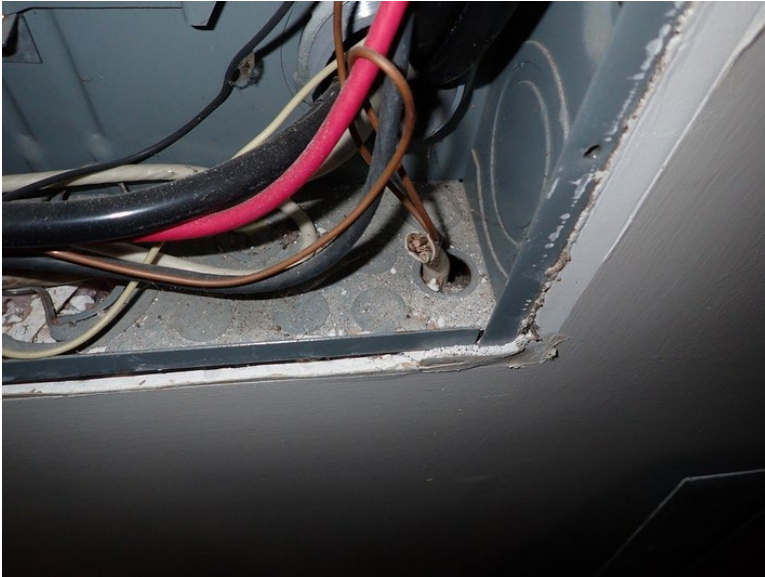
4. Wires in the study closet breaker box were observed to be improperly terminated.

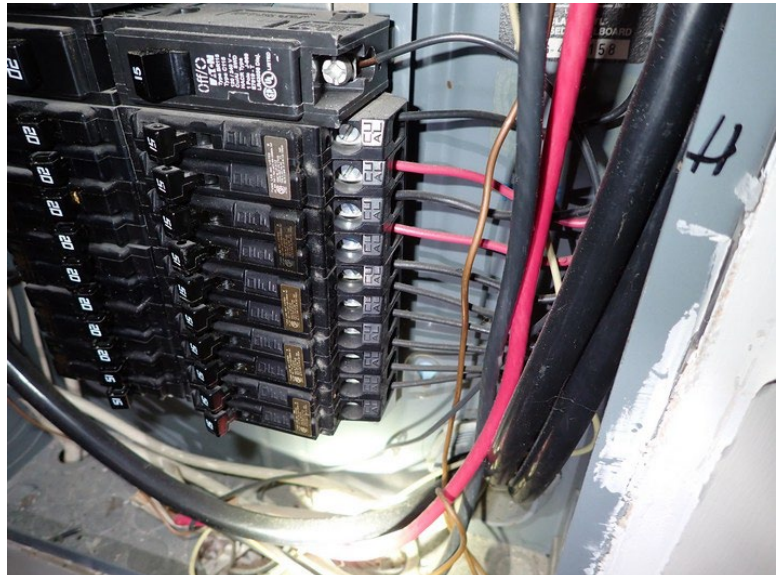
5. Two breakers were observed that appeared to serve a single conductor at the study closet breaker panel box, indicating that conductors may exist that are wired as a 240-volt circuit without appropriate ganging of the breakers serving the conductor to ensure that both legs of the circuit trip. This is sometimes performed to serve kitchen appliances which can share a common neutral {...full text in report}
