Re: 221-B Baker Street, Holmes, Texas

STRUCTURAL INSPECTION REPORT

Mr. Sam Sample
221-B Baker Street
Holmes, Texas
January 1, 2023

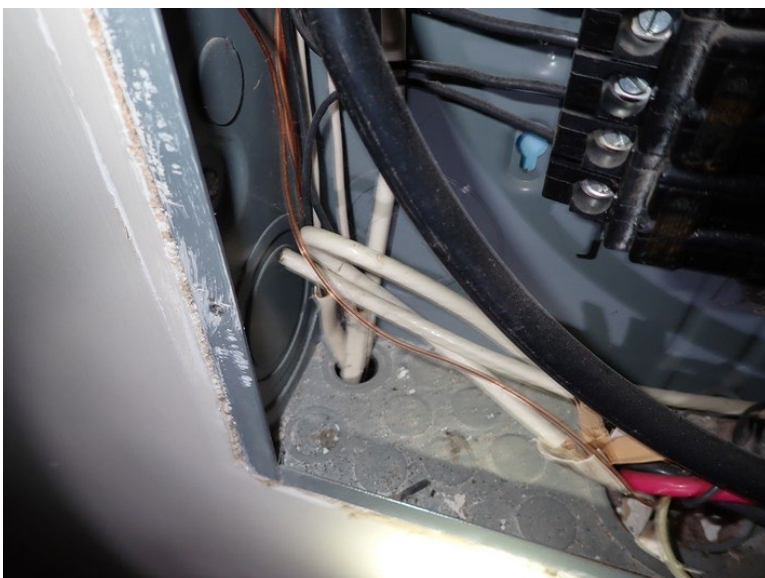
6. Wires had been run through openings in the study closet panel box that did not have strain relief and did not fill the openings to prevent a fire starting at the panel box from spreading to the structure.

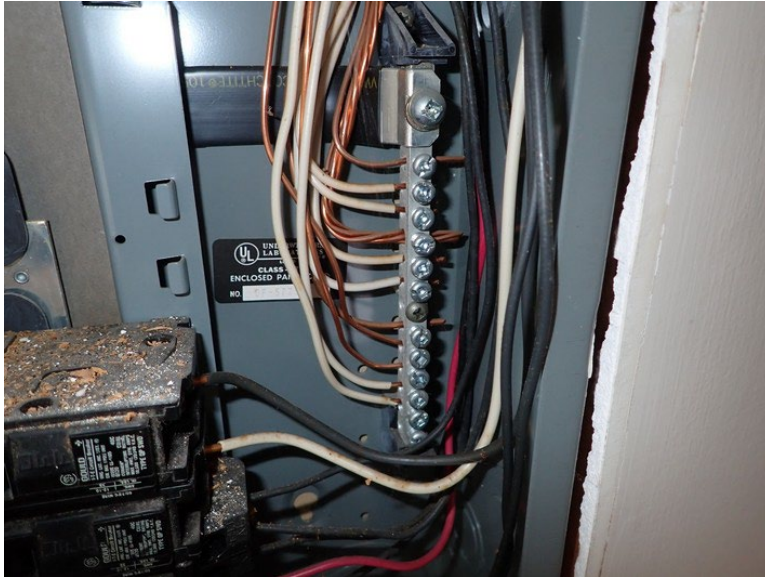
7. The ground and neutral wires were improperly bonded at the sub panel box at the garage.

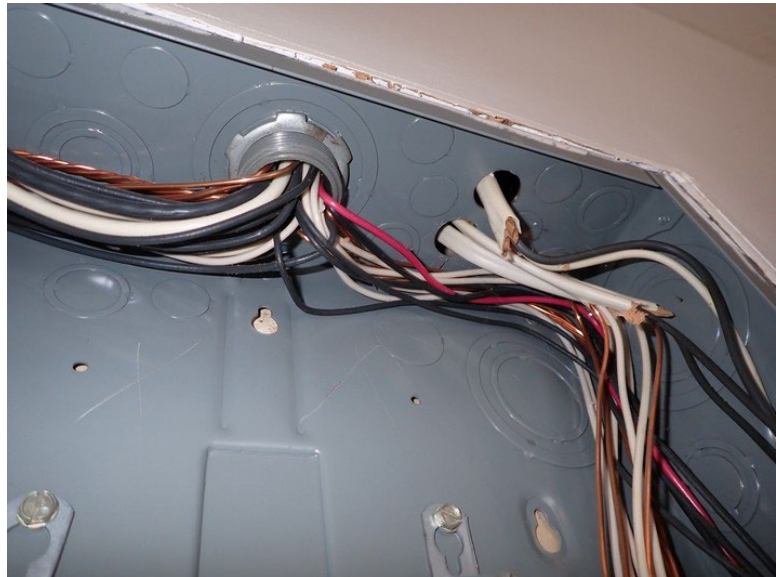
8. Wires had been run through openings in the garage sub panel box that did not have strain relief and did not fill the openings to prevent a fire starting at the panel box from spreading to the structure.

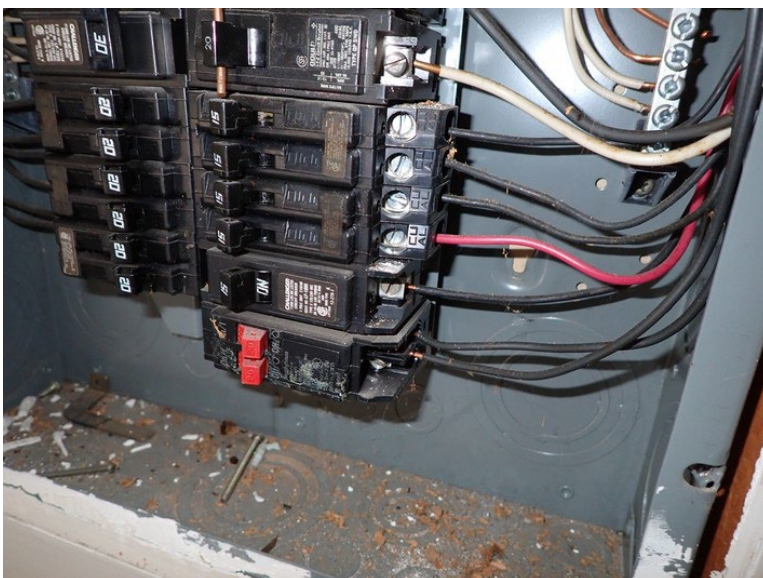
9. Two breakers were observed that appeared to serve a single conductor in the garage sub panel box, indicating that conductors may exist that are wired as a 240-volt circuit without appropriate ganging of the breakers serving the conductor to ensure that both legs of the circuit trip. This is sometimes performed to serve kitchen appliances which can share a common neutral power to a {...full text in report}

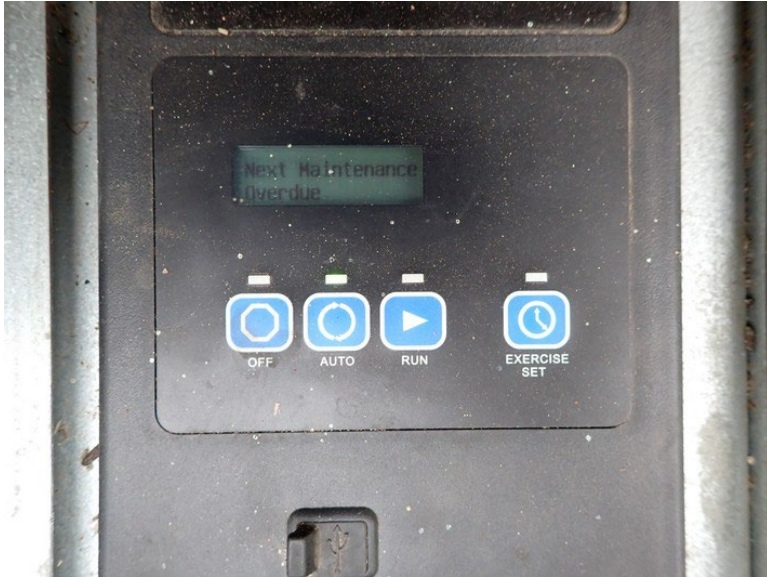
10. The generator control panel indicated a need for servicing of the equipment. The servicing should be made by a contractor familiar with servicing and operation of the equipment or the manufacturer, who can provide a written statement of its condition.
