Re: 1234 Some House Ln., Herein, Texas

FOUNDATION INSPECTION REPORT

Mr. John Doe
1234 Some House Ln.
Herein, Texas
January 1, 2026

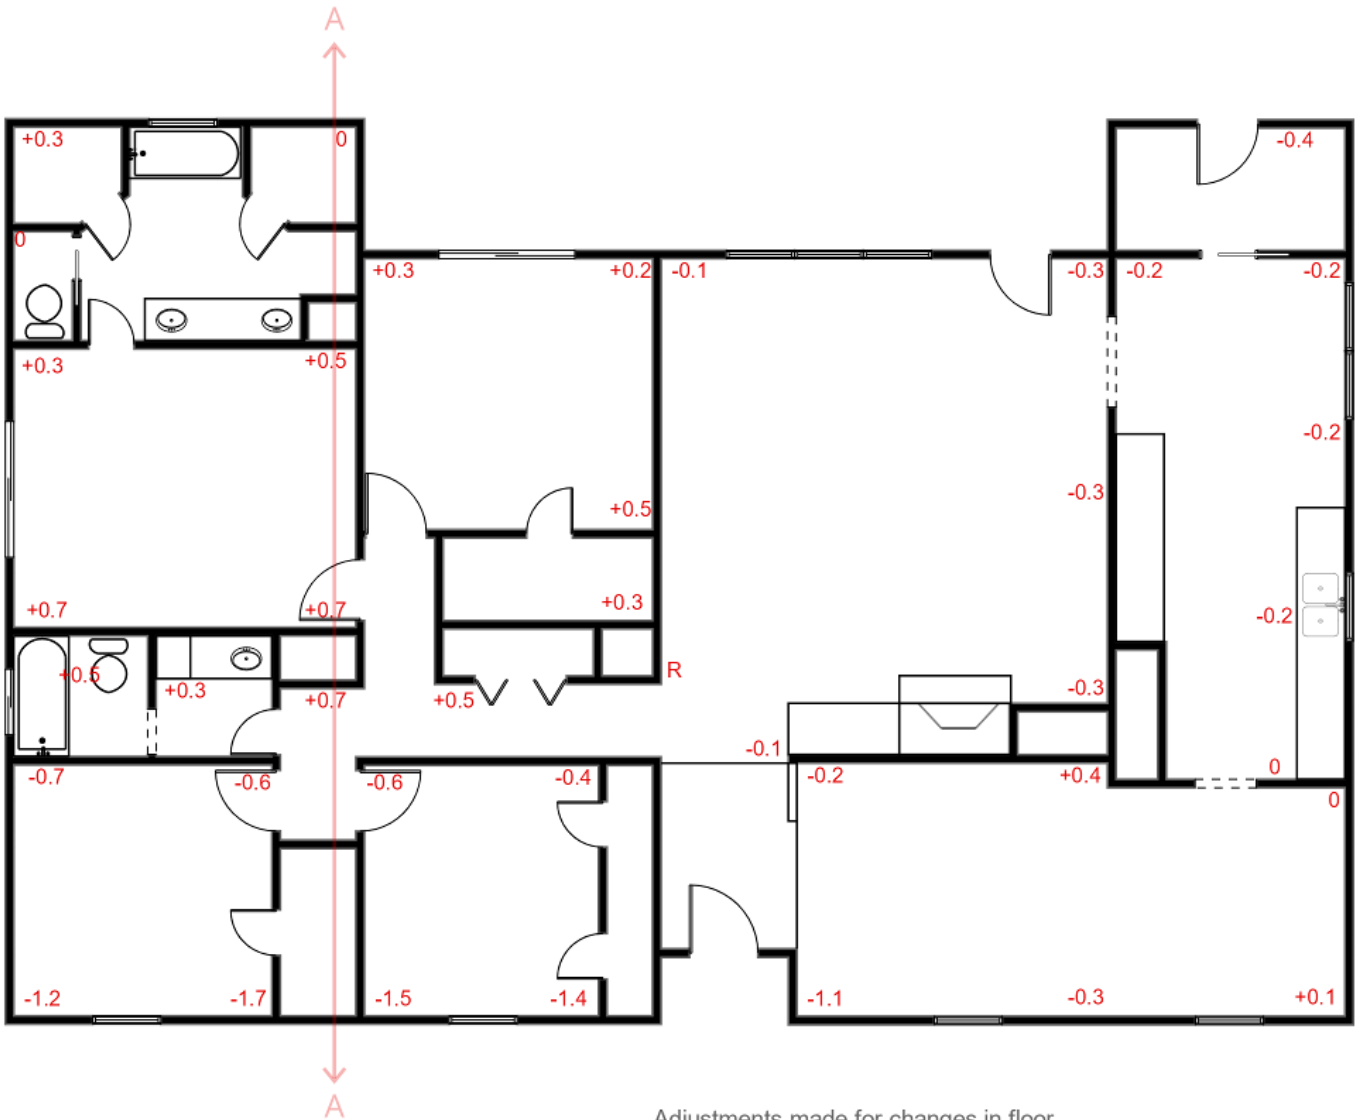
14. The most significant area of differential settlement was determined to be at the northeast side of the foundation at the north side of the building at the north bedrooms. The evidence and/or consequences of differential movement pointed out in the report lead to this conclusion.

18. An analysis of the elevations made at the foundation at the time of this inspection indicates that deflection in the foundation exceeds the guideline for deflection of $L/360$ provided in the Guidelines for the Evaluation and Repair of Residential Foundations issued by the American Society of Civil Engineers for evaluating the performance of residential foundations, where L is the span across the foundation in inches. When deflection is found to exceed these criteria, consideration is normally given to implementing repair to improve levelness of the foundation. Elevation profiles are included with elevation data at the end of this report. Elevations were made using a Zip Level.

- B. If foundation repairs are to be accomplished, the contractor should install drilled footing type piers with bell bottom footings resting on solid clay or press pile type footings to a minimum depth of 12 feet. Drilled footings are preferred but are not used by many repair contractors. Many local municipalities will inspect foundations relevelled inside their city limits. If repairs are not designed by an engineering contractor based upon soils data, city code requirements should be followed as a minimum guide.

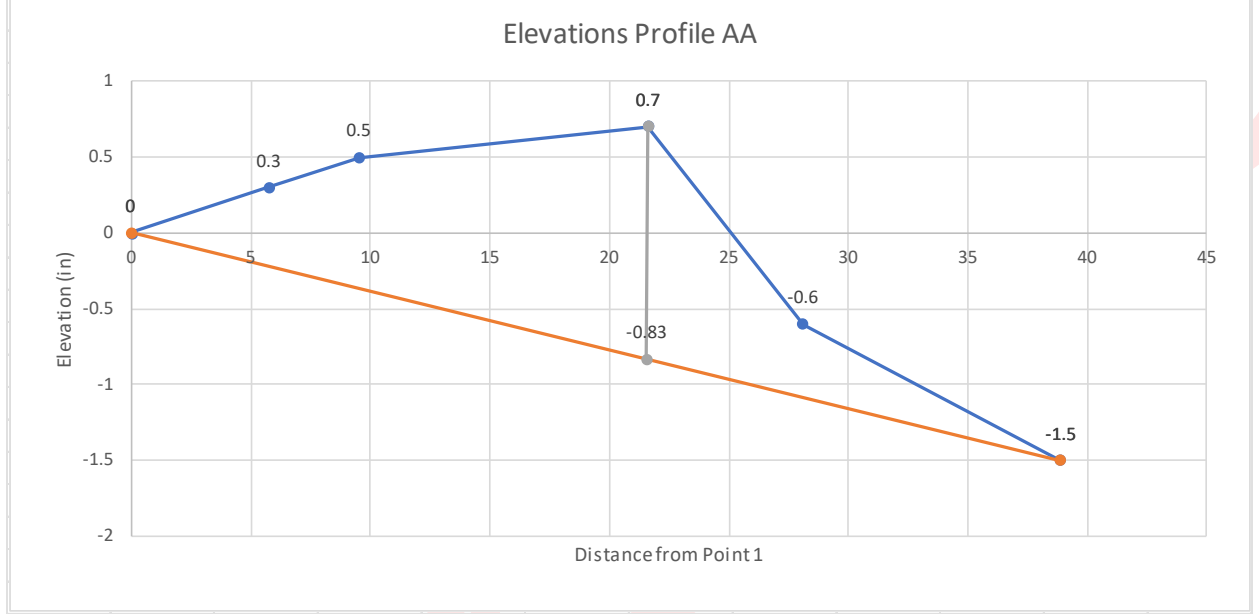
Elevations Profile Line AA											
Point	1	2	3	4	5	6	7	8	9	10	11
L(ft.)	0	5.75	9.52	21.62	28.1	38.89					
Y(in.)	0	0.3	0.5	0.7	-0.6	-1.5					
Deflection	Max Allowable Deflection (L/360)										
		1.53	1.30								
			% Allowable Deflection	% Tilt							
			118%	0.32%

19. An analysis of the elevations made at the foundation at the time of this inspection indicates that tilt in the foundation does not exceed the guideline for maximum tilt of 1% provided in the Guidelines for the
