PROFESSIONAL ENGINEERING INSPECTIONS, INC.

Re: 2094 Huntsville Lane, Houston, Texas

QUALITY INSPECTION REPORT

Mrs. Selma Alabama
2094 Huntsville Lane
Houston, Texas
June 11, 2004

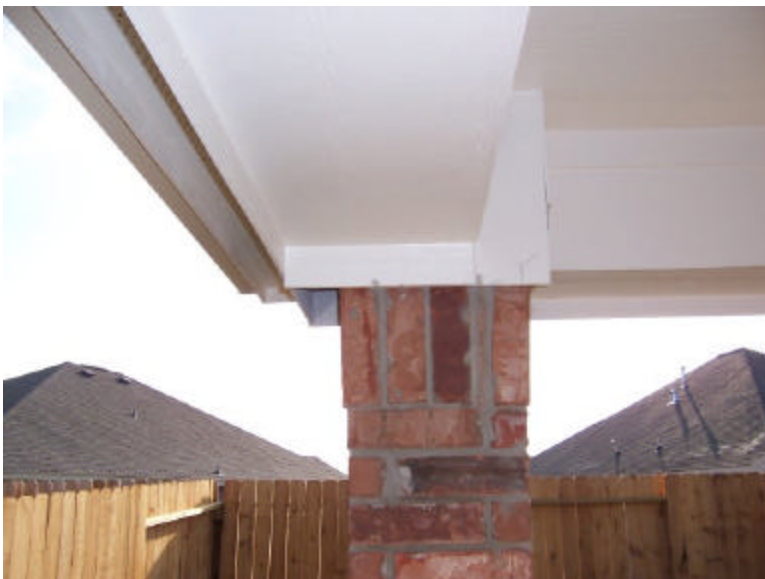
- 6. The column at the northeast corner of the rear porch was improperly located and needs to be removed and replaced in the correct position.
